# Heavy Gas Cherenkov Detector: Window Material Pressure Test

Rory Evans  
University of Regina

October 20, 2016

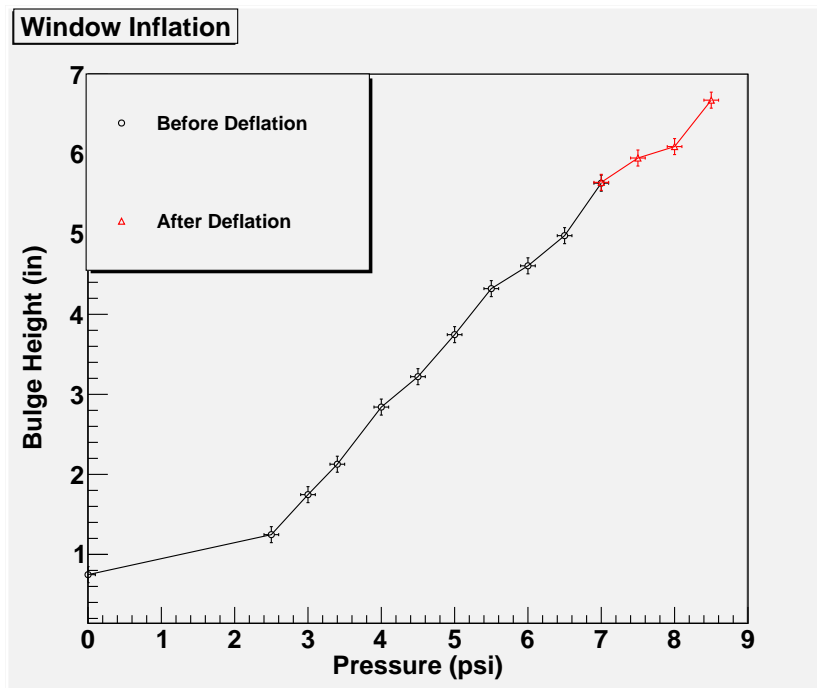
Air was pumped in until the pressure gauge read  $7\text{psi}$ , at which point the material had bulged to a height of  $5.64''$ . The final reading was taken at 4:08pm. The height of the bulge versus the pressure is shown in Fig. 3 by the black points.

At this point we deflated the window to see how well the material would return to its original shape. The tedlar-mylar mostly retained its fully inflated shape, other than some slight wrinkling near the corners of the frame. We then inflated it back to  $7psi$  and, assuming the window had returned to approximately the same height as before, continued to increase the pressure up to  $8.5psi$ . The results are displayed in Fig. 3 by the red points.

Figure 3: Graph showing height of the bulge in the window versus pressure both before and after deflating the window. We assumed that the bulge returned to within error of the same height at 7psi for the second inflation.

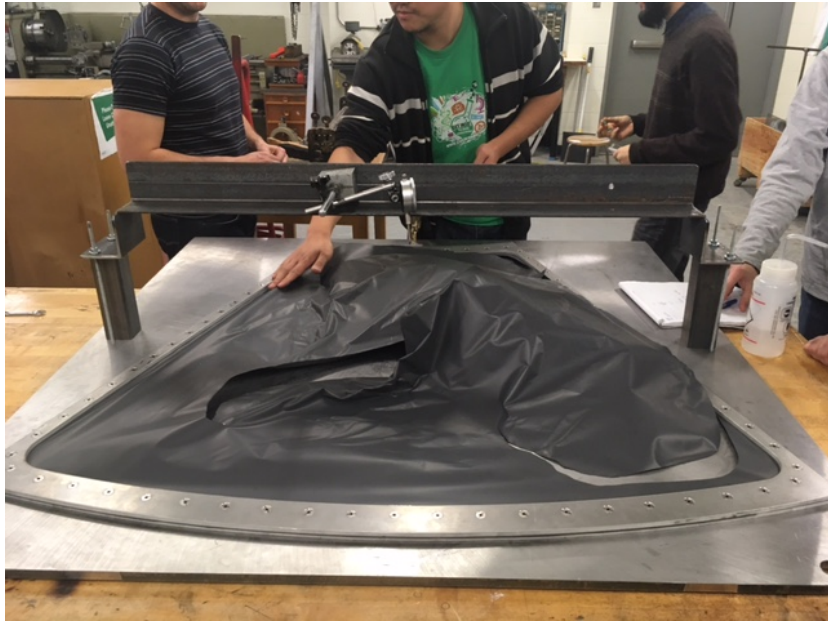
At  $8.5psi$ , and an increase in bulge of  $1.037''$ , we noticed leaking near the edge of the window. The air current from the leak was perceptible by touch, and appeared to be coming from in between the window and the frame. While inspecting the material for the cause of the leak, catastrophic failure occurred, and the window burst. Fig 4 shows the aftermath.

The leak occurred at a point along the window frame close to where the previously noted repair was. The hardened epoxy over the patch may have been a factor in the failure, as the material was not able to stretch at this point.

Figure 4: Photo showing the window after it burst.

Tedlar-mylar with a 5 mil instead of 3 mil internal PET layer had also been previously suggested, but based on the performance of the the three-layer material, we do not expect this to be sufficient either. We are currently considering using the three-layer tedlar-mylar to create the air-tight seal, with a carbon-fiber shell to strengthen the window and minimize the bulging. We will also be testing an aluminum window.
