# Heavy Gas Cherenkov Detector: Window Material Pressure Test

University of Regina

December 5, 2016

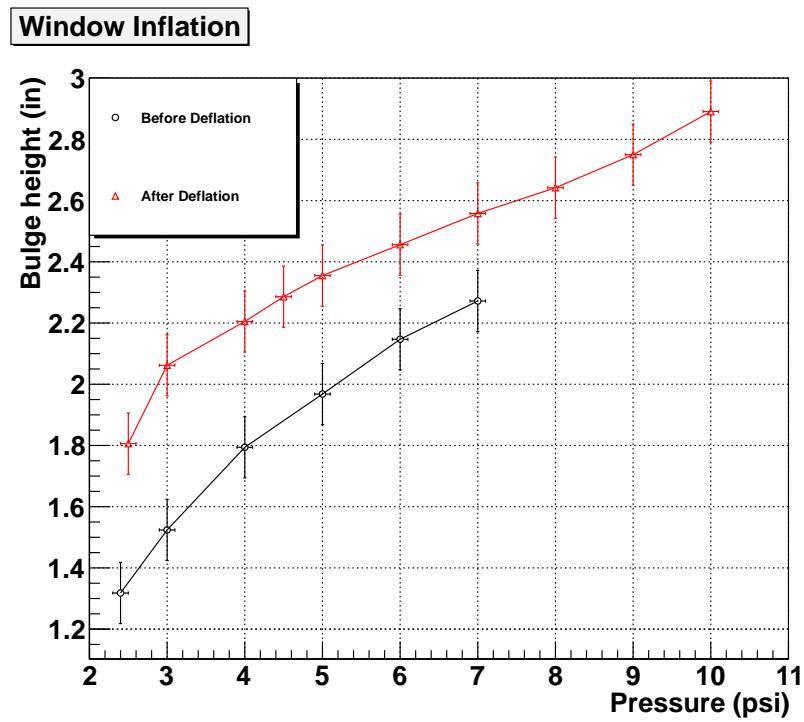
Air was pumped in until the pressure gauge read 7 *psi*, at which point the material had bulged to a height of 2.174". The height of the bulge versus the pressure is shown in Fig. 3 by the black points.

The data in Fig. 3 shows that after being inflated for the first time, the material had become stretched, and stretched more easily upon further inflation. The difference in height on the second inflation is approximately 0.4" at low pressure, decreasing to 0.3" at 7 *psi*.

Figure 3: Graph showing height of the bulge in the window versus pressure both before and after deflating the window.

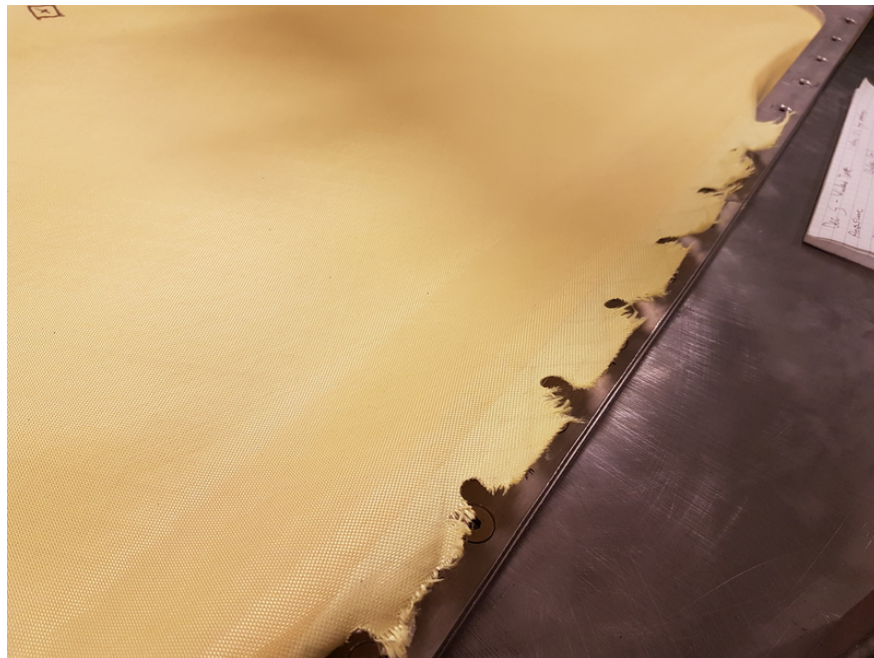
While pumping between 8 and 10 *psi* we noted creaking noises coming from the window. After passing 10 *psi* a portion of the material tore and slipped out of the flange causing the window to burst. The aftermath at the point of failure is shown in Fig. 4. The point of failure was very close to where the mylar-tedlar window failed on the same frame [4].

Inspection of the material and flange after the failure occurred indicates that the point of failure was where the bolts passed through the material. We suspect that as the material pulled through the clamping wire in the flange, the tension started being placed on these bolts. This indicates a flaw in the design of the flange. It is unlikely to be coincidence that both windows failed at the same point on the flange, so there is some particular flaw at this point. Inspection of this area showed no obvious anomalies.

Figure 4: Photo showing the window after it failed.

The bulging in this material does not satisfy the requirements for the HGC. However it is a substantial improvement over the previously tested Mylar-Tedlar, which bulged to 6.1" at 8 *psi*, compared to 2.6" at the same pressure for this material. As such we will soon repeat these tests with a second layer of Kevlar.

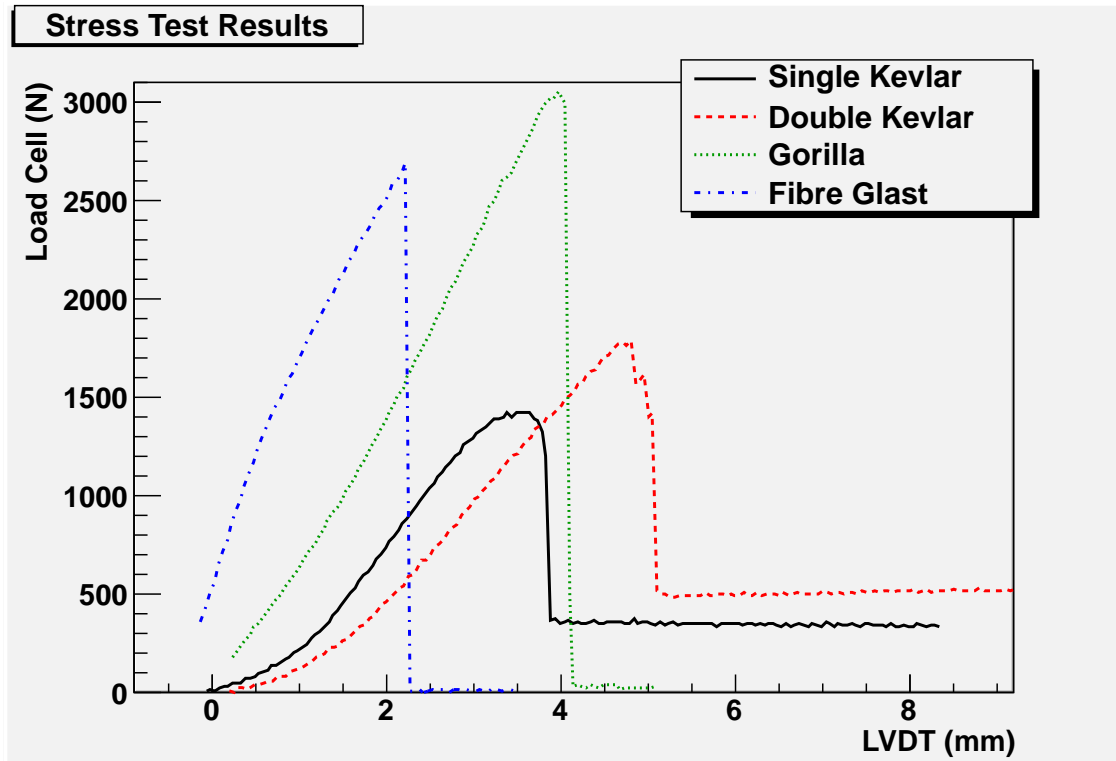
Figure 6: Results from stress test for four different configurations of Kevlar-mylar. The horizontal axis represents the distance the material has stretched. The vertical axis represents the tension in the sample.

The results are shown in Fig. 6. The failure point of each sample can be seen in this figure as the sudden drop in tension. These failures occurred at approximately: 1.4 *kN* for the single Kevlar, 1.5 *kN* for the double Kevlar, 3 *kN* for the Gorilla Glue, and 2.6 *kN* for the epoxy.

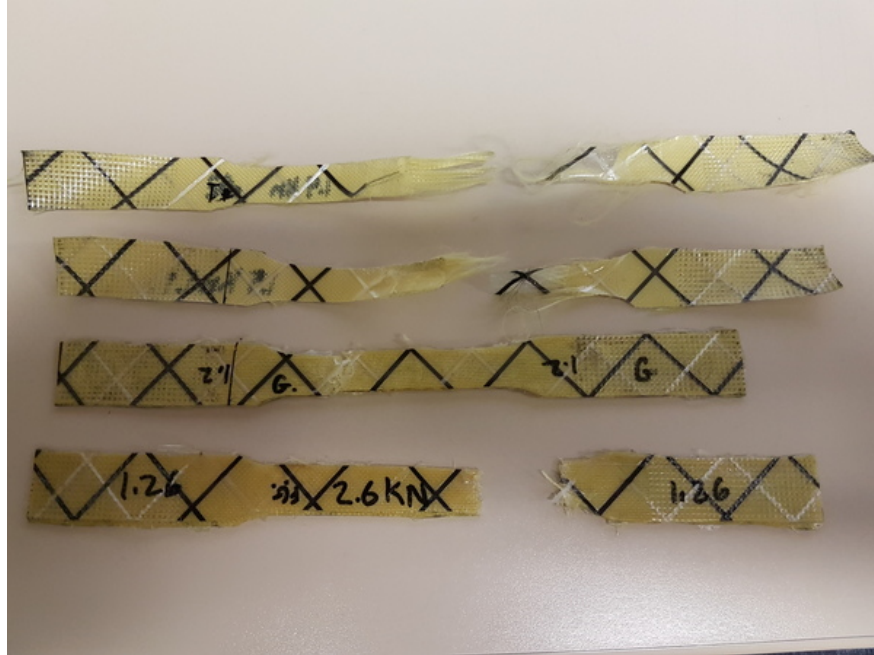
We also note the state of the samples after the failure. See Fig. 7. The single and double layer samples tore apart, leaving frayed strands of Kevlar at the ends. The epoxy sample snapped more cleanly at the failure point. The Gorilla glue sample snapped at the failure point, but remained attached by a few threads of Kevlar.

Figure 7: Stress test samples after testing. From top to bottom: Single layer, double layer, Gorilla Glue, epoxy.

While none of these samples meet our ideal requirements (and only one meets the requirements for a  $3''$  tolerance), we can see that there are substantial benefits the treating the material with epoxy.
