HGC Window Test - Kevlar-Mylar with Circumferential Epoxy Coating

University of Regina

February 16, 2016

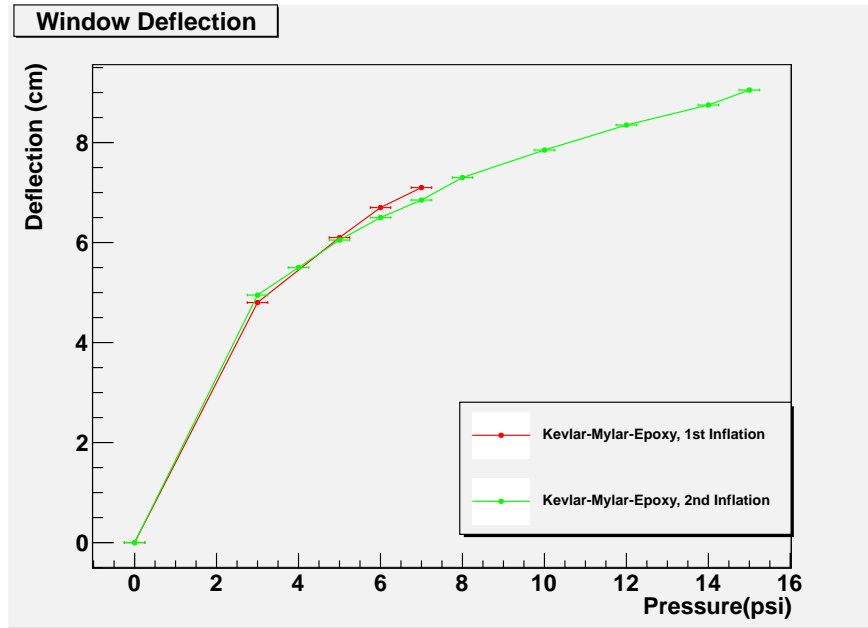
Figure 3: Graph showing height of the bulge in the window versus pressure both before and after deflating the window. Note that there was no soak test between the two inflations, so the difference is minimal.

Air was pumped in until the pressure gauge read 7 *psi*, where the window had bulged to a height of 6.85 *cm*. The deflection versus the pressure is shown in Fig. 3 by the red points.

The bulging in this material does not satisfy current requirements for the HGC. The deflection at 7 *psi* overpressure was found to be 6.85 *cm*. This is approximately 0.25 *cm* greater than the deflection in the same material without the epoxy as found in the previous test [2]. This finding is unexpected as it appears to be contrary to tensile strength tests performed on these same materials both with and without epoxy [2].

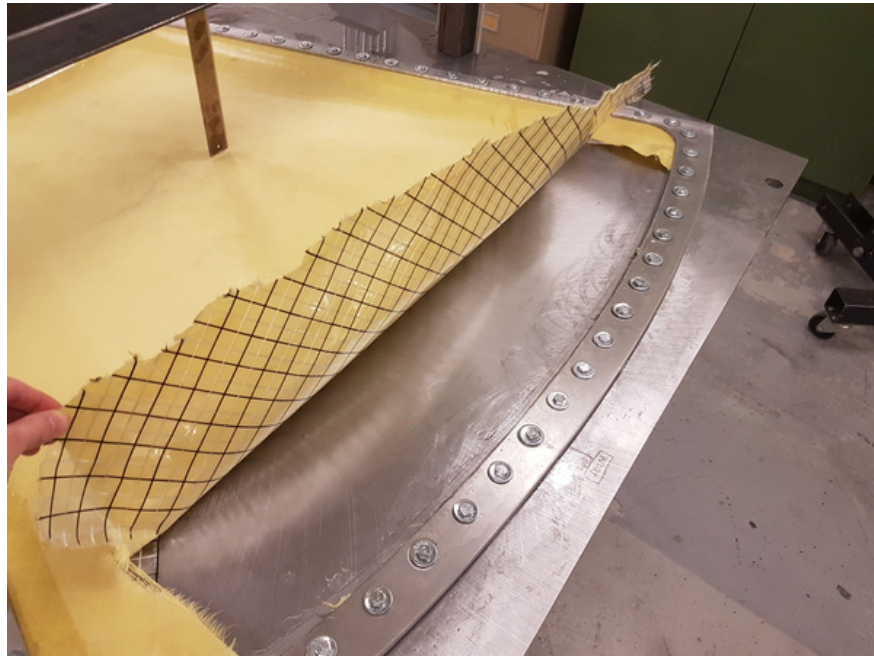
Figure 4: Photo showing the window after it failed.

The window reached a pressure of over 15 *psi* and deflection of at least 9.05 *cm* before failure. While pumping beyond 15 *psi* the material tore from the frame along one edge and burst. The window after failure is shown in Fig. 4.

The maximum pressure reached by this material before failure was at least 15 *psi*, which is a substantial improvement over the previous maximum of 10 *psi* [2]. The point of failure would appear to be shear force at the along the longest edge of the window, rather than slipping from the clamp as before [2].
