# HGC Window Prototyping - July Testing Series

University of Regina

August 16, 2017

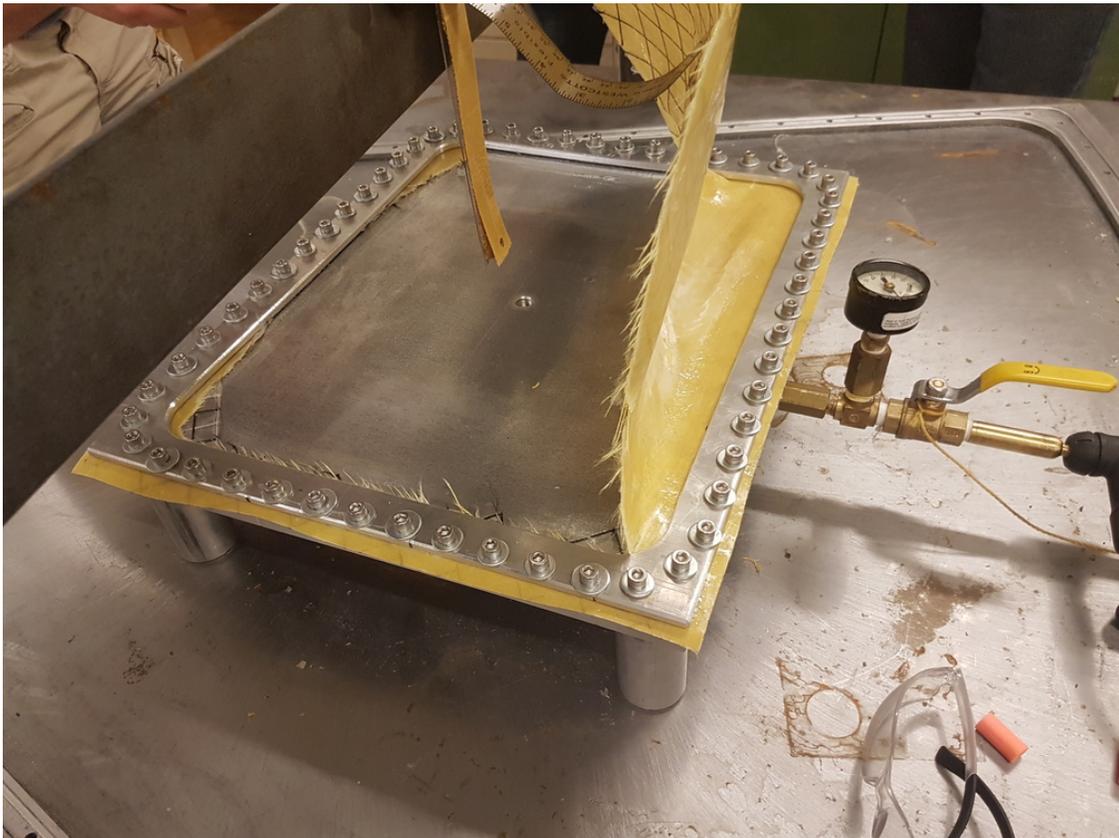
Between 40 and 45 psi, the window burst, ripping along three sides of the frame, as shown in Fig. 6. Fig. 7 shows the window after it was dismantled. It was hypothesized at this point that the window failed due to the sharp edge on the flange against the material. This edge of the flange was therefore radiused for the next test.

Figure 6: Mylar-Kevlar window after bursting during the first test.

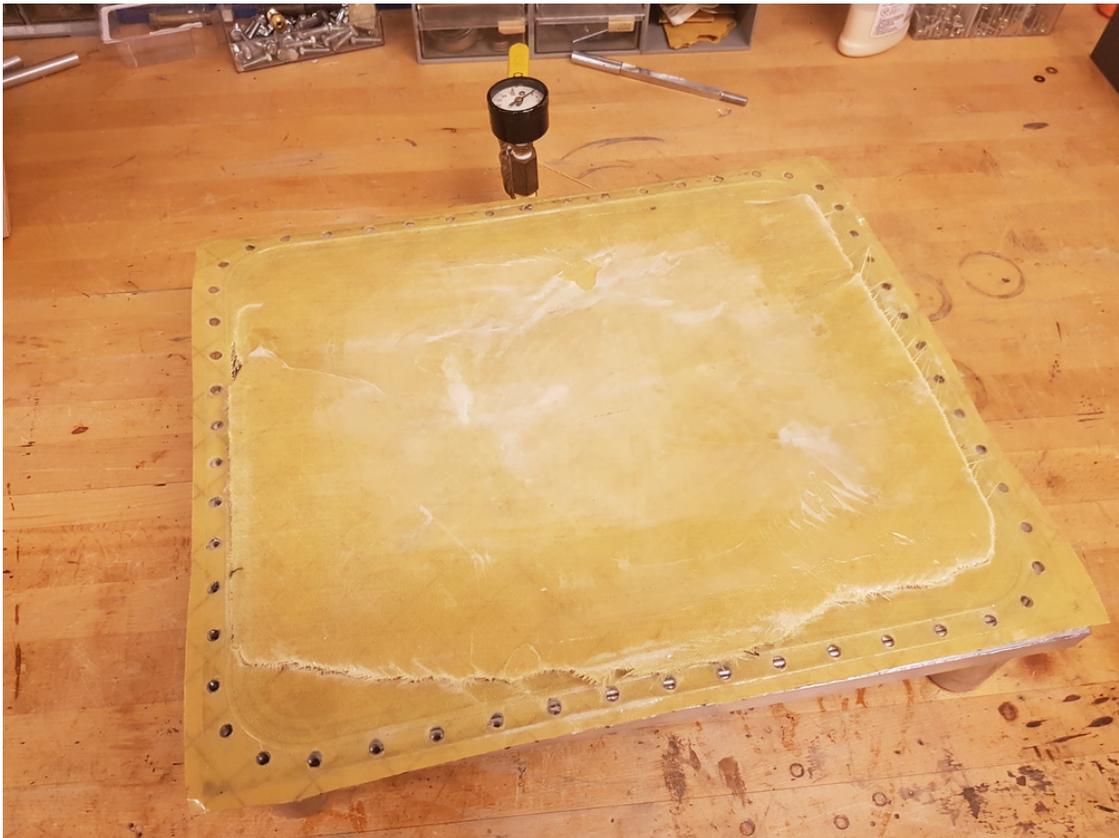
Figure 7: Mylar-Kevlar window after dis-assembly following the first test.

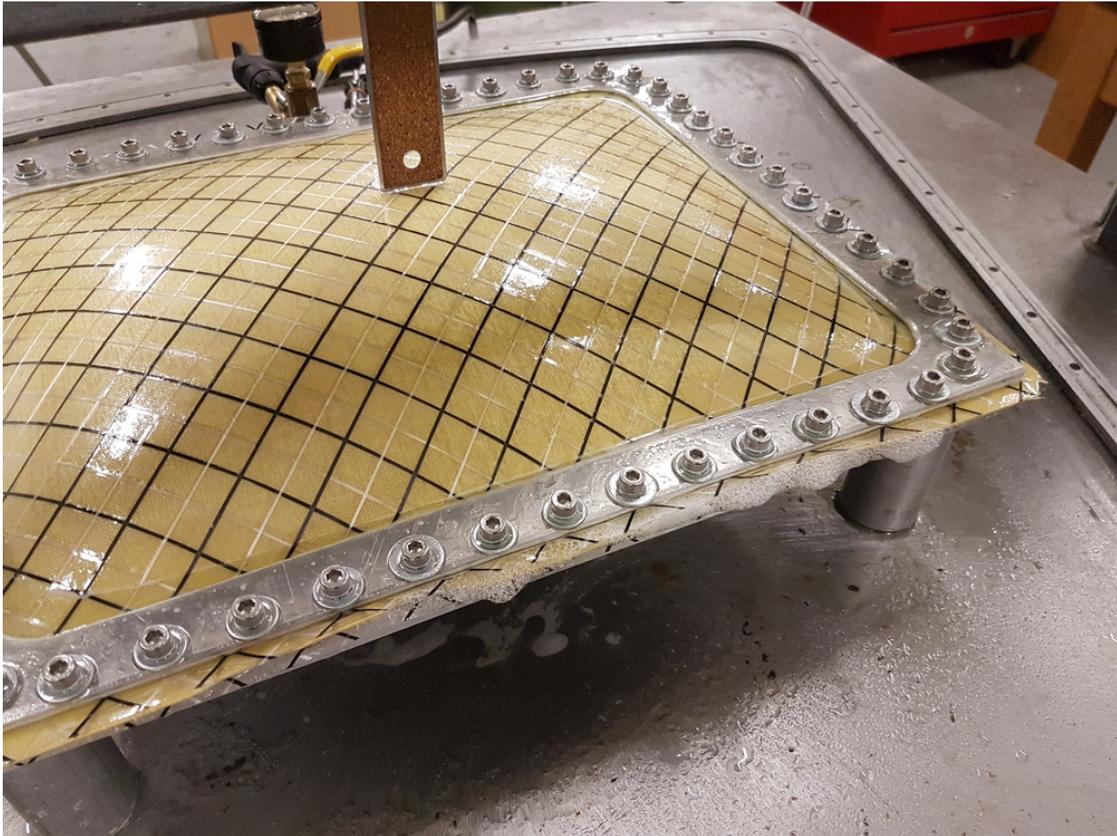
The window was left at pressure for 30 minutes, after which the pressure had decreased to 25 psi. A spray-bottle with soapy water was used to check for leaking, but none was found. The window was re-inflated to 35 psi at which point air was found to be escaping between the material layers. Fig. 8 shows the separated layers, and the soap bubbles indicating the escaping air.

Figure 8: MKKM window after maximum pressure was reached. Soapy water was applied to the perimeter to make any leaks visible.

The bolts were tightened, and this appeared to stop the leaking as it was inflated again up to 52 psi, when the leaking resumed. Curiously, once the pressure dropped below approximately 30 psi the window appeared to stop leaking and maintain its pressure.

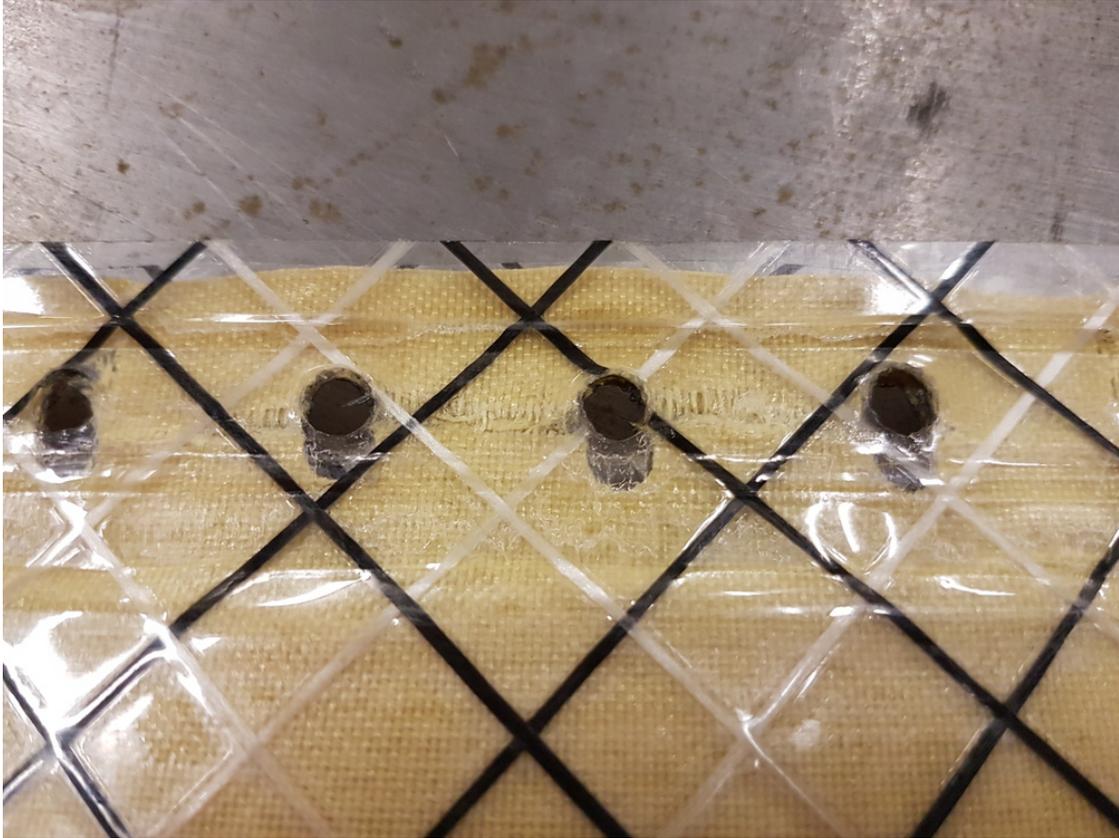
Fig. 9 shows a closeup of one of the edges of the window material after dis-assembly. It appears that the Kevlar layers were drawn inwards, while the Mylar remained mostly in place. As the Kevlar was drawn inward, the force was placed on the material near the bolts, leading to the tear visible here.

It was at this point hypothesized that the upward force of the inflated window was causing a prying action on the flange, weakening the grip on the material. It was then decided to use a thicker flange in order to reduce this effect and maintain grip strength.

Figure 9: Closeup of tear in Kevlar layer of the MKKM window after dis-assembly following the second test. It is clear here that the Kevlar material slipped and tore along the bolt holes when under pressure.

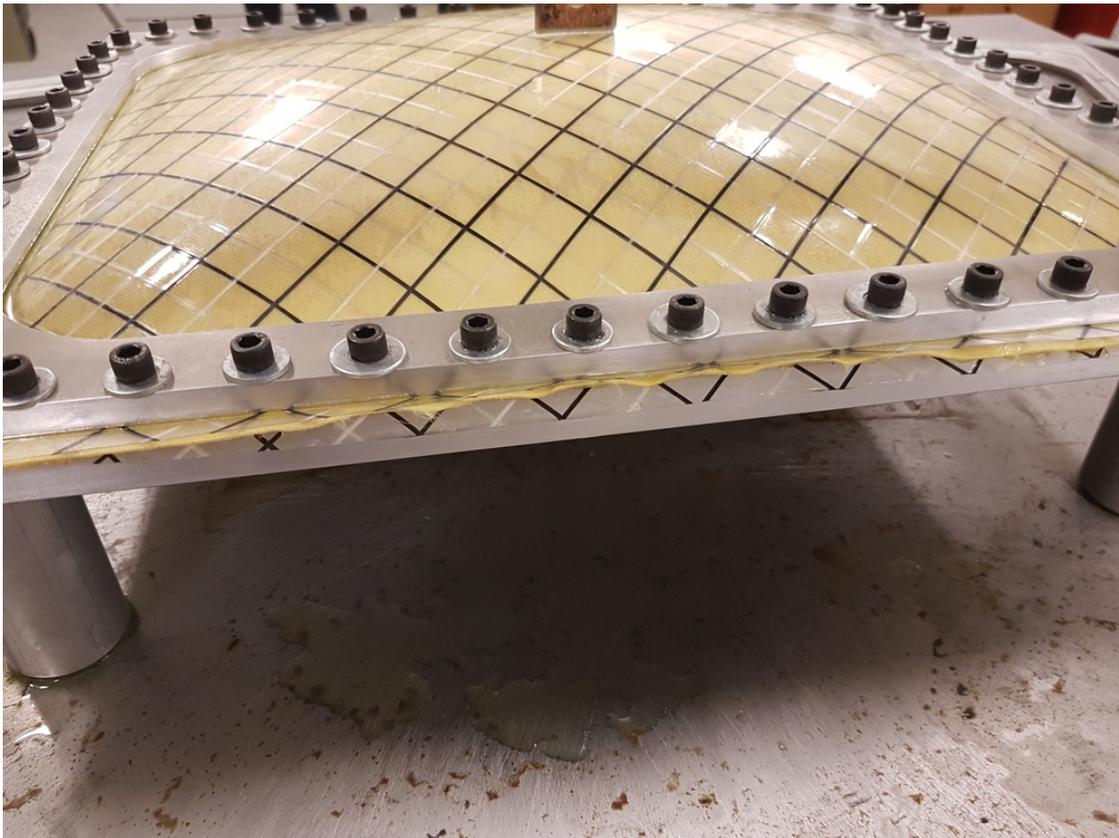
Between 50 and 60 psi, the same edge separation was observed as in the previous test. Fig. 10 shows the separation of the window layers. The window reached a pressure of 60 psi with no apparent failure. With the pump valve sealed, the pressure dropped to 58 psi as the window expanded an additional 2 mm.

Figure 10: Separation of material layers in the MKKM window during the third test.

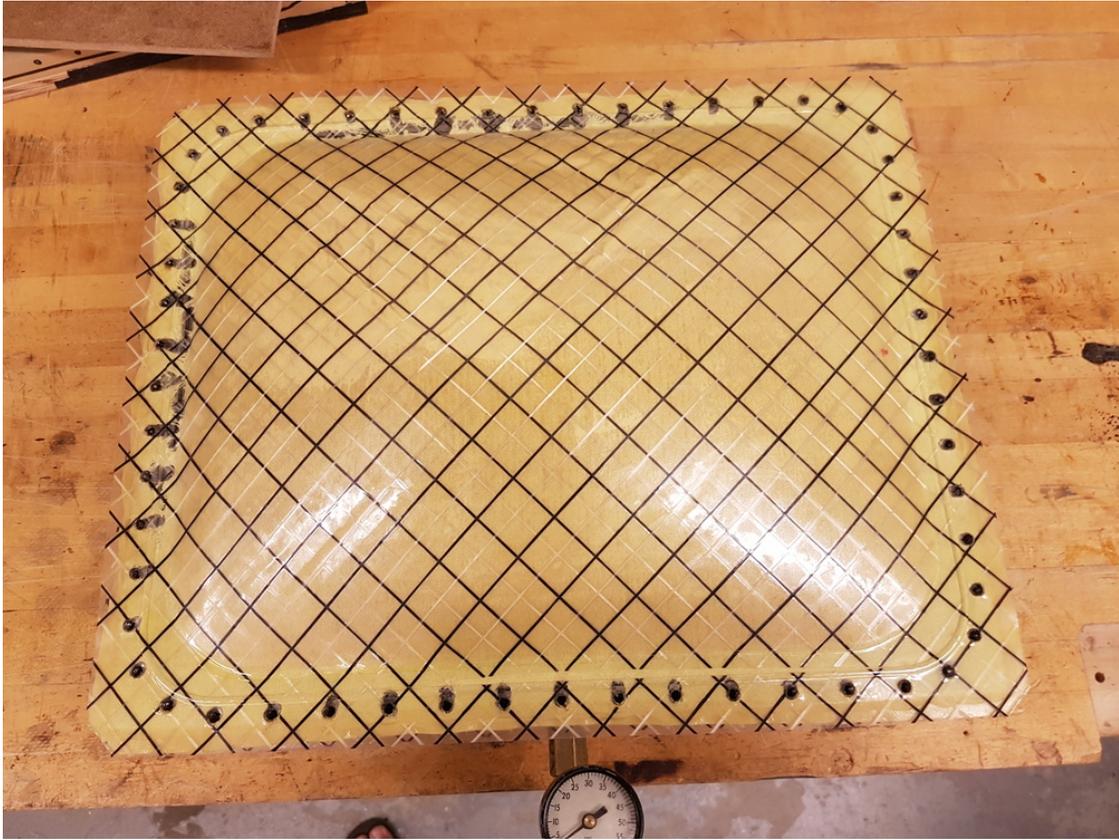
Fig. 11 shows the window material after dis-assembly. Despite the fact that this test appeared to be an improvement over the previous test, the damage to the Kevlar layer was much more extensive. Fig. 12 shows a closeup of the edge of the window at the top of Fig. 11. Once again, the two Mylar layers seem to have remained mostly in place while the Kevlar slid between them, tearing at the bolt holes.

Figure 11: MKKM window after dis-assembly following the third test. Note the extensive tearing at the top and left.

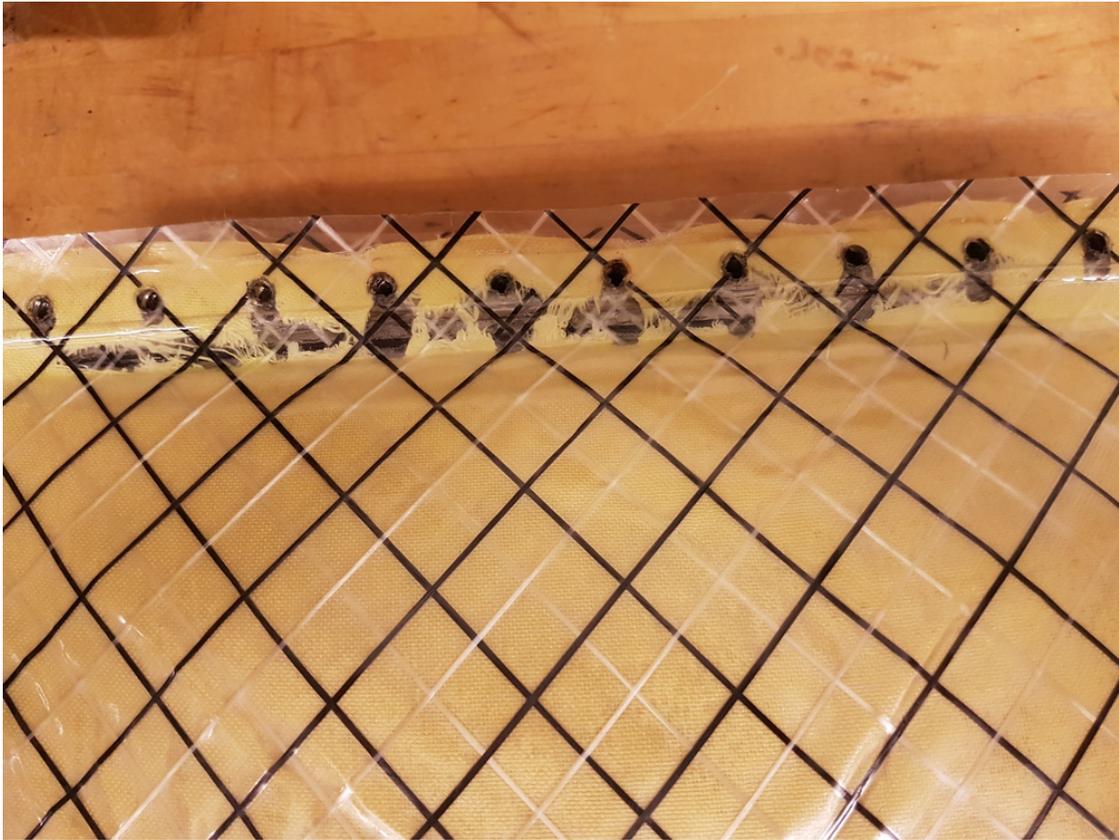
Based on this damage, it was hypothesized that the friction and adhesive between the Mylar and Kevlar was not enough to hold the Kevlar in place. It was suggested that removing the top layer of Mylar might improve the grip by allowing the clamping wire to contact the Kevlar directly.

Figure 12: Closeup detail of damage to the Kevlar layer in the MKKM window following the third test.

It was also noted after dis-assembly that the two layers of Kevlar, bound together by the epoxy, could be pulled apart (by hand) with significantly less force than the Mylar from the Kevlar, which were bound with the included adhesive. It was therefore decided to also forgo the epoxy in the next test.

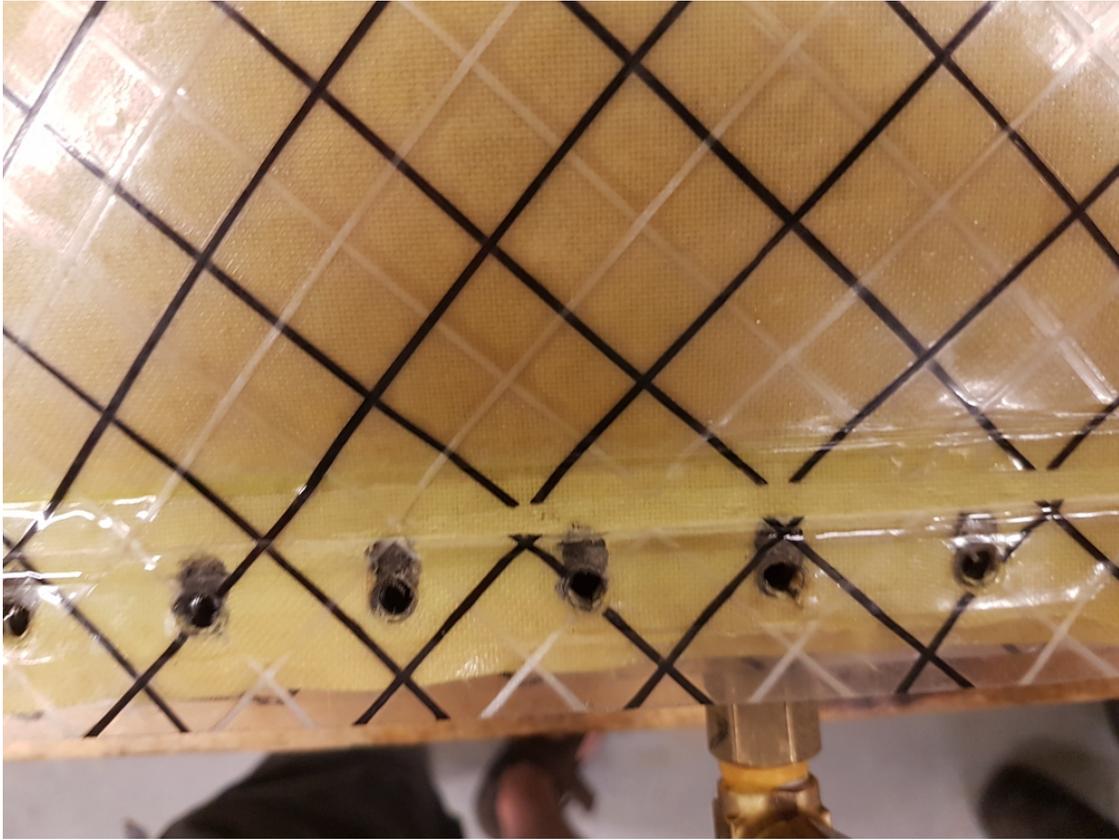
Further damage was noted at the edge at the bottom of Fig. 11, as shown in Fig. 13. Here, the top layer of Mylar had been cut along the location of the wire groove. It was suggested that the wire groove in the flange had a sharp edge against the material, and so the groove was filed to be round for the next test.

Figure 13: Closeup detail of damage to the top Mylar layer along the location of the wire groove, after the third test.

This test also used the 3/8" flange as in the third test, with one additional modification: The groove for the clamping wire was filed from the original rectangular cross section to a rounded one. This was done to remedy damage caused by the wire groove during the third test (see Section 2.3).

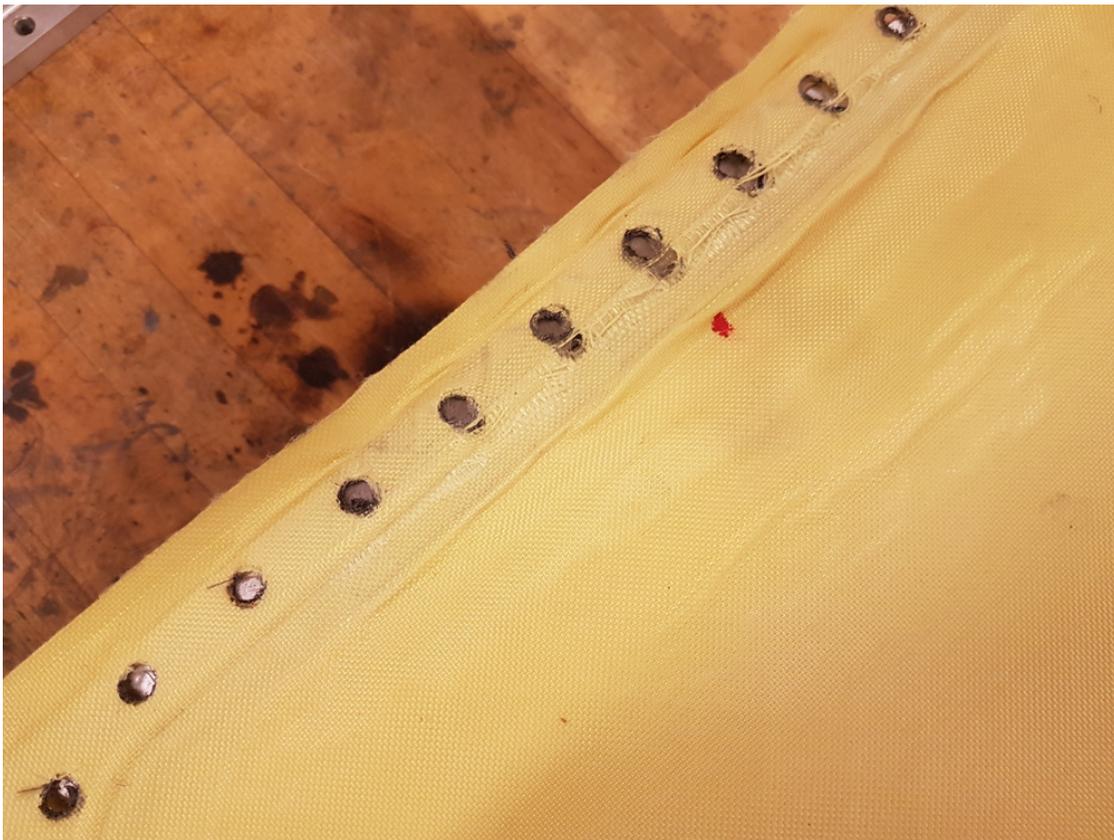
The damage to the window material was similar to that seen in previous tests, though less extensive. Fig. 14 shows the only tear in the Kevlar layer after this test. The red dot shows the location of the bolt through which air was escaping. It was noted that this point lined up closely with the welded joint in the clamping wire.

Figure 14: Closeup of damage to the Kevlar layer after the fourth test. The red dot indicates the bolt hole which was found to be leaking while under pressure.

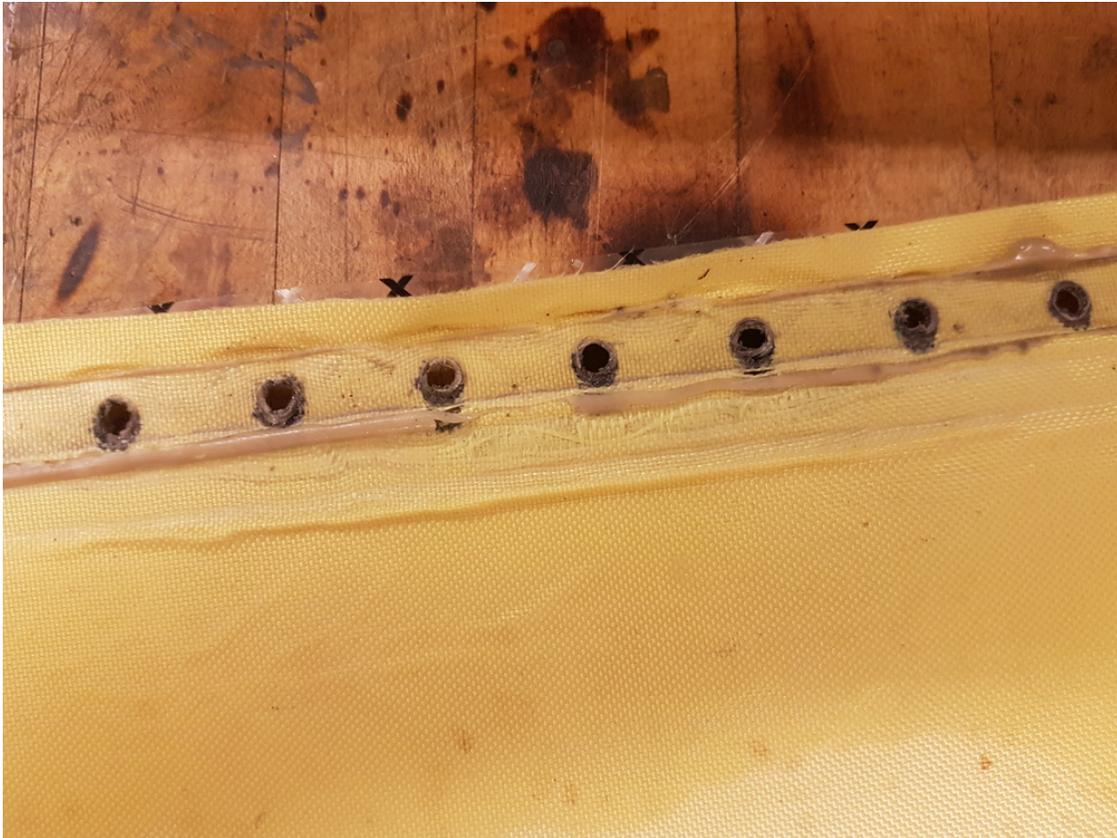
It was decided then that nothing more could be learned from this window and it was dis-assembled. Similar damage to that found in the fourth test was found at one edge, as shown in Fig. 15.

Figure 15: Closeup of damage to the Kevlar layer after the fifth test.
