# HGC Window Prototyping - Carbonfiber Testing Series

University of Regina

February 26, 2018

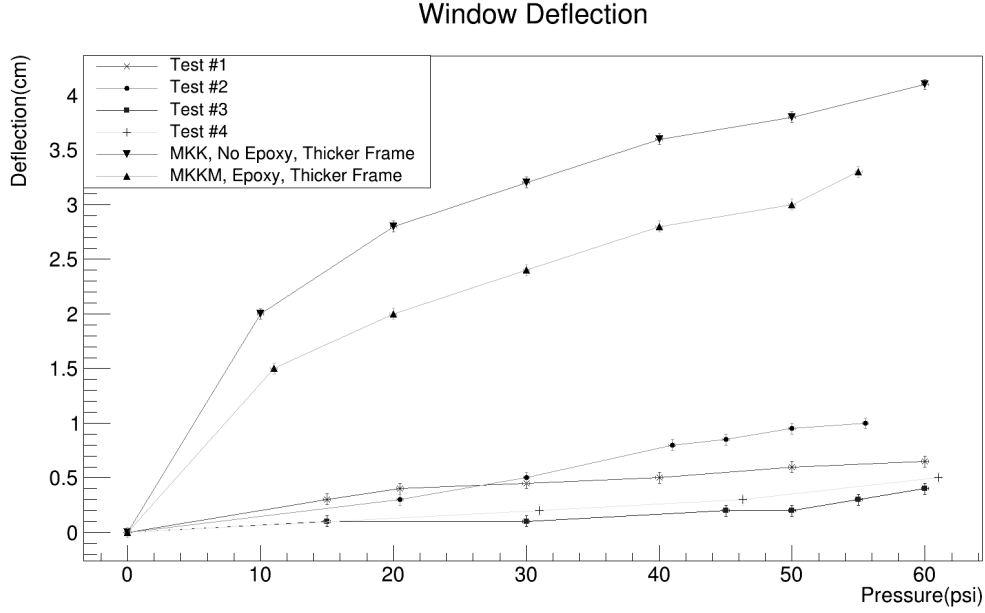
The two flat carbon fiber windows failed at less than 40 psi. These initial mock-ups indicated that a harder epoxy was needed, and that the shell should be given some initial depth.

Figure 15: Deflection past the original depth of the four miniature window tests, and comparison with best of previous Mylar-Kevlar tests.

During this test, the creaking sounds were greatly reduced, indicating an improvement in the deeper shell design. However the pressure seal again failed at 60 psi, leaking air through the bolt holes. Upon disassembly, the carbon fiber was noted to have cracked underneath the flange, which possibly caused the seal to fail, while maintaining the integrity of the load bearing part of the window.

The “sandwich” design of the fourth test seems to have addressed the pressure seal issues. The window reached 60 psi with only minor creaking and had no noticeable leaking. The window maintained this pressure for just over 3 weeks before it was deflated for inspection. The shell and Mylar were both found to be intact. At this point, this test was the most significant success thus far, however this design has the drawback of the window material being permanently fixed to the frame. This may be acceptable for the final manufacturing of the HGC, however it is undesirable during the prototyping phase.

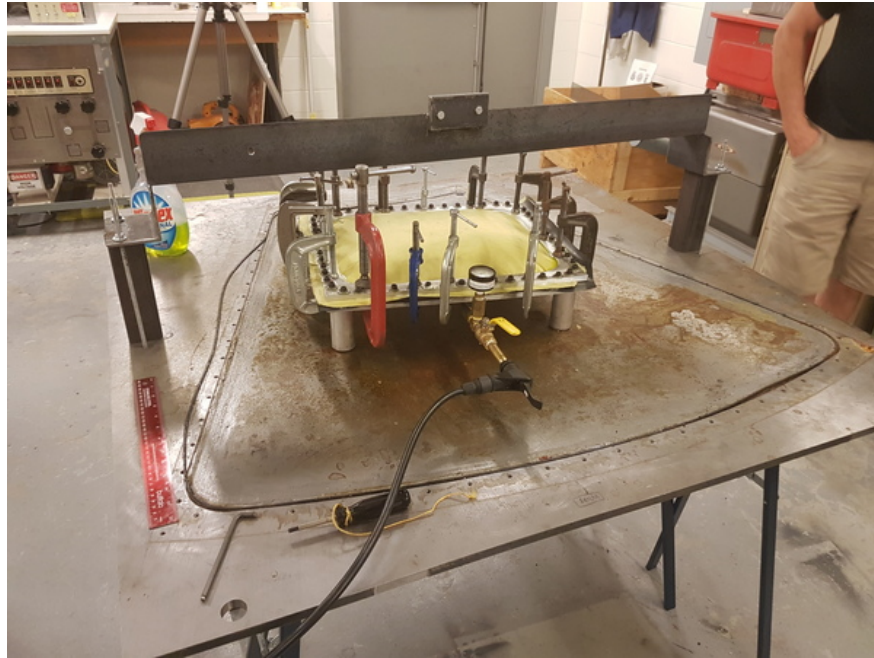
Throughout this test, shell #1 was observed to make creaking and popping sounds as pressure was increased. At around 40, psi the window was found to be leaking between the frame and bolt holes, and by 60 psi, the leak rate was outpacing the pump. C-clamps were applied around the edge to try to reduce leaking (Fig. 16), and was moderately successful, though leaking was still significant. This suggested that while the window was holding the stress, the pressure seal was failing due to poor contact with the o-ring.

Figure 16: Reinforcement of window frame using c-clamps.

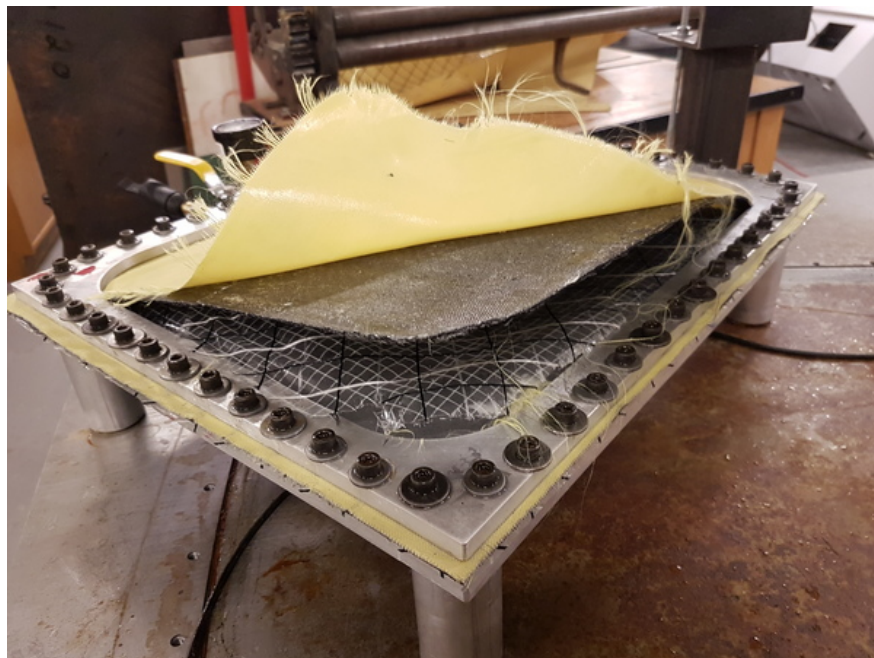
When retesting shell #1 with the clamping wire in place and a new Mylar sealing layer, the creaking was noticeably louder, and after a large pop, deflection began to rise much more rapidly. The shell was suspected to have been compromised and testing was halted. The decision was made to force a failure of this window to observe failure mode (Test 2.5). The window was inflated to 60 psi, where it remained briefly before the carbon fiber burst, tearing the Kevlar with it. The Mylar remained briefly intact before bursting. Fig. 17 shows the aftermath of the window failure.

Figure 17: Aftermath of test #2.5.

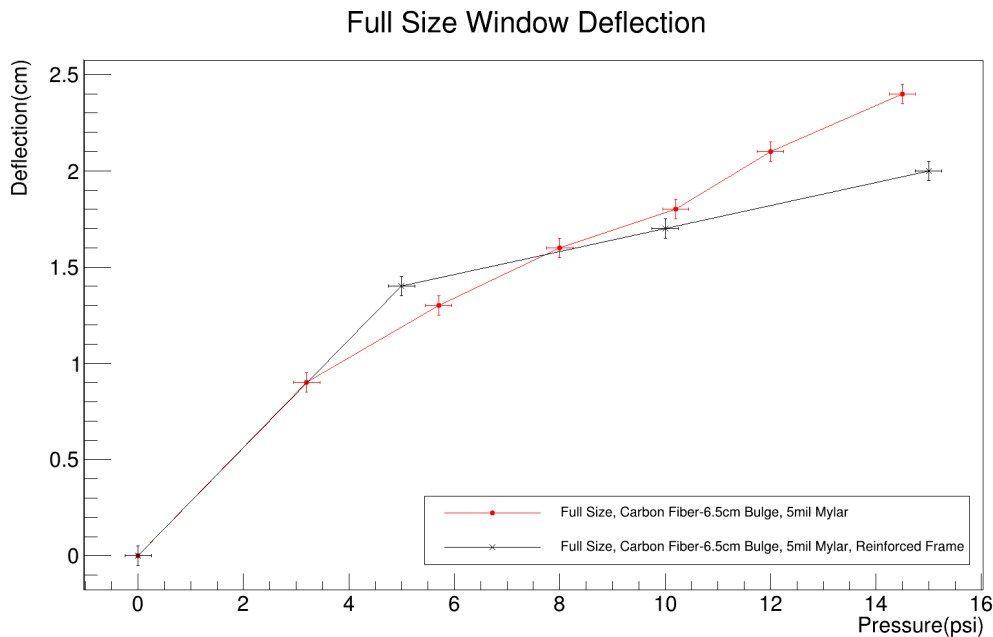
The deflection of the window during the two full size window tests is shown in Fig. 18. In the first test, the window began to leak from the long, straight sides underneath the flange above 12.0 psi, losing about 0.5 psi before stopping. The window reached a maximum pressure of 14.5 psi with no damage to the shell, however leaking continued through the side, so testing was discontinued.

Figure 18: Raw deflection data of the two full size window tests.

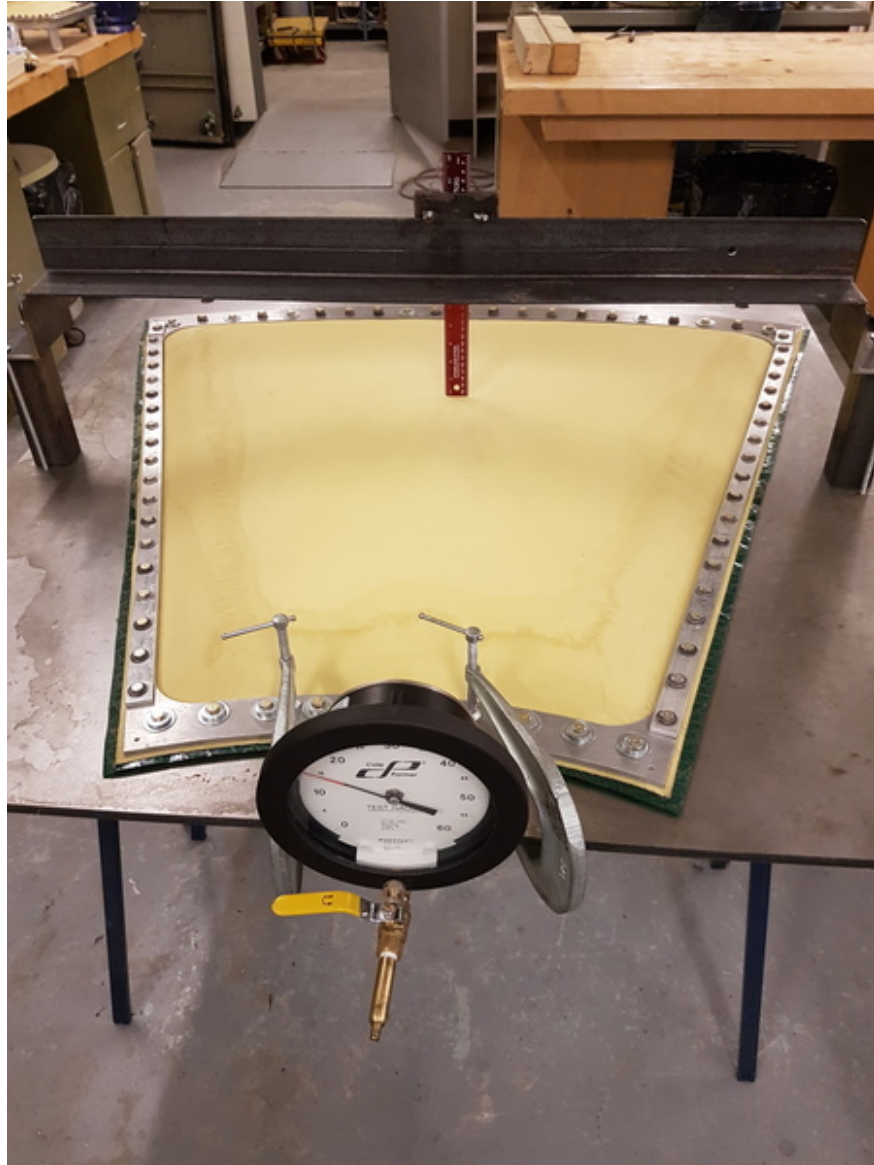
In order to address the side leaking, 1/4" thick Aluminum bars were added to the straight sides of the window frame in order to simulate a thicker frame and increase the force on the o-ring (Fig. 19). During this test, the window reached a maximum of 15 psi with no detectable leaking. The window was left in this state on December 1st. By December 4th (three days later), the pressure had decreased to 14.4 psi, however it had also expanded by an additional 4 mm. At this time, the window was reinflated to 15 psi. By December 8th, the pressure decreased again to 14.8 psi, but it remained at this point until at least Dec. 21. At some time after this date, while unattended, the window pressure decreased to 5 psi and was unable to maintain pressure again. This indicates that the pressure seal had failed. Analysis after dissassembly showed no obvious cause.

Figure 19: Reinforced full-size window.
