# HGC Window Prototyping - Full Scale Carbon Fiber Testing Series

#### University of Regina

August 20, 2019

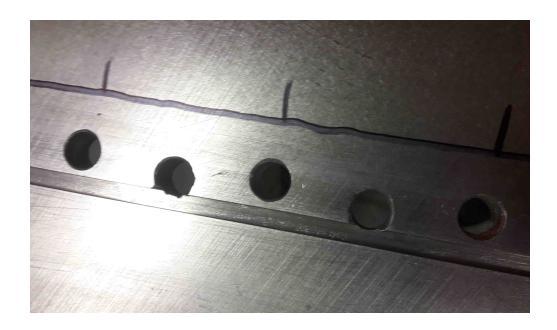
The window frame that was used during these tests was the original mock up of the design from 2015. Since its creation, several flaws have been found with the design, in the most recent design these have been addressed. The first draft of the window frame (Figures 1 and 2) was made using a poor estimate of the required clamping force. When the calculation was redone, it was found that the required clamping force was higher than expected and larger bolts were needed to hold the window in place. As such, the existing holes on the frame were drilled out to be wider than they were previously. In some areas the holes were close to the O-ring slot, causing the overlap seen in Figure 3. The quantity of bolts required to reach the

Figure 3: Holes that were drilled right into the O-ring slot on the test frame base.

new clamping force value was also higher than in the initial design. The additional bolts that were required were placed further from the O-ring slot, this is the cause of the staggered bolt pattern that can be observed in Figure 3. The current design of the HGC window frame (Figure 4) now takes into account the required clamping force, as well as proper positioning of the bolts in relation to the O-ring. This has the net result of wider holes that are placed further from the O-ring and that are spaced further apart from each other. This design conforms to the requirements for clamping force and rigidity, as such, this updated design should resolve any leaking issues that are due to the frame.

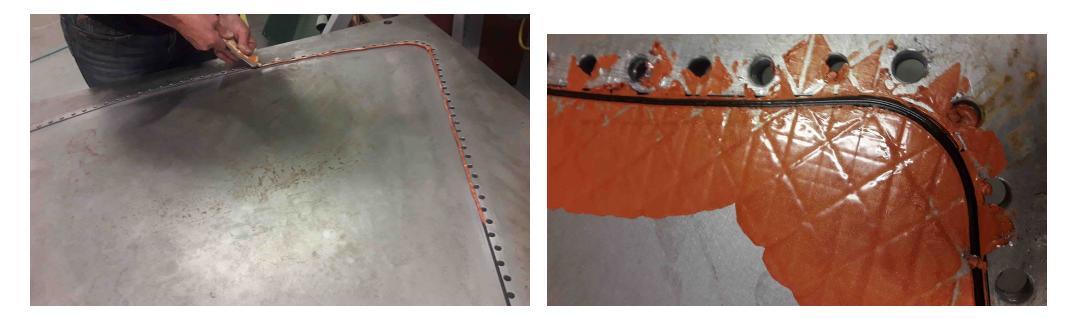
deal of it to be pushed to the inside of the window, causing it to be ineffective at providing a seal. This was not known until the window was taken apart; Figure 9 shows the window during assembly and after later disassembly. When this window leaked, it was thought that the reason was this poor placement of the gasket maker, however, further leaking from future tests with proper application ruled this out.

Figure 9: (left) The ultra copper gasket maker being applied, notice it is right on top of the O-ring. (right) After taking the window apart this is the distribution of the gasket maker. On the inside of the O-ring (i.e. not the side with the bolts) there was no gasket maker on the Mylar, suggesting that there was no contact during testing. There was however about the same amount of gasket maker on the Mylar on the outside of the O-ring as what is seen in on the test jig.

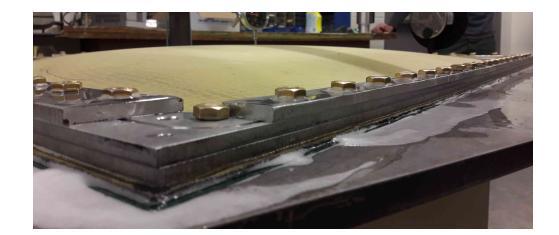
Figure 10: Leaking from around the frame in test 2, similar leaks were found around the entire window. The leaks are the locations where there is a buildup of bubbles from air escaping into the soapy water.

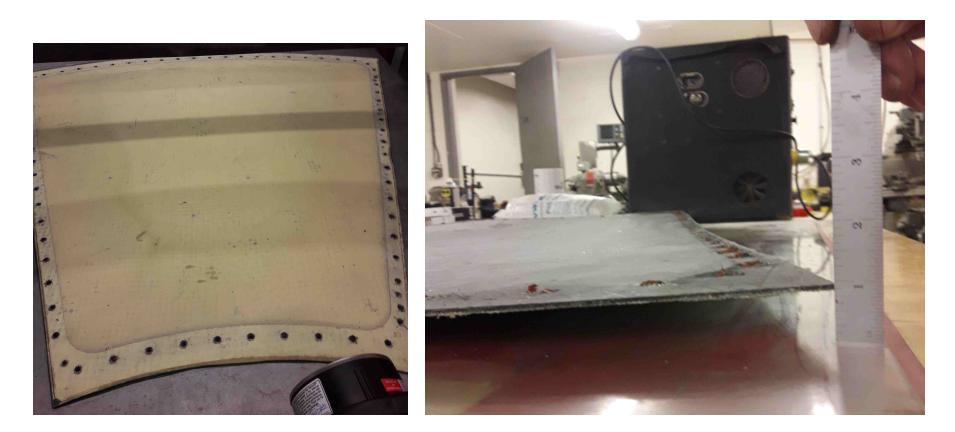
Figure 12: The carbon fiber shell after the test. The right frame shows the measurement of the deflection after the first test.

fiber shell was used as in the previous test, when the test had concluded the shell did not relax all the way back down to flat and had gained a profile. This deflection was measured to be roughly 15/16" or 2.38 cm.

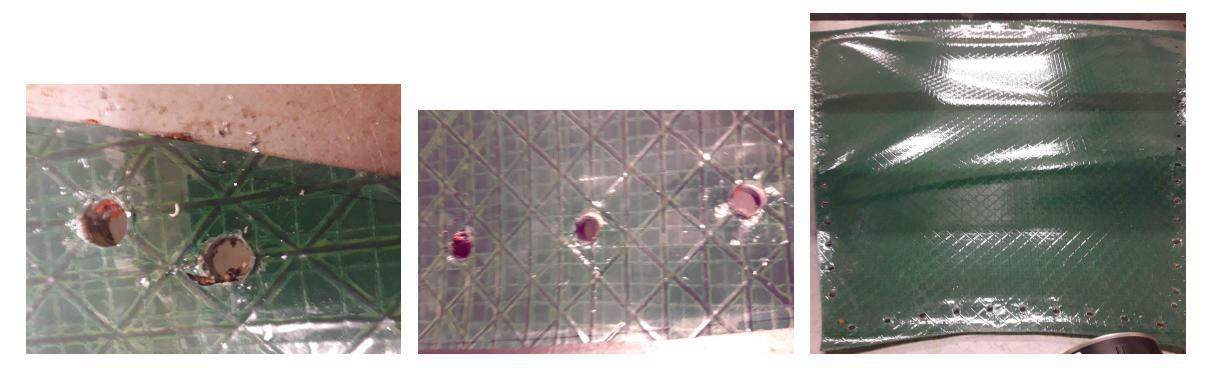
Figure 13: Mylar after Test 1. (left) the cut to the Mylar, probably caused by some stray shard of carbon fiber or aluminum. (middle) An example of the most stretched holes. (right) Overview photo of the Mylar.

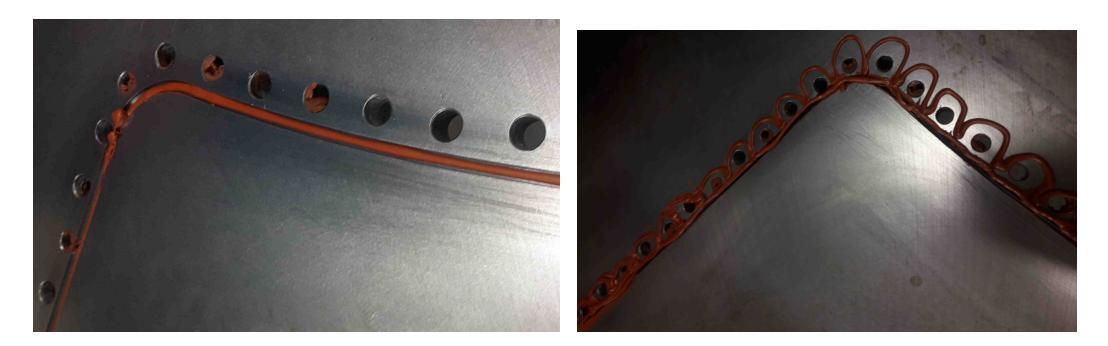
Figure 14: (left) The gasket maker in the slot before the O-ring went in. This was done to fill the bolt holes that were to close to the slot (Figure 9). (right) The final 'flower petal' pattern, taken directly before placing on the Mylar.

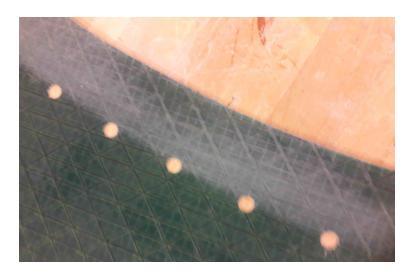
Figure 15: Scratches put into Mylar for better contact with the gasket maker.

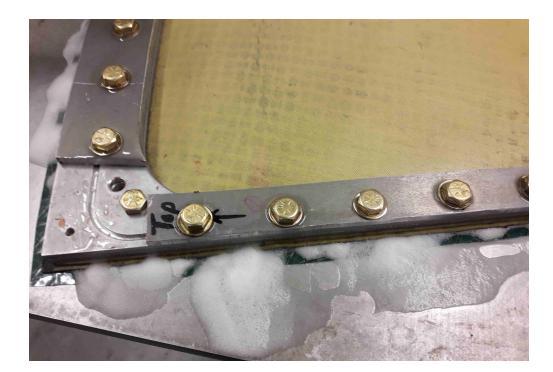
Figure 16: The location of some of the leaks observed in test 2, this is the same location as those shown in Figure 10. Leaking during the second test was much more apparent as seen by the much larger quantity of bubbles. This is believed to be caused mostly by air trapped between the Mylar and carbon fiber escaping, although some will still be from a poor seal at the O-ring.

There were many more bubbles during this test (Figure 16) and they are believed to be from the air trapped in between the Mylar and carbon fiber layers escaping. This air was trapped there due to the carbon fiber being misshapen from the last test and the Mylar being a new flat sheet. Since there is nothing to keep air in between the carbon fiber and Mylar, it will escape through the gap between them. To remove this effect, one could simply drill a hole in the top of the carbon fiber shell, this was done in previous small scale tests where the shell was purposely formed to be not flat [2]. In those cases, the hole caused no compromise in structural integrity, so it should be applicable here, and this was tested subsequently as outline in Section 7. This trapping of air is undesirable, but not devastating and it is suspected that most of the air was pushed out by the end of the inflation.

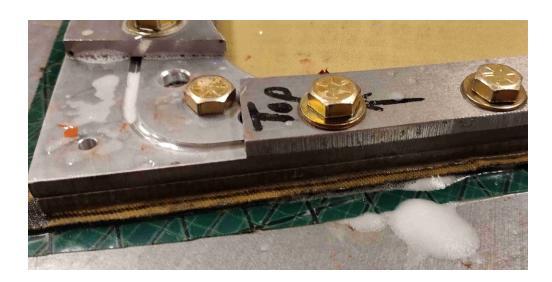
Figure 22: Leakage found in test 7. This is the same location as in Figures 10 and 16

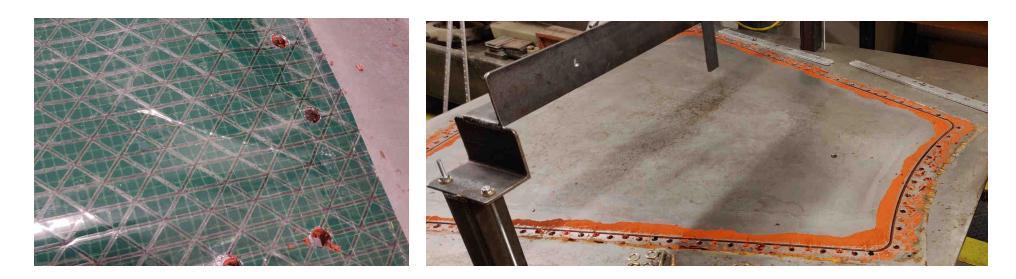
A post-mortem was conducted after this test. This post-mortem applies to tests 2 through 7 since all these tests were done without disassembling the window. This post-mortem showed two things: first, that the technique that was used to apply the gasket maker was effective, and second, that there are no signs of damage that could have caused the leaks. Figure 23 shows the Mylar without the carbon fiber shell, as well as the test jig without the Mylar. After inspection, the bolt holes on the Mylar had been stretched similar to the stretching observed after the first test, and there were stretch marks on the Mylar in the window area. Looking at the distribution of gasket maker, it is clear that the applied gasket maker covered outside of the O-ring, and thoroughly covered the area around the bolt holes, giving good contact with the Mylar.

Figure 23: (Left) test jig before removing Mylar, stretch mark is visible. Multiple stretch marks were found along all sides but no failure was found. (Right) Test jig after removing Mylar. The distribution of gasket maker is much better than in the previous test.

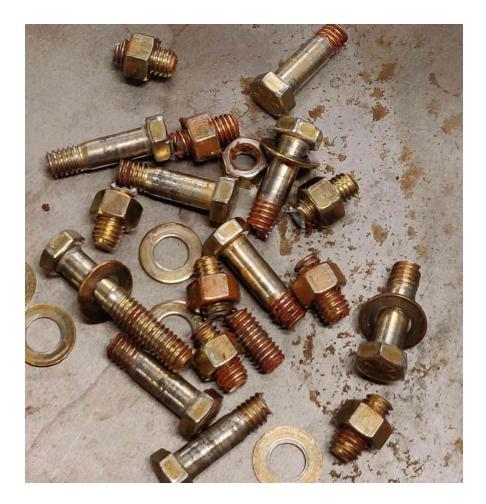
Figure 24: Example of bolts that broke during reassembly. These bolts were all replaced with new ones in the test assembly.

The window was assembled again using the same techniques as the previous assembly, detailed in Section 6. The same piece of carbon fiber was used for this test, The Mylar however was replaced with a new piece. Of note, the bolts that were used here are the same as the ones used on the previous assembly and some of them broke before they could be tightened to the 60 ft - lbs that was required (Figure 24). This is likely due to the fact that they had been worked once, and that the bolts themselves are only rated to go up to 60 ft - lbs when new. The bolts that broke were replaced with new ones.
