SoLID Heavy Gas Cherenkov Update

Garth Huber
(on behalf of the HGC group)

University
of Regina

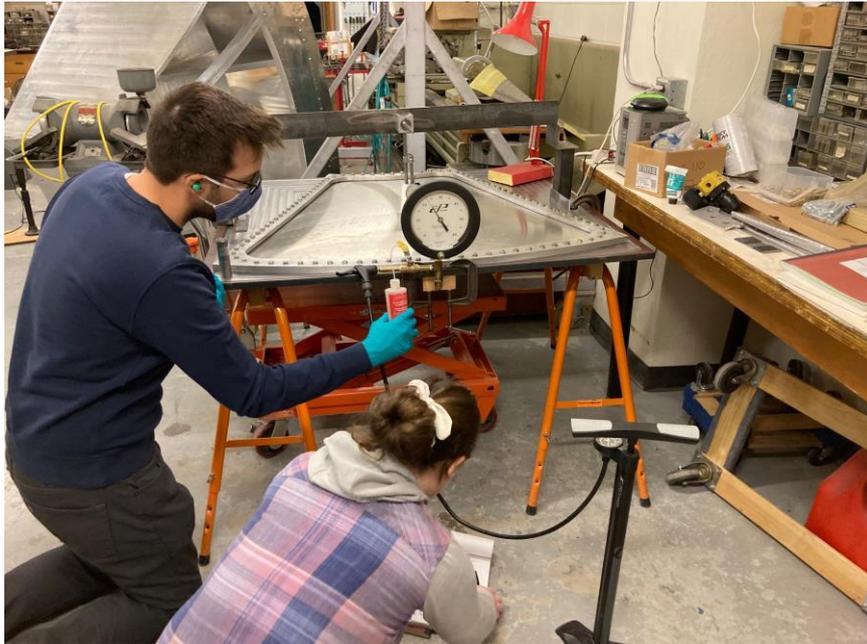
AL Entrance Window Test Results

AL window performed well, holding the pressure for long periods of time with minimal leakage at 26 psi

- $Leak_{min} = 5 \times 10^{-5}$ Torr-L/sec at test pressure (2.5 mg/day C_4F_8)
- Cannot discount some leakage was from test setup

Maximum deflection of the window was 4.5 cm at test pressure

- Window bulge flattens with time after pressure was removed (3.5 to 1.3 cm in a few days)
- Subsequent inflations had 1cm larger bulge than initial inflation

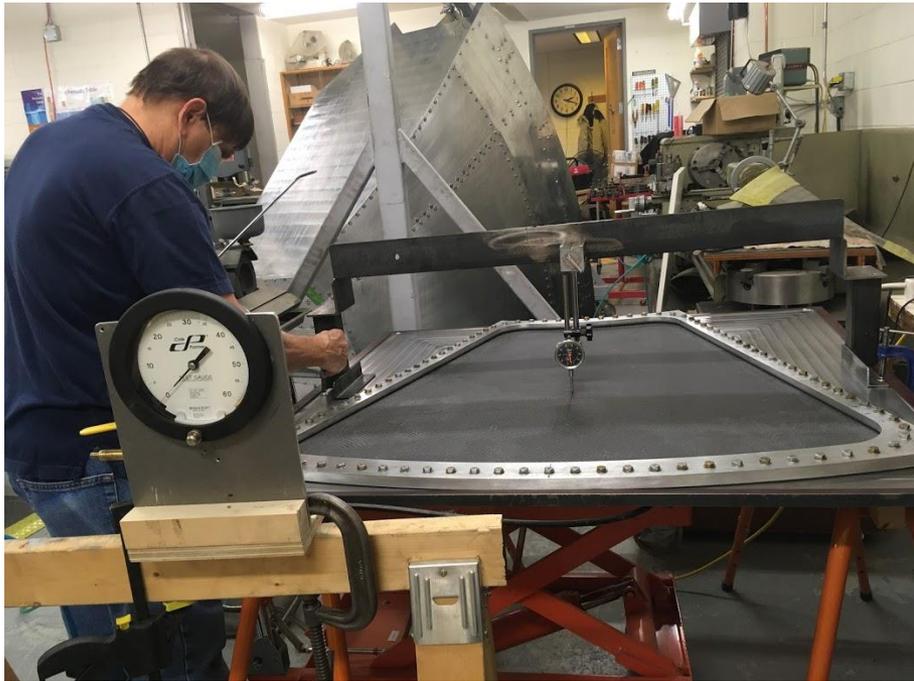
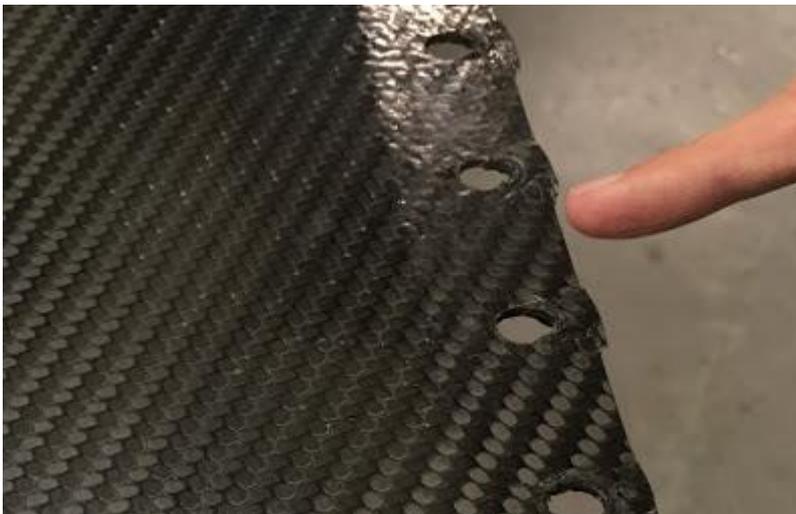
CFb Entrance Window Results

CFb window was made by a different instrument maker than earlier versions, with better 12k 2x2 twill weave vs old 3k 2x2

- First test was with Tedlar lining from CLAS-12 LTCC
- $Leak_{min} = 6.2 \times 10^{-3}$ Torr-L/sec at test pressure (0.3 g/day C_4F_8)
- Second test was same Kevlar reinforced Mylar used in earlier tests
- The CFb bolt holes ripped during second test, causing pressure failure

Maximum deflection of the window was 4.5 cm at test pressure

- Similar bulge overall to AL, except that there was less relaxation after pressure release, and less change from initial inflation

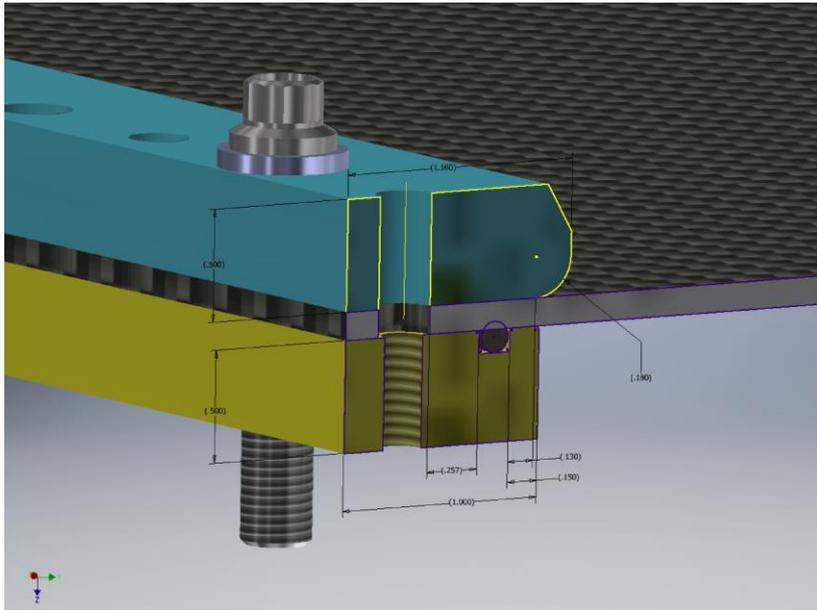
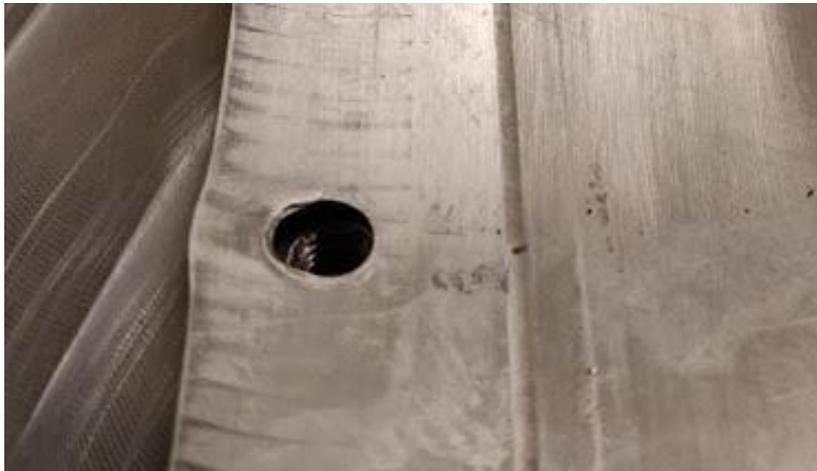
Entrance Window Clamping

In addition to the CFb window slippage on previous slide, the AL window also experienced some slippage when the bolts were not torqued to a sufficient level of uniformity

This indicates the window clamp design is not yet sufficient

- Most likely, decreased bolt spacing is needed (Whit Seay), as increased bolt diameter requires a wider frame
- This will need to be tested again with project funds

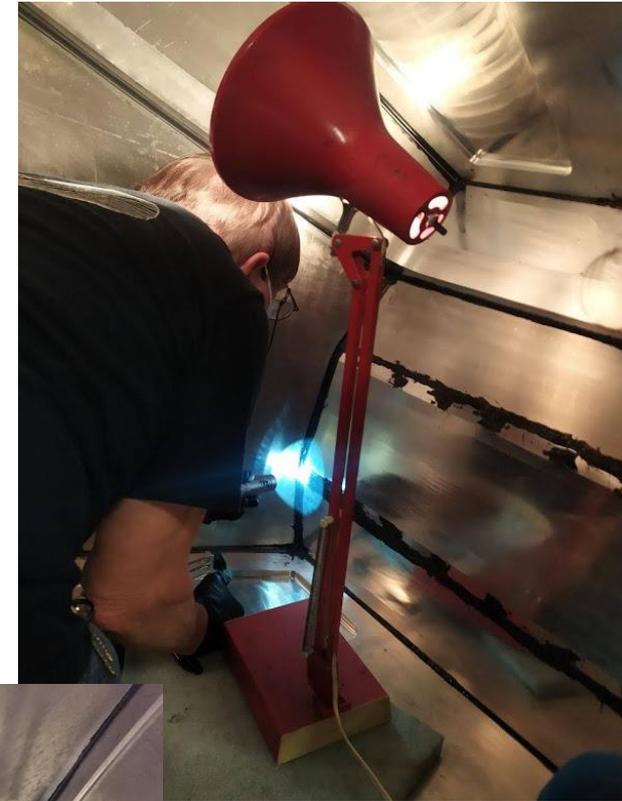
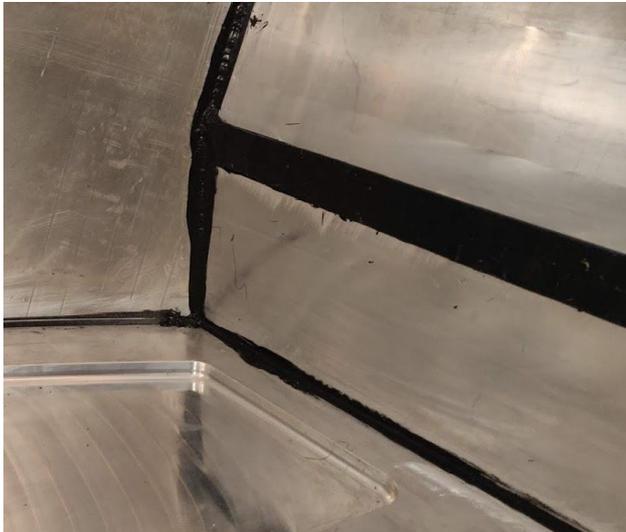
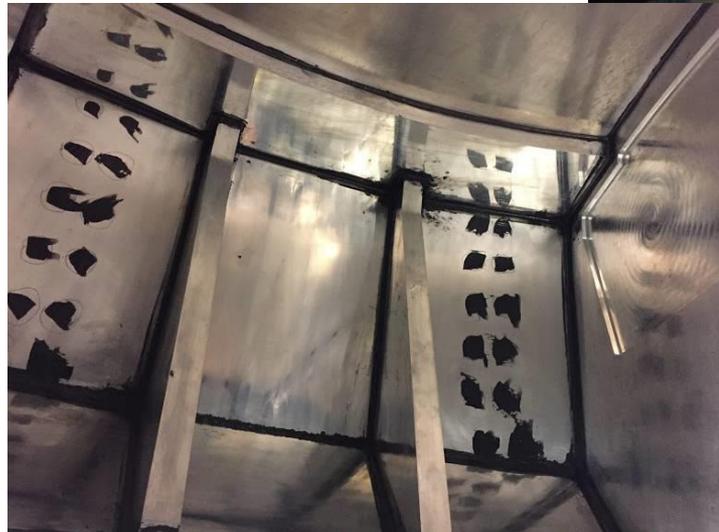
Item 3: Vessel Leak Sealing

- Vessel was cleaned with ethanol, acetone
- Vessel joints then sealed using **DOWSIL RTV 832** sealant used also on the GRINCH Cherenkov. Minimal outgassing when cured
- Vessel pressurized with air compressor and large leaks identified using soapy water
- **Scratches to the walls to improve adhesion and a large RTV bead got all of the joints properly sealed**
- **A few design mistakes were identified as leakage through bolt holes drilled too deep (almost through)**

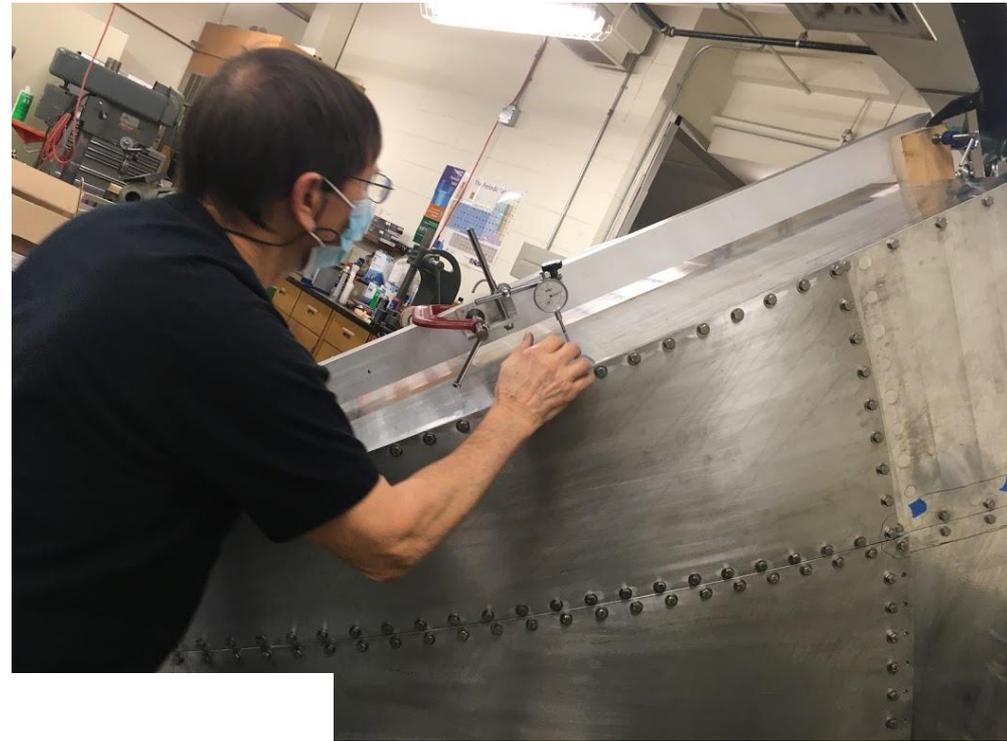
Vessel Side Panel Deflection Measurement

- Measurement of the deflection of the vessel side panel was made as it was deflated from 8 to 0 psi
- Window deflection of ~6 mm (0.25") observed
- A second test at 12 psi is planned
- **Vessel is designed for 3x safety factor, but some clearance in SoLID will be needed to accommodate HGC "swelling"**

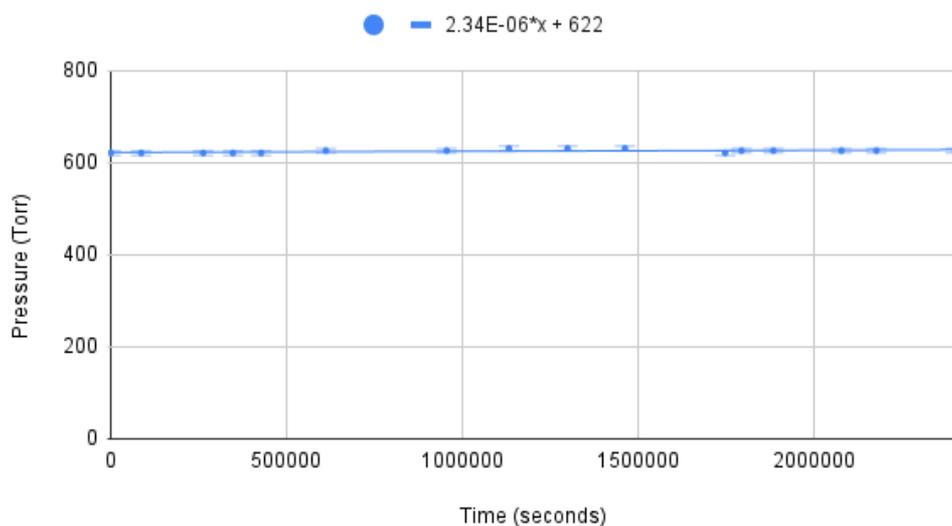
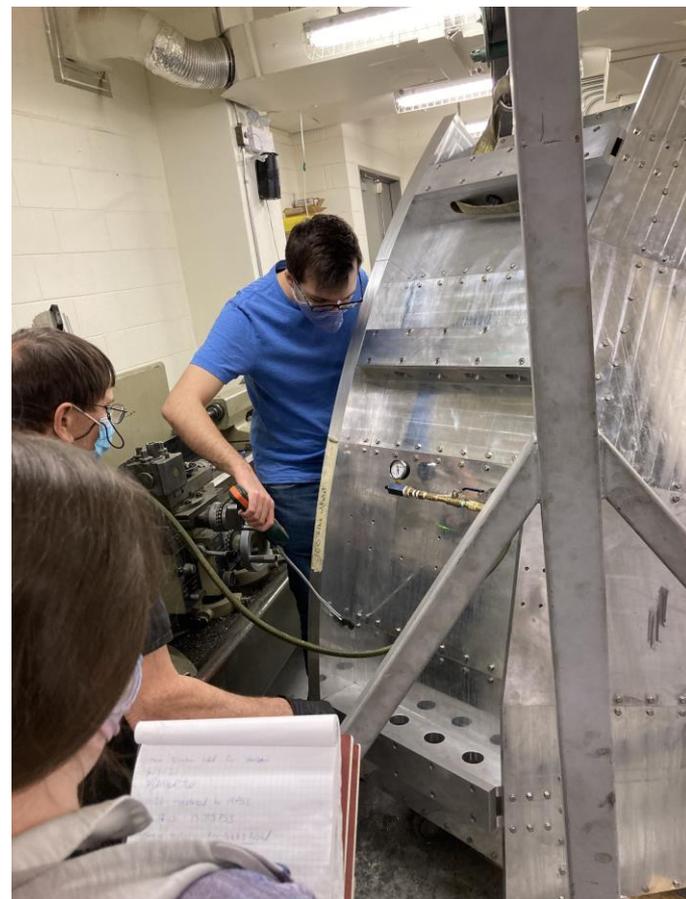
Vessel Long-Term Leak Test

- The most sensitive check for leaks was done following the procedure used on the GRINCH Cherenkov
 - The vessel was pressurized to 12 psi with a mix of 1% hydrogen/99% dry air
 - Leaks were identified with EzFlex Combustible Gas Detector (natural gas sniffer)
- **One month pressure test at 12 psi indicated negligible leakage**
- **Two month test with dry air in progress**
