SoLID HGC Prototype Front Window Testing

University of Regina

June 21, 2021

Abstract

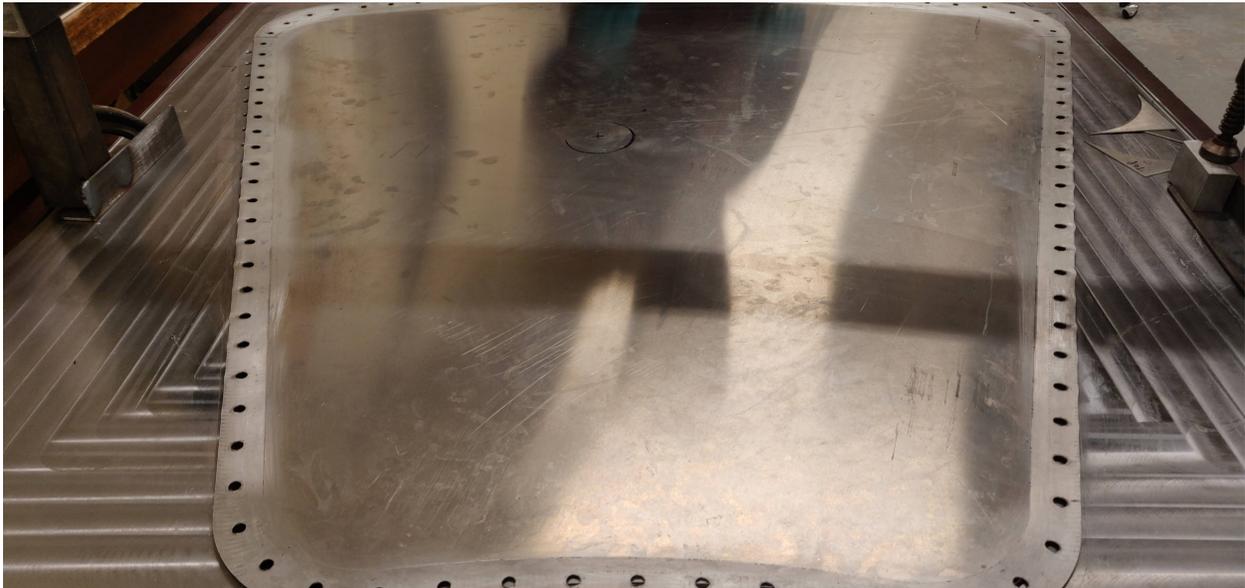
Test 3 - The window had slight tearing around its bolt holes. It was placed on the vessel during the vessel's pressure test.

Figure 13: The aluminum window's bolt holes on February 18th. Stretching is observed around some bolt holes on the left.

The deflection decreased rapidly when the window's pressure was almost gone (during the last 10 psi). The measurements can be found in Table 8. A graph of this deflation is in Fig. 12. After the window was deflated, the window was removed and its deformation was measured using a dial gauge. Some elongation around the bolt holes was noticed (see Fig. 13). Unfortunately, the dial gauge was bumped in the process of removing the window. Since the gauge was bumped, the deformation may be either 1.102 inches or 1.202 inches. The window was placed back on the steel plate and was bolted in a zigzag pattern with 100 in-lbs torque, then 110 in-lbs and finally 120 in-lbs torque.

- Overall, the aluminum window is a better choice due to its lower leak rate, reliability and easy construction. However, the aluminum window needs a second long-term leak test, due to the possible problem identified with the gauge in the test reported here. Longer term, the issue identified with the elongation of the aluminum window bolt holes needs to be rectified via further improvements to the frame design.

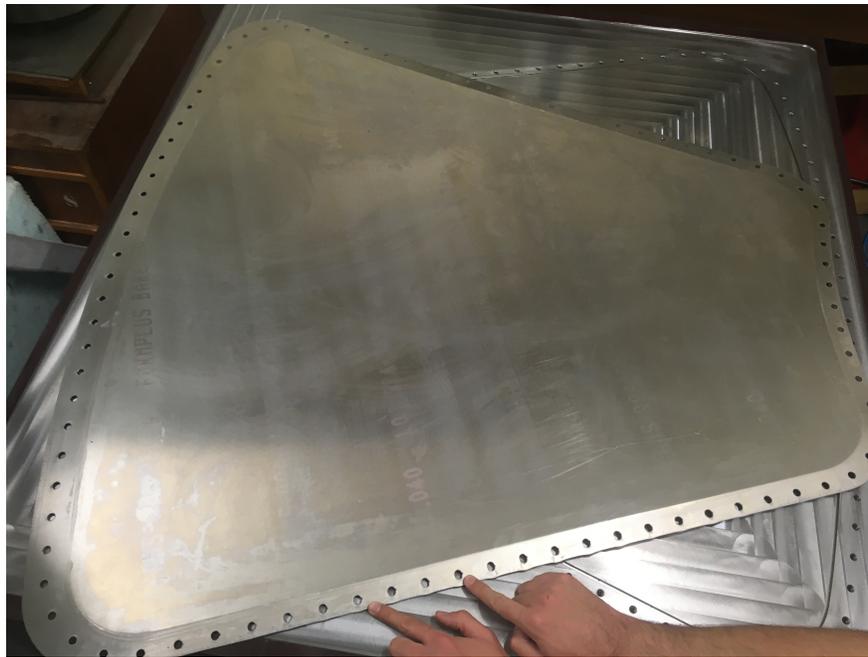
The window was used in one more pressure test. On March 1st, the vessel was tested with a pressure of 15 psi. Afterwards, the window was removed and significant stretching near the bolt holes was noticed (see Fig. 14). A new window was required for further testing. A comparison of the stretched bolt holes can be found in Fig. 15.

Figure 14: The aluminum window bolt holes on March 1st.

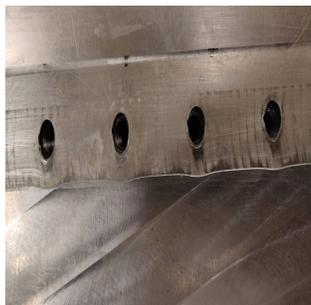
(a) Close up of the bolt holes on February 18th.

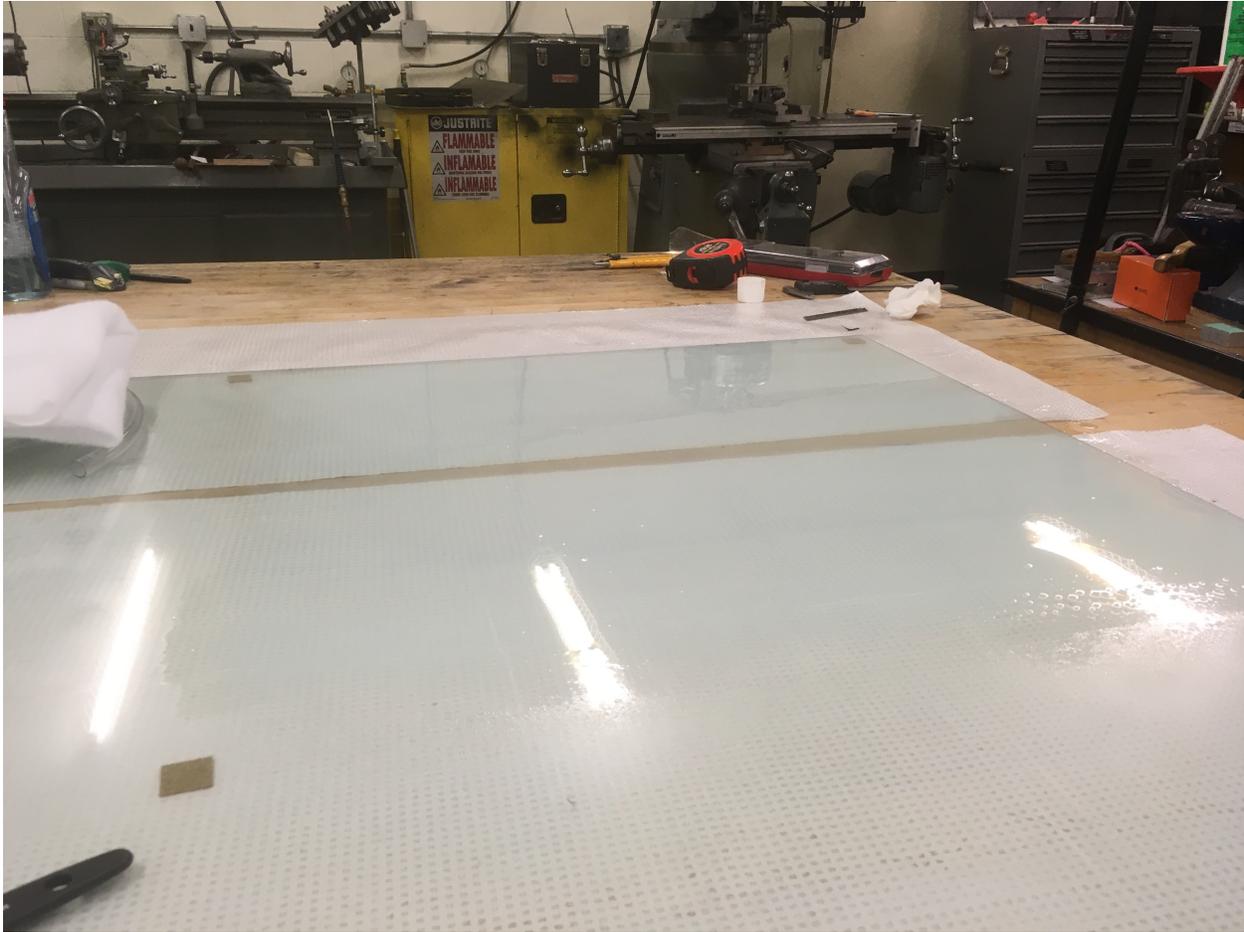
Figure 16: “Fisheyes” that formed when the release agent dried.

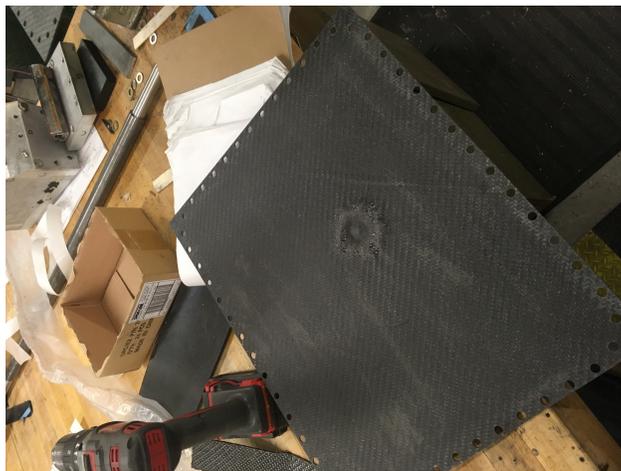
Figure 20: The final result of constructing the first small window.

After the epoxy was applied, the nylon release ply was placed on top of the carbon fiber, then the breather and bleeder cloth was placed on with extra cloth where the vacuum tubing will connect (see Fig. 18). The bagging film with the tubing attached was stuck down with the vacuum sealant tape. A vacuum was pulled overnight (see Fig. 19). The final window was unfortunately distorted from the vacuum tubing (see Fig. 20).

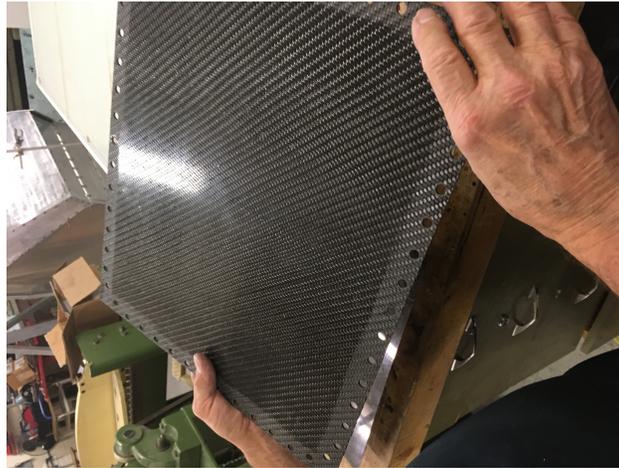
On March 26th, a final small window was made using the same method as the first window, but the 20120 cure was used instead of the 2020 cure. Unfortunately, the epoxy was mixed with the wrong ratio. It should have been a ratio of 100:27 resin to cure, but instead was mixed to 100:23 resin to cure. The epoxy didn't cure correctly and the window remained tacky. The final result is in Fig. 22.

Figure 22: The final result of constructing third small window.

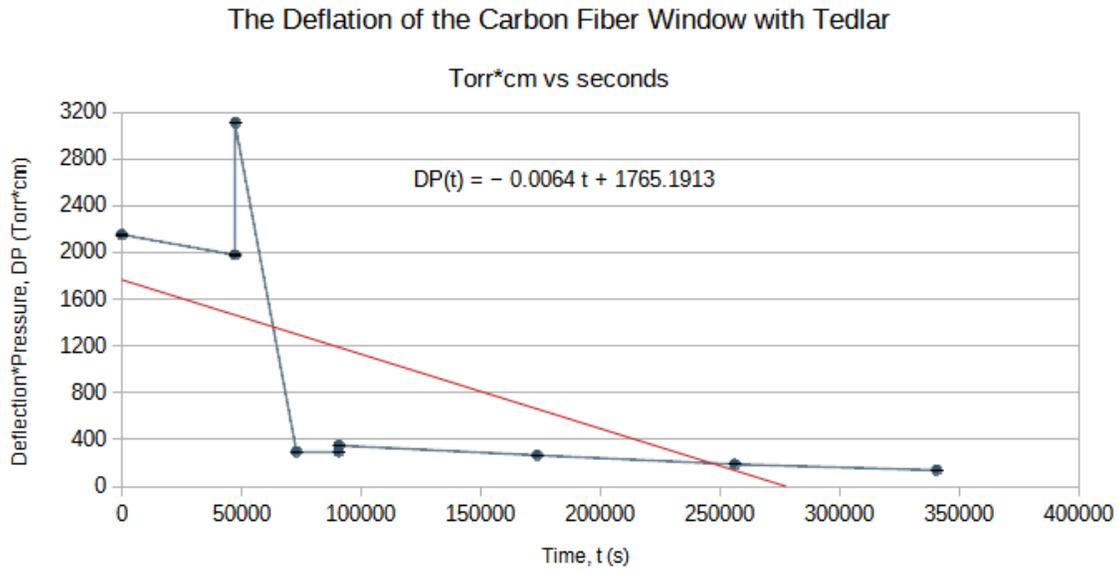
Figure 28: The deflection and pressure over time. It is clear from this graph that the window had a leak.

There were loud crackling and popping sounds heard during the first 10 psi of inflation. The crackling became less frequent as the window inflated. A loud pop was heard when inflating between 12.0 psi and 14.0 psi. The window's colour became lighter by the frame as the window inflated, indicating a reduction of the carbon fiber thickness there. The window was left over a few days, it was occasionally inflated to 26.0 psi. The results are in Table 11. Graphs of the deflection and pressure over time are in Figs. 28, 29.

The leak rate for the carbon fiber window is about $0.0062 \pm 0.0002 \frac{\text{Torr}\cdot\text{L}}{\text{s}}$. This leak rate was calculated using the change in deflection and pressure from the last time it was pumped during the test. However, since the window was pumped up multiple times, this number doesn't describe the window's full behaviour. It was clear that there was a leak from some part of the setup. There were attempts to fix leaks in the plumbing underneath the steel plate. The window was pumped up to 26.0 psi and left overnight. On April 18th, at 11:50 the pressure dropped down to 23.9 psi, which showed the leaks were still there.

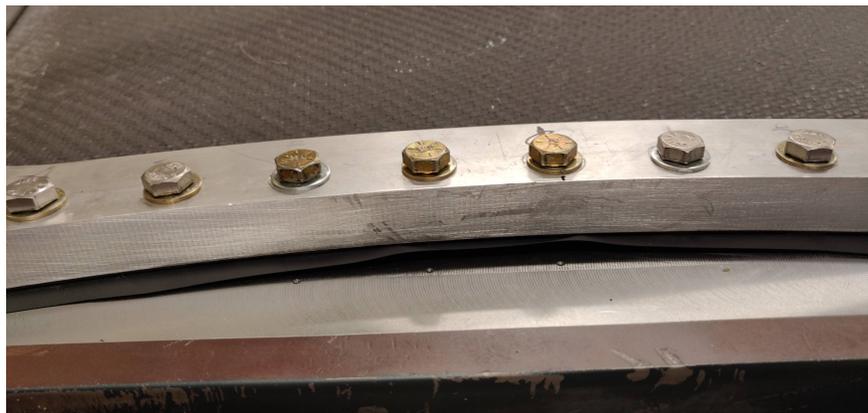
Figure 30: The Tedlar peaked out of the frame while being inflated.

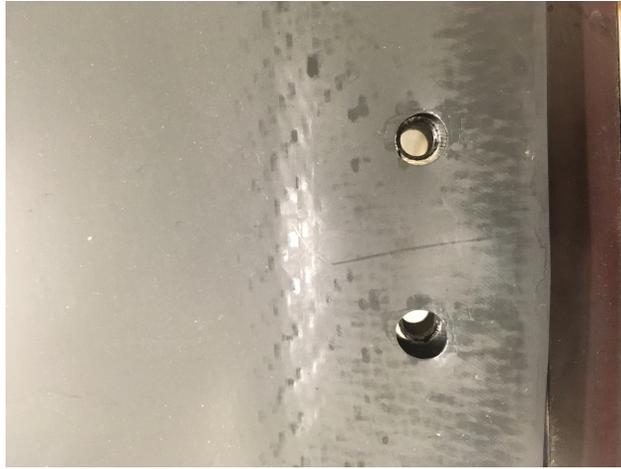
Test 1 - The window leaks from various locations near the window frame. Creases in the Tedlar were found at these locations.

To find the source of the leak, a hydrogen gas mixture test was done on the window. On April 19th, the window was deflated and filled with a mixture of 98.013% dry air and 1.987% hydrogen, the same mixture used for the vessel tests, to 26.0 psi. The bulge of the window was 1.565 inches. A natural gas sniffer was run along the window frame and test apparatus. Leaks were found in-between the 10th and 11th bolt holes on both the left and the right sides. There was also a leak by the window frame along the center line by the wide end. Some Tedlar was poking out of the window frame (see Fig. 30). The window was deflated and the setup was disassembled. There were scratches (see Fig. 31) and creases (see Fig. 32) in the Tedlar near where the leaks were. Tedlar appears to not be a good material for this project because of its stiffness and tendency to crease and scratch.

Figure 31: The Tedlar scratched by the leaks.

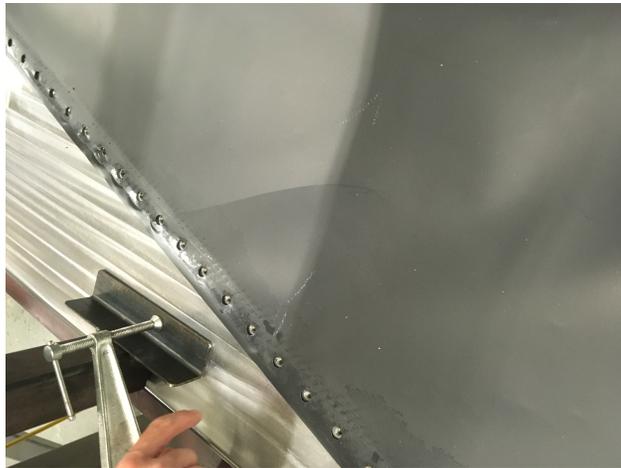
Figure 32: Creases in the Tedlar were also found near leaks.

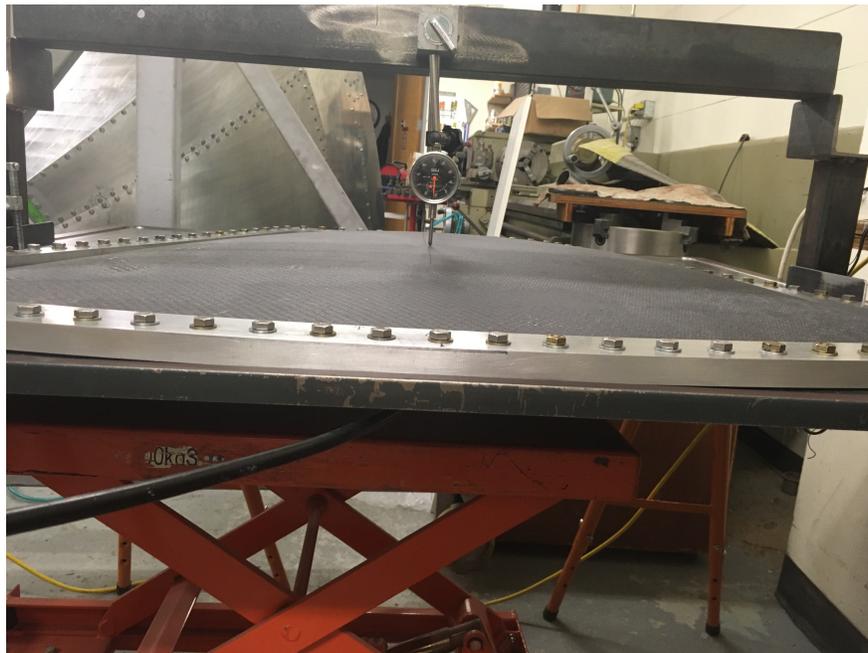
Figure 34: The carbon fiber window bulging more on the right side.

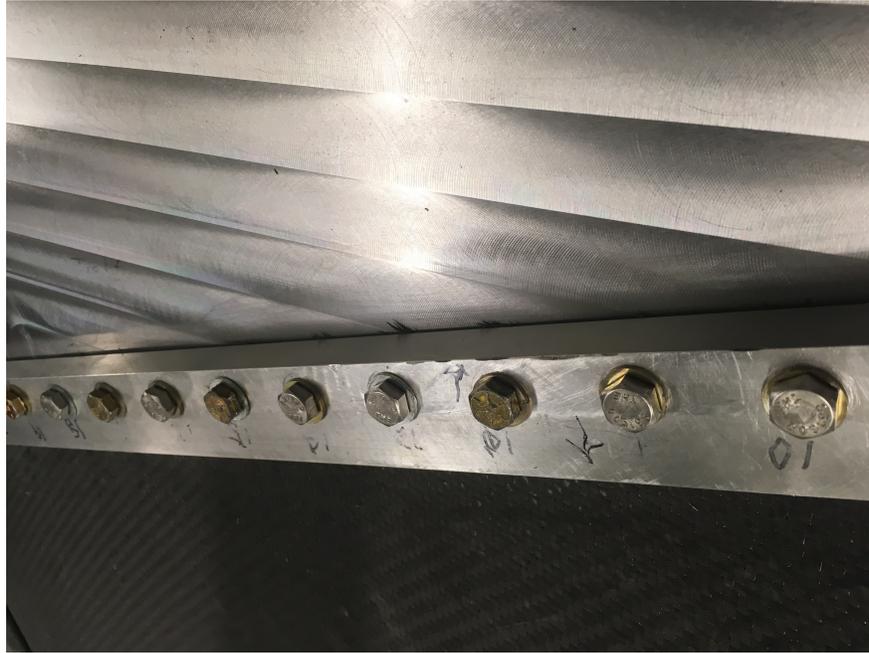
Figure 35: Stress on the window forcing out some shards of the carbon fiber window beyond the frame.

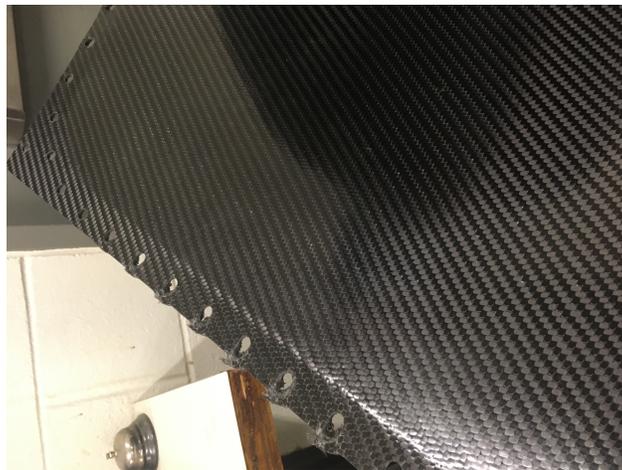
Figure 36: Torn and stretched bolt holes on the carbon fiber window.

- The carbon fiber window's maximum deformation was at 4.4 cm and its leak rate was $(6.2 \pm 0.2) \times 10^{-3} \frac{\text{Torr}\cdot\text{L}}{\text{s}}$, which converts to $(2.0 \pm 0.1) \times 10^{-5} \frac{\text{g}}{\text{s}}$ of C_4F_8 gas. The carbon fiber window leaked when used with Tedlar inner liner, and the bolt holes tore when used with the Mylar liner.

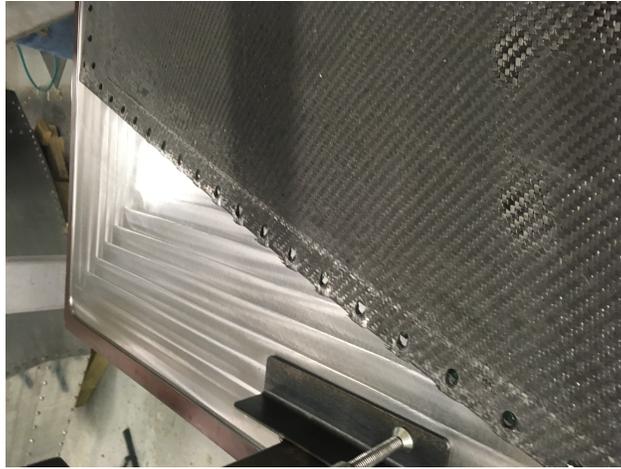
Figure 37: The left side of the stressed window.

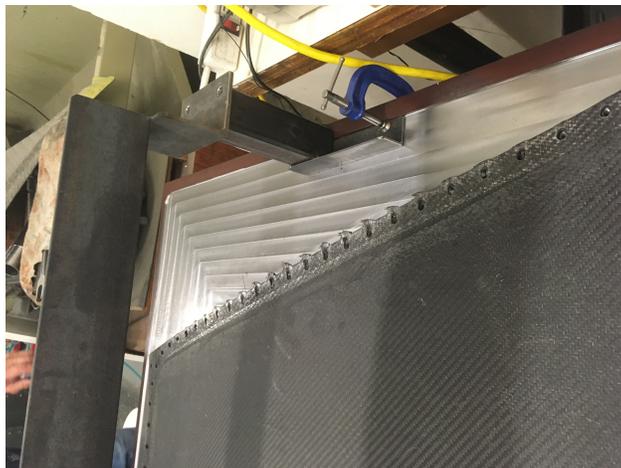
Figure 38: The right side of the stressed window.
