# SoLID HGC Prototype Vessel Leak Testing

University of Regina

August 20, 2021

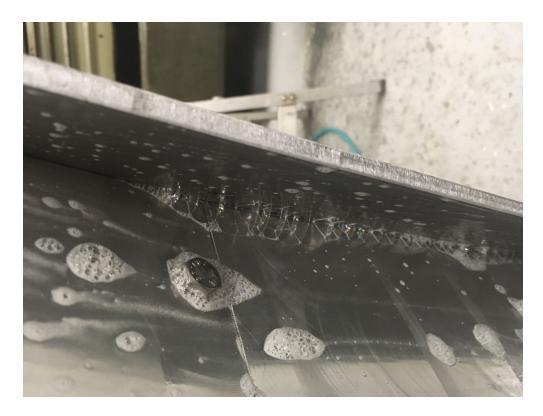
Figure 7: This is what a leak looks like when doing the soapy water test.

On February 8th, the front window with an O-ring was bolted to the vessel. The window's frame was accidentally placed on backwards, so it had to be taken and placed back on again. The vessel had no sealant or epoxy on it at this time. The vessel was pressurized with an air hose, but there were many leaks, enough that no differential pressure could be built up. Soapy water was sprayed onto the vessel to check for leaks (see Fig. 6). If a leak was found, it would bubble like in Fig. 7. Some of the leaks were large enough to feel by hand and to hear. They were located:

- edge of front plate towards the outer radius
- edges of side plate-left, especially where it connects to the back plate extension and the top plate
- between back Window and side plate
- between back window and rib
- a bad leak on the entire seam between the back plate and top plate
- between the top plates
- between front top and top plate

- some leaking on the bottom plates
- in the corner where the top plate, back plate and rib meets

Between February 9th–11th, the vessel was cleaned four times to prepare it for the sealant. Ethanol was used to clean most of the vessel and acetone was used to clean difficult areas. Rags were used to clean large areas, kimwipes where used to clean smaller areas and Q-tips where used to clean the seams. The first time, it was cleaned with ethanol using kimwipes. The second time, it was cleaned with ethanol using rags, kimwipes and Q-tips. The third and fourth times, it was cleaned with both ethanol and acetone separately, using rags, kimwipes and Q-tips. The cleaning was done with the vessel back panels removed, to allow for more ventilation, and a fan was used to help with air flow. Due to concerns with fumes while cleaning the vessel, breaks were given at least every hour. Foam was used for padding to protect knees. The setup can be seen in Fig. 8. The sealant was then applied on the 11th and the 12th. The setup was similar to the cleaning setup. A lamp was used to help illuminate the vessel and its heat helped the sealant to cure. Headlamps and flashlights were also used to illuminate the inside of the vessel.

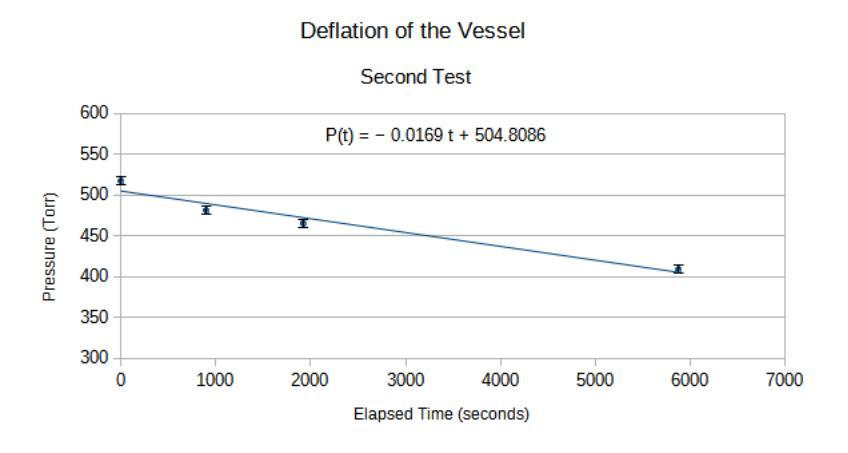
On February 19th, after the tank was cleaned and sealant was applied, the tank was tested for leaks. The vessel was inflated to 9.0 psi (relative pressure) and the inflation took roughly 8 minutes. The changes in pressure are listed in Table 3. A graph of the pressure over time is in Fig. 11, this graph was used to calculate the leak rate. The leak rate was  $19 \pm 1 \frac{\text{Torr} \cdot L}{s}$ .

Figure 11: Result of Test 2. The leak rate of the vessel can be determined from the slope of this graph.

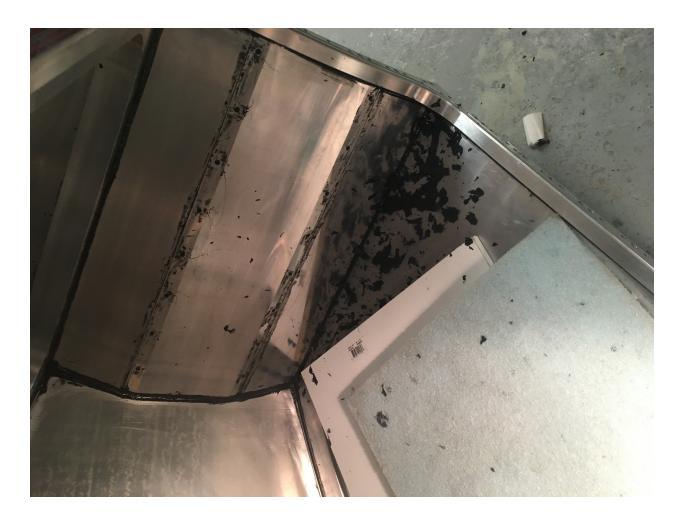
The vessel was checked for leaks using soapy water. The leaks were found:

- the outer radius and inner radius of the vessel
- around the gauge

Most of the leaks were on the top and bottom of the vessel. The front window was deflected when the vessel was inflated to 9.0 psi. The deflection was measured to be 2.125 inches.

Figure 12: The sealant was scraped off with a utility knife.

After the vessel test on February 19th, we decided to scrape off sealant on areas that were most likely causing problems (see Fig. 12). These areas included the joints on the bottom of the vessel, as well as the top of the vessel. The sealant was scraped off with a utility blade and dissolved with ethanol and acetone. Ethanol tended to work better at dissolving the sealant. Scratches were added to the aluminum near the seams so that the sealant will adhere better. On February 23rd, the sealant was applied to the scraped off areas. The bottom seams were sanded and cleaned. Several holes on the inside radius penetrated through into the vessel. To seal the two rows of holes, thin wood spacers (0.090 inches thick) were stuck to either side of them with double-sided tape (see Fig. 13). The wood spacers were used as screeds to allow a thicker layer of sealant over the holes, they were removed after the sealant cured. This thicker layer of sealant covered up the seams better than before (see Fig.14).

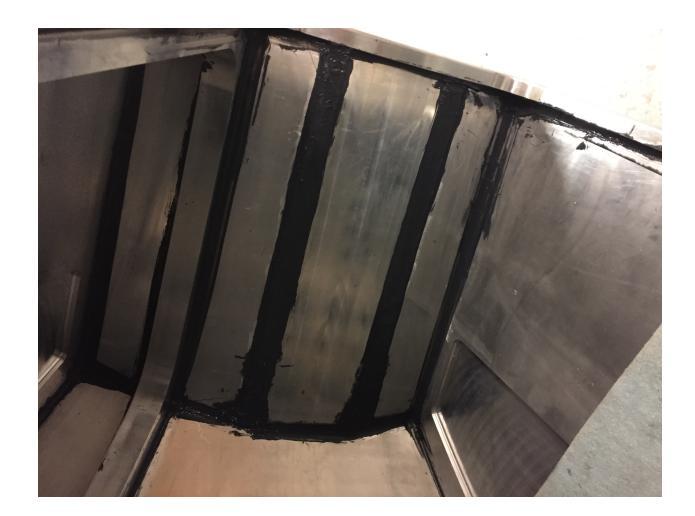
Figure 13: The bottom panel's seam were covered in a thick layer of sealant.

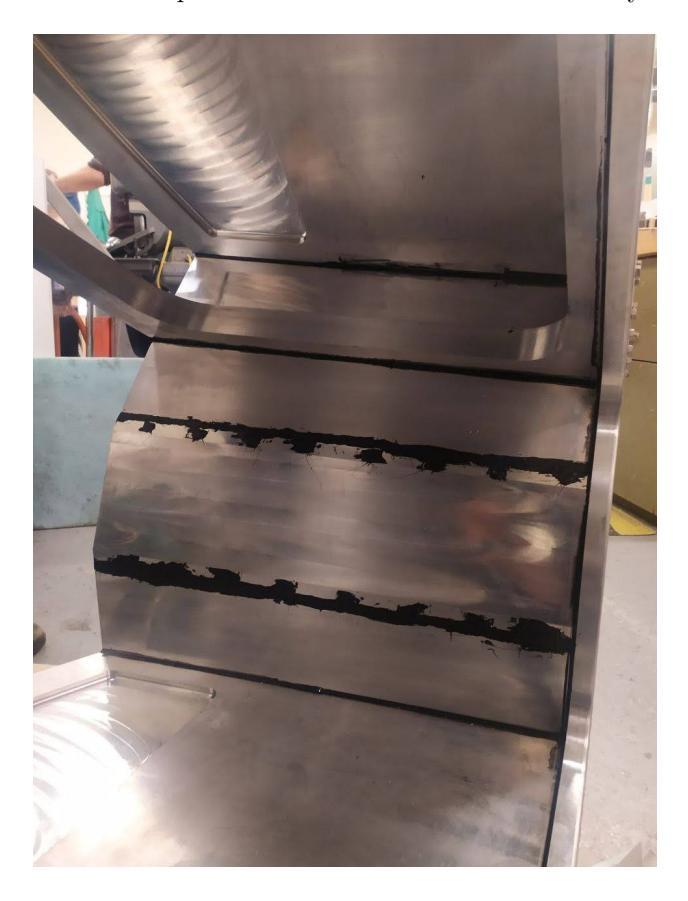
Figure 14: The sealant on the bottom panels before scraping, for comparison.

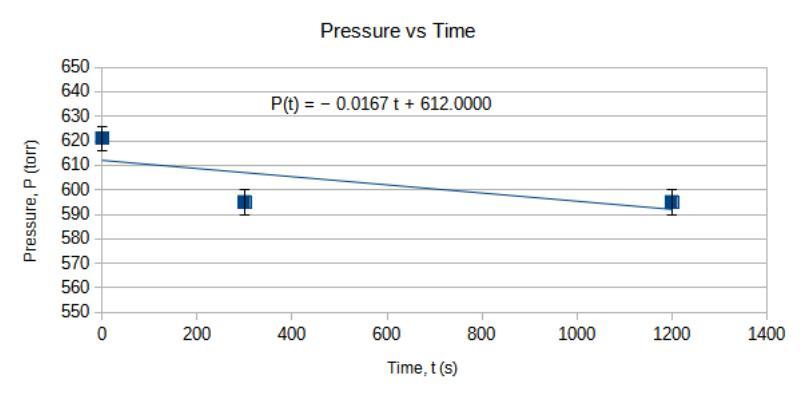
Figure 19: The deflation of the vessel before it was inflated to 15 psi (relative pressure). The change in pressure over time is  $0.017 \pm 0.002 \frac{Torr}{s}$ .

On March 1st, the vessel was tested again. It was taken to an even higher pressure than before. The results are in Table 6 and Fig. 19. The leak rate before the vessel is inflated to 15 psi is  $19 \pm 2 \frac{Torr \cdot L}{s}$ . There were more leaks discovered during this test than the third test. This may have been due to the higher pressure. On March 5th and 7th, more sealant was applied to the vessel. Extra sealant was applied to the corners of the vessel and to areas where the leaks appeared. The sealant was applied with a silicone trowel scraper with a wide radius (7mm). On the 7th, the second aluminum front window was installed on the vessel.

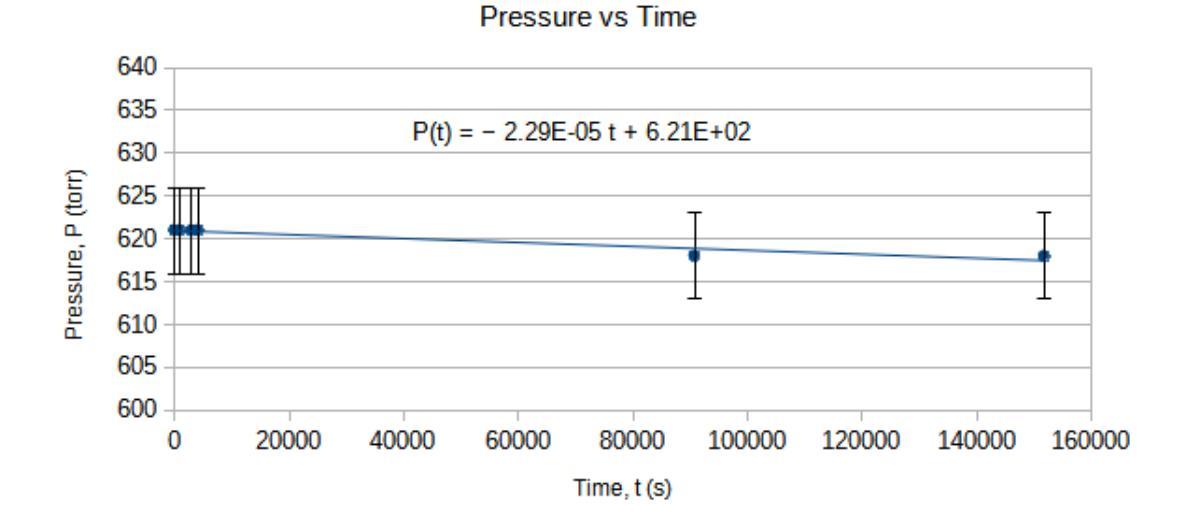
The vessel was left for two days and a drop in pressure was observed. The results of the pressure over time are in Table 7 and Fig. 21. The leak rate is  $0.03 \pm 0.01 \frac{Torr \cdot L}{s}$ .

Figure 21: The deflation of the vessel. The change in pressure over time is  $(-2 \pm 1) \times 10^{-5} \frac{Torr}{s}$

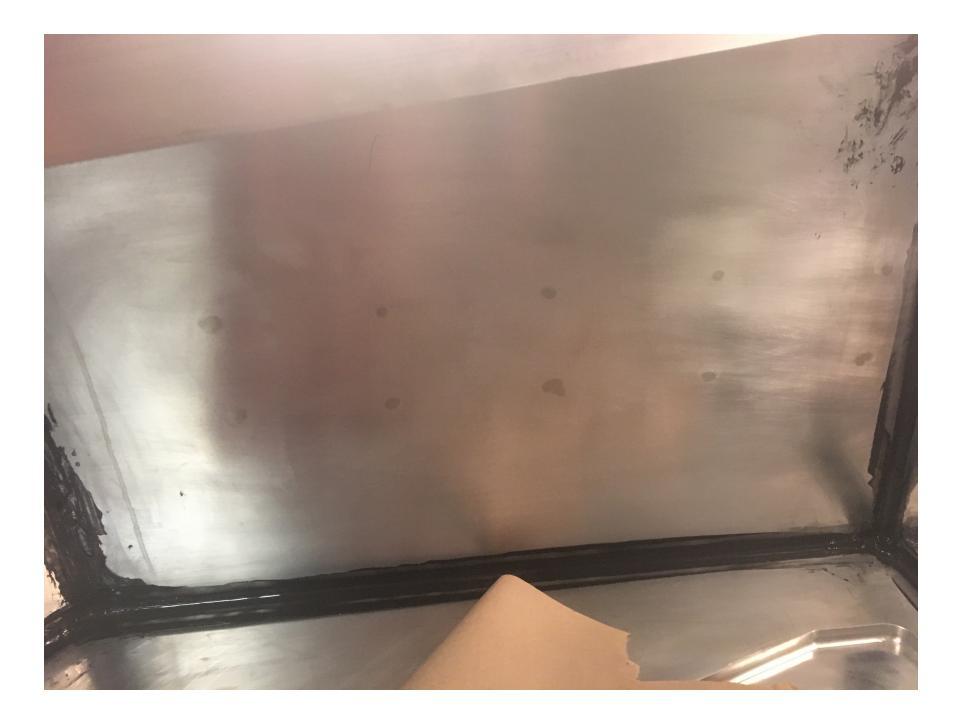
Figure 22: Discoloured blotches on the top panel.

The vessel was depressurized and the window was removed. Some discoloration was found on the inside of the top plate where the rib is bolted (see Fig. 22). This was later investigated and we found that the bolt holes in the top plate were drilled almost all the way through, due to an error in the construction drawings. Extra sealant was applied to these areas (see Fig. 23).

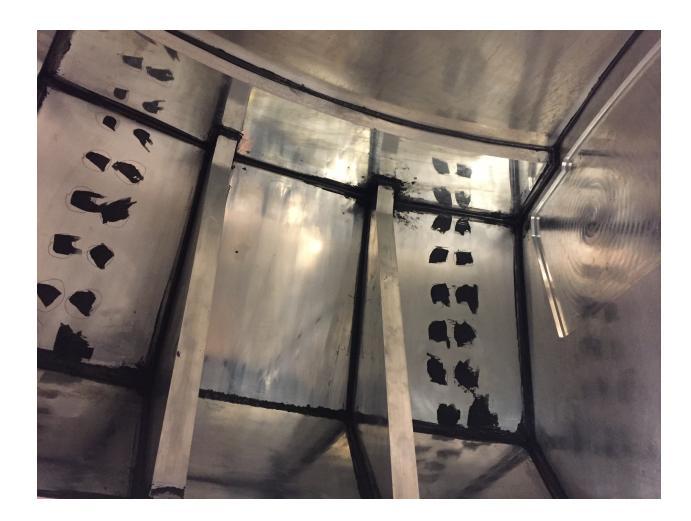
Figure 23: The stressed areas were covered with RTV sealant.

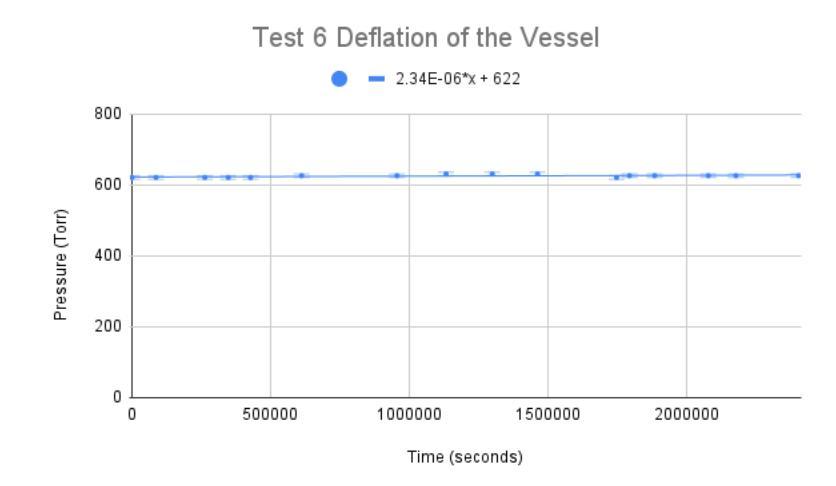
Figure 24: The deflation of the vessel over roughly a month. Assuming the gauge worked properly, the pressure over time was  $(2.3 \pm 2.8) \times 10^{-6} \frac{T_{orr}}{s}$ . This rate is positive, but within one uncertainty of zero. The last point in Table 8, which is lower due to the sudden drop in pressure when the valve was opened, is not included in the fit.

corresponding to an upper limit of the leak rate as  $0.00056 \frac{Torr \cdot L}{s}$ . On April 8th, the valve was opened and the pressure immediately dropped to roughly 11 psi, and then continued to fall normally as the vessel depressurized. The sudden drop to 11 psi may have indicated a problem with the gauge during the long pressurization test, i.e. the needle became stuck after being in a fixed position for too long.

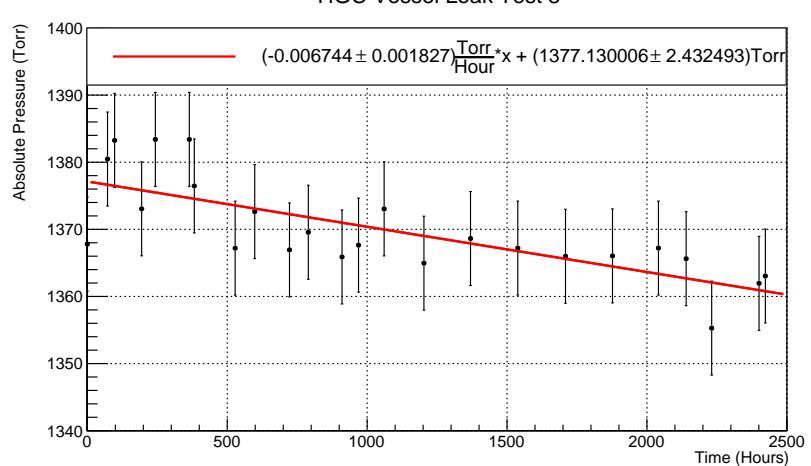
#### HGC Vessel Leak Test 8

On April 25th, The vessel was inflated again, this time to 11.8psi, using the same configuration as was used in Test 7. Shown in Fig. 25 is a plot of the absolute pressure of the vessel over time, as well as a linear fit used to calculate the leak rate. This gives a leak rate in air of  $l_{\rm air} = (3.4 \pm 0.9) \times 10^{-6} \frac{\rm g}{\rm s}$ , and a C<sub>4</sub>F<sub>8</sub> equivalent leak rate of  $l_{\rm C_4F_8} = (9 \pm 2) \times 10^{-6} \frac{\rm g}{\rm s}$ .

Figure 25: The vessel was left for three months after being inflated on April 25th. Measurements were then taken roughly once a week. It is unclear why the pressure increases after the first measurement. A linear fit, shown in red, gives a slope of  $-0.007 \pm 0.002 \frac{Torr}{Hour}$  which is later used to calculate the equivalent leak rate for  $C_4F_8$ .

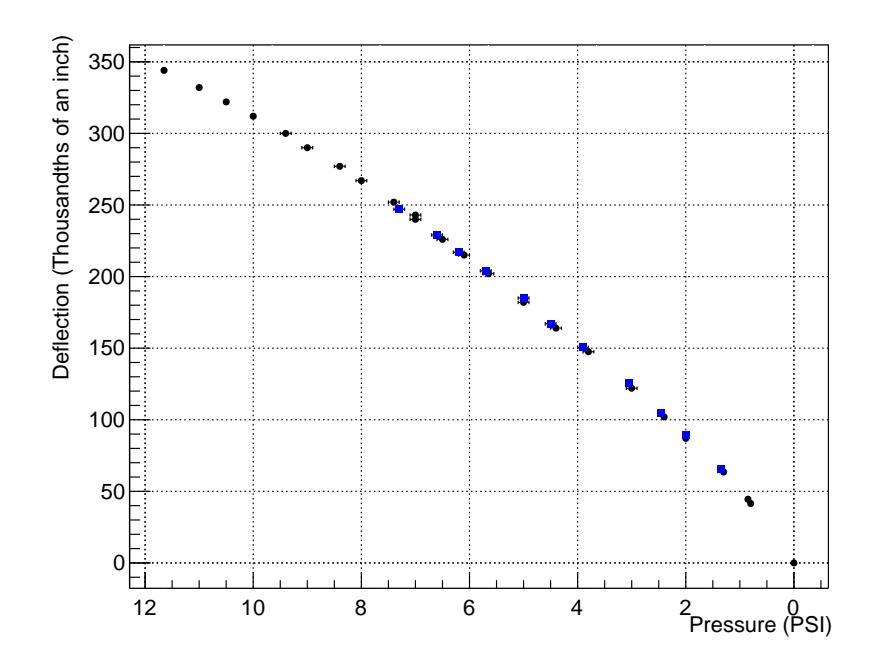
When the vessel was deflated after this long term leak test, the deflection of the vessel was measured as it was deflating. These data are shown in Fig. 26. The maximum deflection was  $344 \pm 0.5$  thousandths of an inch, or  $8.73 \pm 0.02$  mm. After taking the first reading at 7 psi, it was noticed that with the valve closed the vessel was 'relaxing', that is both the pressure and the deflection increased after a few minutes. This effect is depicted via the blue squares in the Fig. 26; after letting the vessel settle, the vessel was deflated back down to 7 psi, where it stayed although at a slightly lower deflection than the first reading. After this, at each point the vessel was allowed to relax, and both the pre-relaxation and post-relaxation numbers were recorded. The effect seems to be dependent on the pressure, but the cause is unknown. We speculate there might be some effect caused by the slow leaking of gas out of the vessel that causes the temperature to increase in the vessel, otherwise one would not expect both an increase in pressure and deflection (volume).

Figure 26: Plot of the deflection of the vessel it was deflated on August 4th. Compare the results to Fig. 17. The blue squares represent the post-relaxation reading. i.e., After closing the valve, it was noticed that both the pressure and deflection seemed to 'settle' at a slightly higher pressure and deflection than was noted immediately after the value was closed (black points). All these blue points are related to the black points nearest to their bottom right. The relaxation effect seemed to diminish as the pressure decreased.
