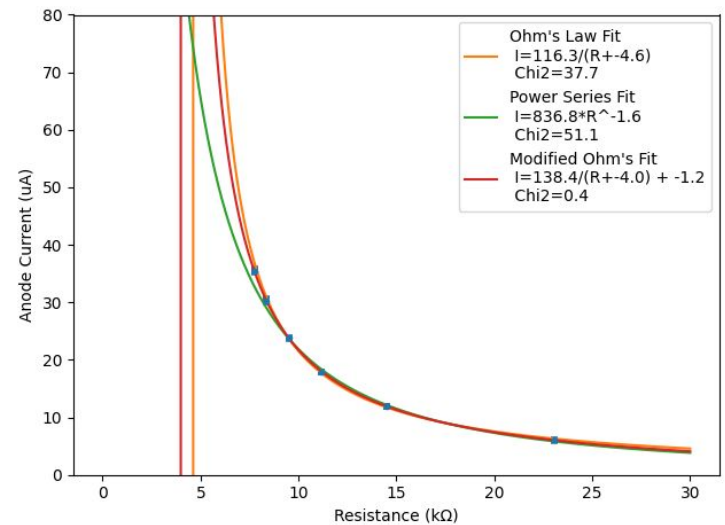
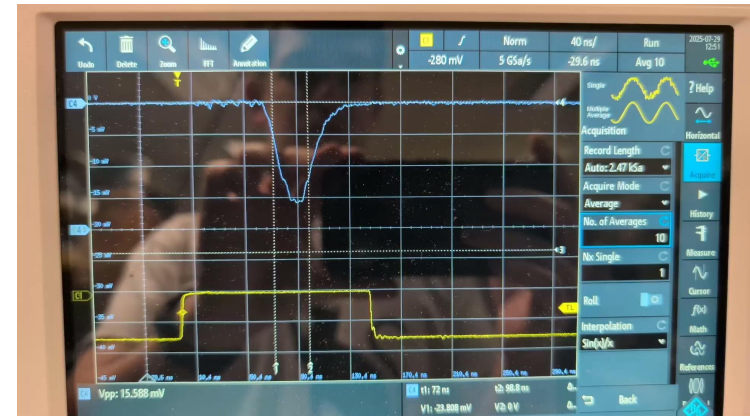
SDU4 Warm Up

- Came in on Monday, signal height changed to ~16 mV from 25 mV on Friday
- On Tuesday noticed signal peak bounces around a lot while the PMT warms up
 - Carl thinks this is due to the HV divider, said it is odd
- Eventually took new resistance measurements and fit them
- Came in wednesday to find the signal was now 14mV tall!
 - Carl says it may be from degradation of PMT as we run it with high current
 - Cycled HV and it changed to 15.5 mV, but seemed to be decreasing slowly
- Now signal also sharply grows and shrinks when DC LED is turned on, whereas it just grew in response to the background before
