SoLID Collaboration Meeting

Magnet Test & Detector Support

May 8, 2023

Magnet – Cold Test Update

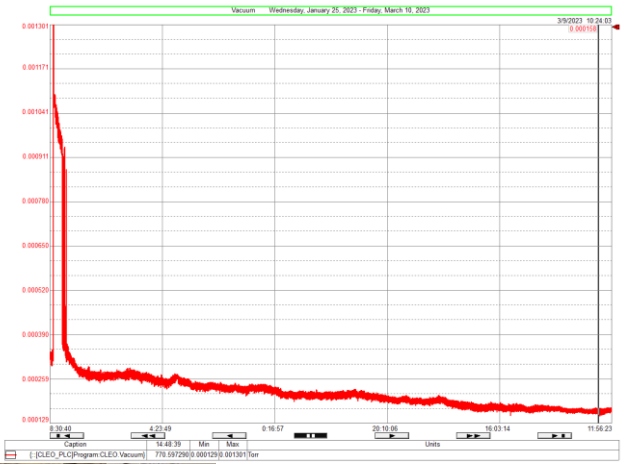
- Started pumping on vacuum space Dec 6th
- Progress was slow – expected since magnet was open to atm for several years and fire extinguisher residue in turret.
- Multiple pump and backfills with GN2 completed
- Leak check completed – potential small leak identified at base of service turret
- Vacuum putty added and showed improvement
- Continued to pump on space through holiday shutdown and CTF maintenance period (Jan 23)
- Turbo pump ran continuously during cool down and testing
- Ultimate vacuum level of 1.8 x 10^{-5} Torr via cryo-pumping at 4.5K

Suspected leak location

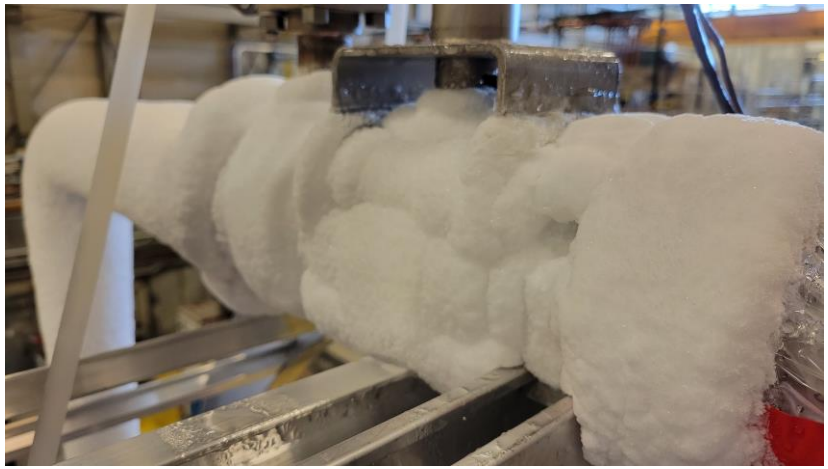
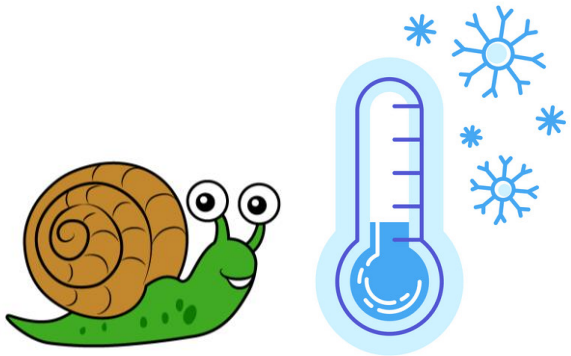
- Cryo transfer lines stung on Dec 15th in CTF cold box.
- A one day mini cool down was completed on Dec 16th to test cryo and controls systems using 80K N2.
- CTF had a scheduled maintenance down between Dec 21st and Jan 23rd.
- Full cool down started on Jan 24th using heat exchanger with 80K N2 to cool GHe.
- Simultaneous cooled down of the N2 shield started but with no heat exchanger on the N2 circuit made it challenging to moderate temp.
- Dealt with multiple noisy signals or faulty sensors in the C&I system.
- ½" diameter 300K GHe copper supply line from CTF to CLEO and ¼" fitting on regulator in CTF greatly slowed the cooling rate. (1.8K/day)

Warm return valve icing up

- CTF upgraded the regulator with ½” fittings and Physics Division installed a 7/8” diameter copper line between CTF and CLEO on Feb 21st.
- Cool down rate increased to 7.2K/day (vs 1.8K/day).

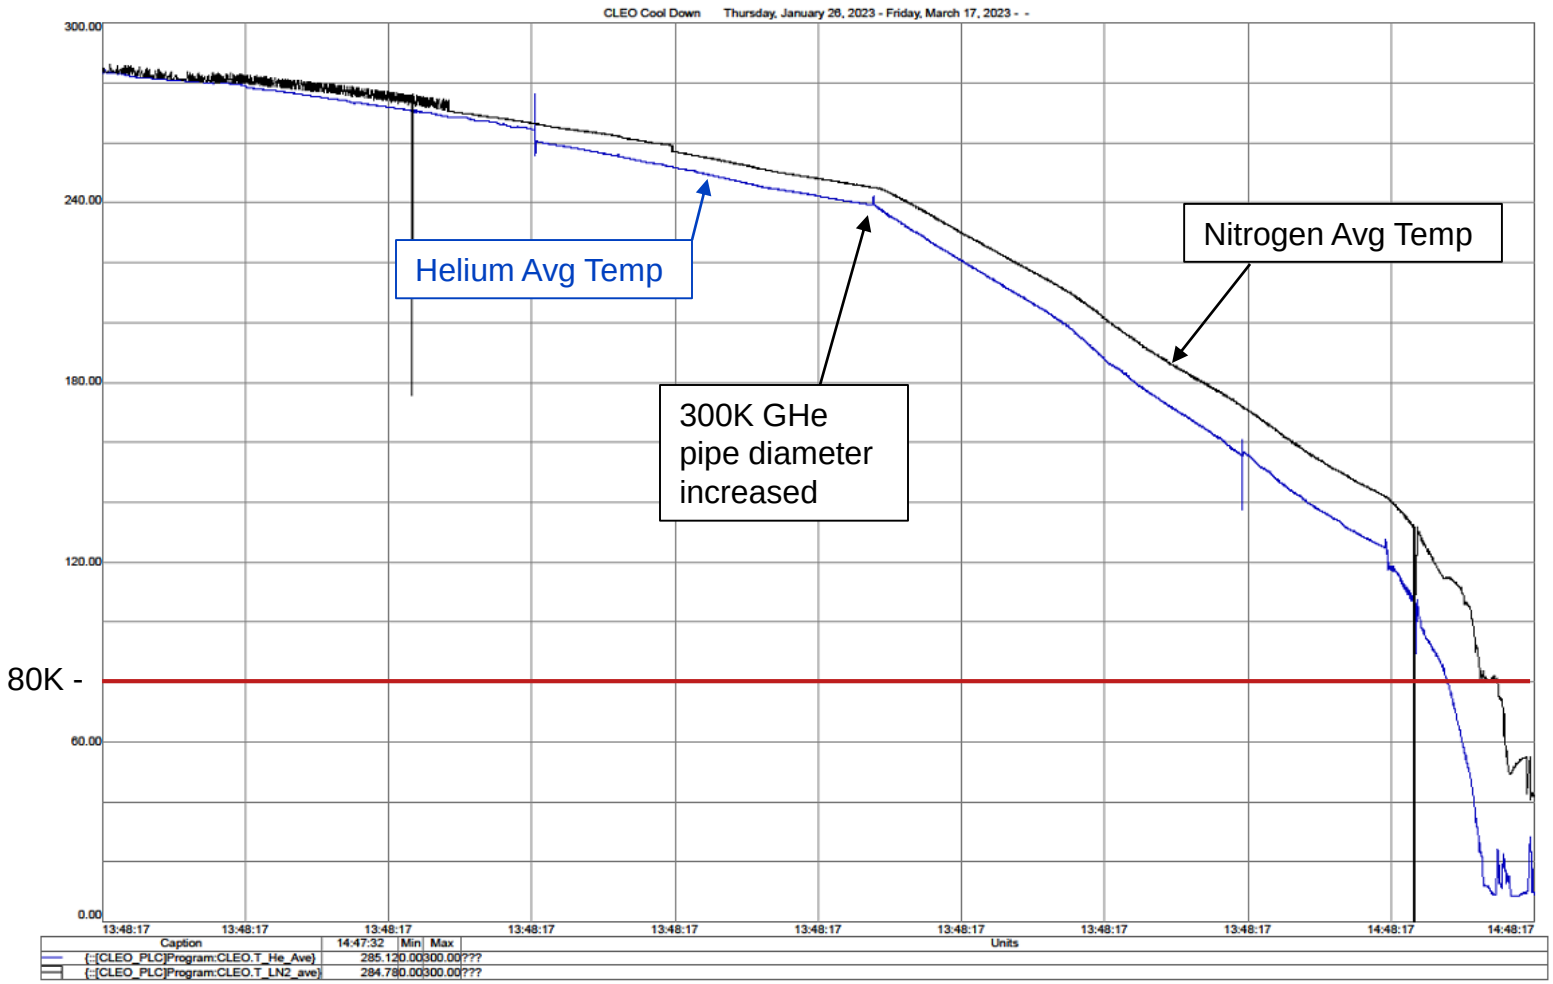
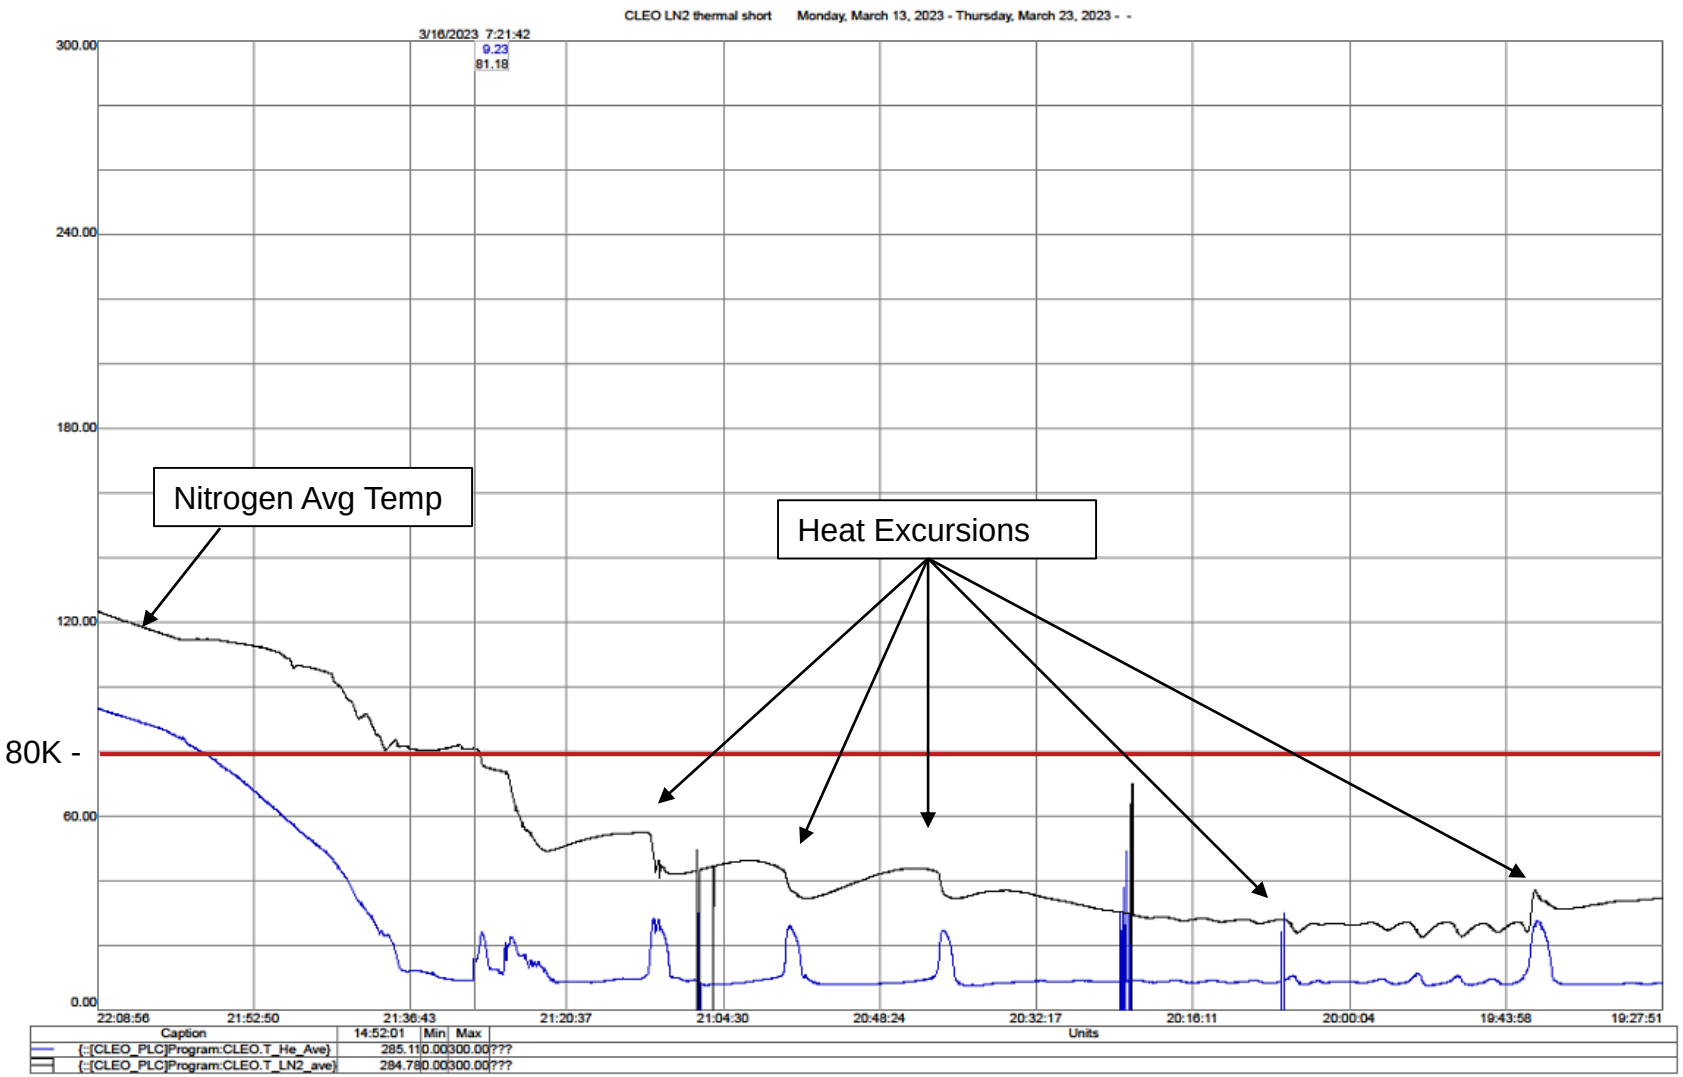
- Possible thermal short noticed on N2 supply and return temp sensors in the neck on March 12th as they both started reading higher than shield avg temp. Suspected location where the two lines coil around each other in the top of the neck.

- Noisy temp sensors added to the difficulty of maintaining required temp deltas across the coil and N2 shield. (nuisance alarms)
- On March 16th, as the N2 shield reached 80K, an apparent thermal short developed between the N2 and LHe circuits. N2 temps decreased below LN2 saturation temps @ 1.1 atm and continued to drop into the low 20K range.

- Temperature fluctuations in one circuit corresponded to changes in the other circuit.
- These fluctuations continued for the remainder of the cold test.

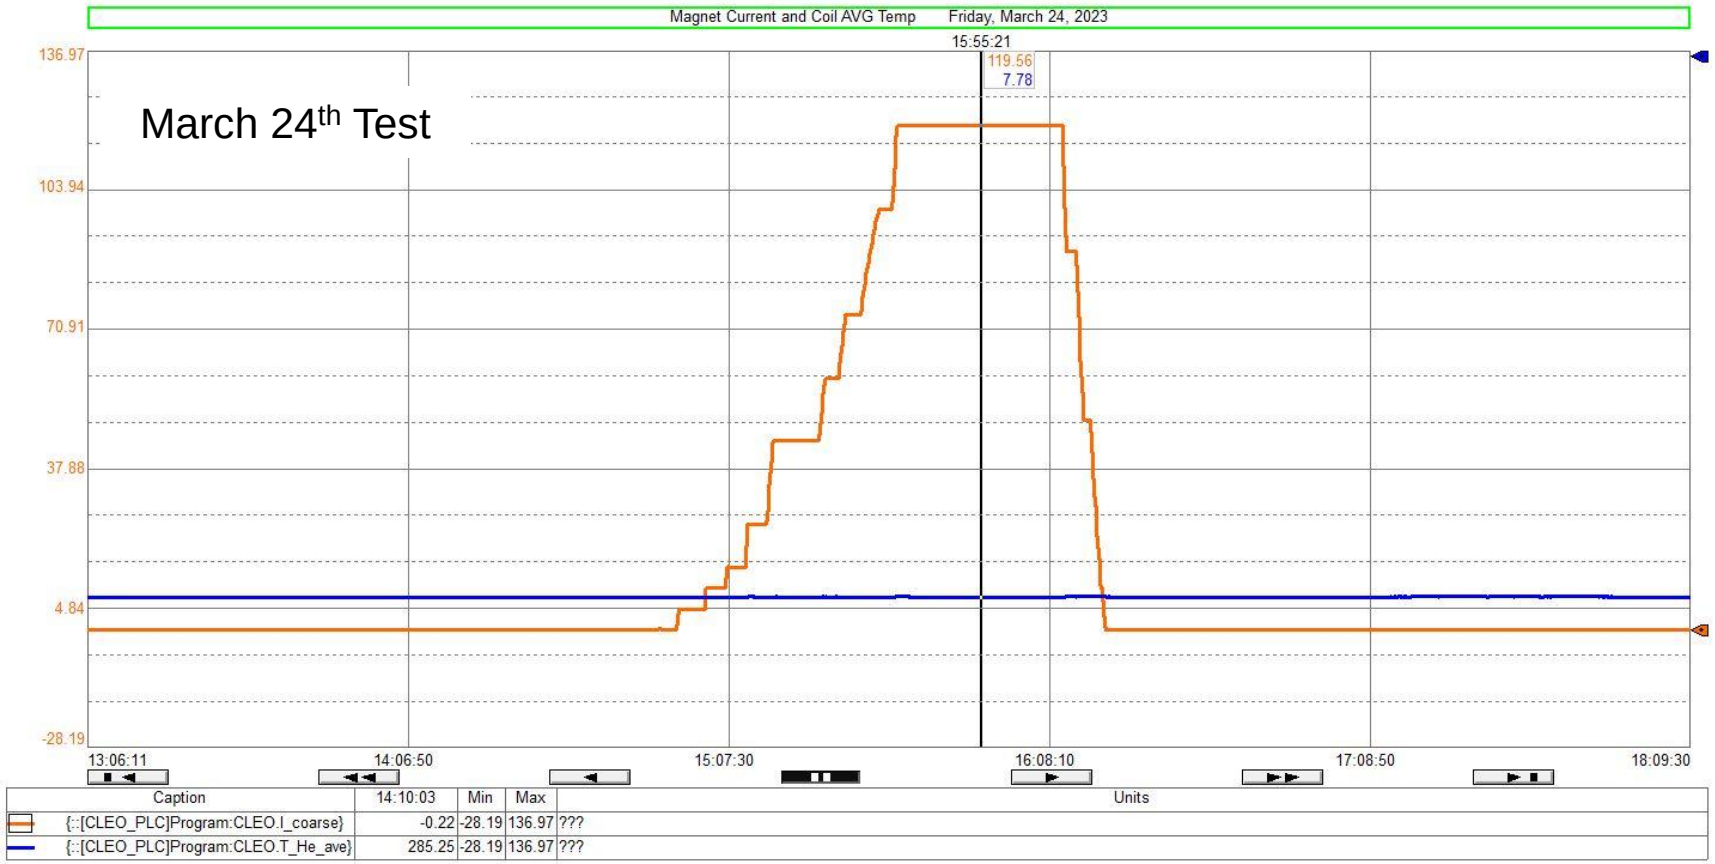
Coil average temperature remained constant during low current test.
Test current of 120A.
Coil average temp read 7.8K – RhFe sensors likely need low end offset adjustment.
