# HGC Window Prototyping - July Testing Series

University of Regina

August 16, 2017

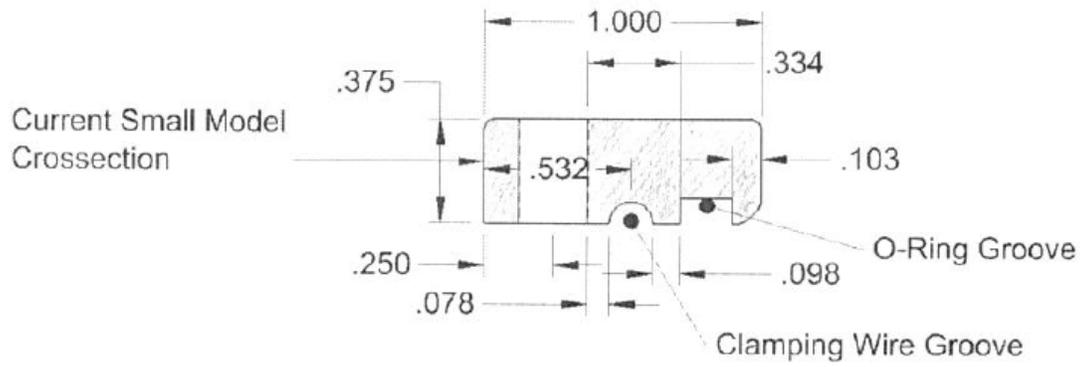
Figure 1: Cross-section schematic of window flange. All units are shown in inches. These specifications are based on design principles from Mapes and Leonhardt [2], and safety guidelines from FNAL [1].

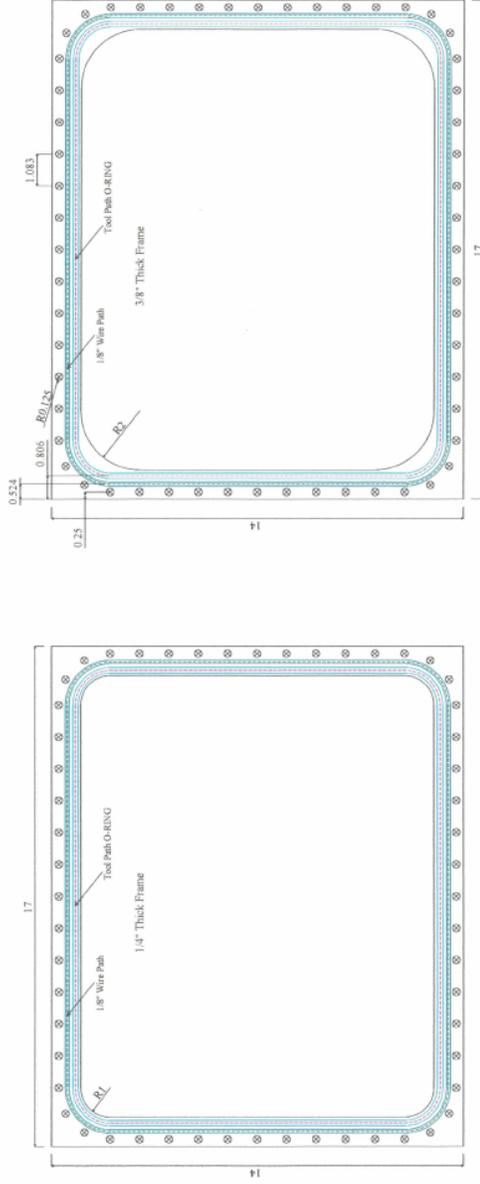
Figure 2: Schematic diagrams of the 1/4" (left) and 3/8" (right) window flange. The radius  $R1=1''$  was found to be too small according to the FNAL guidelines [1], so was increased to  $R2=2''$ .

The original flange to be used in these tests was 1/4" in thickness. However, after the second test it was deemed necessary to make a new flange with a thickness of 3/8", and a larger inner radius on the corners. The schematics for each flange are shown in Fig. 2.

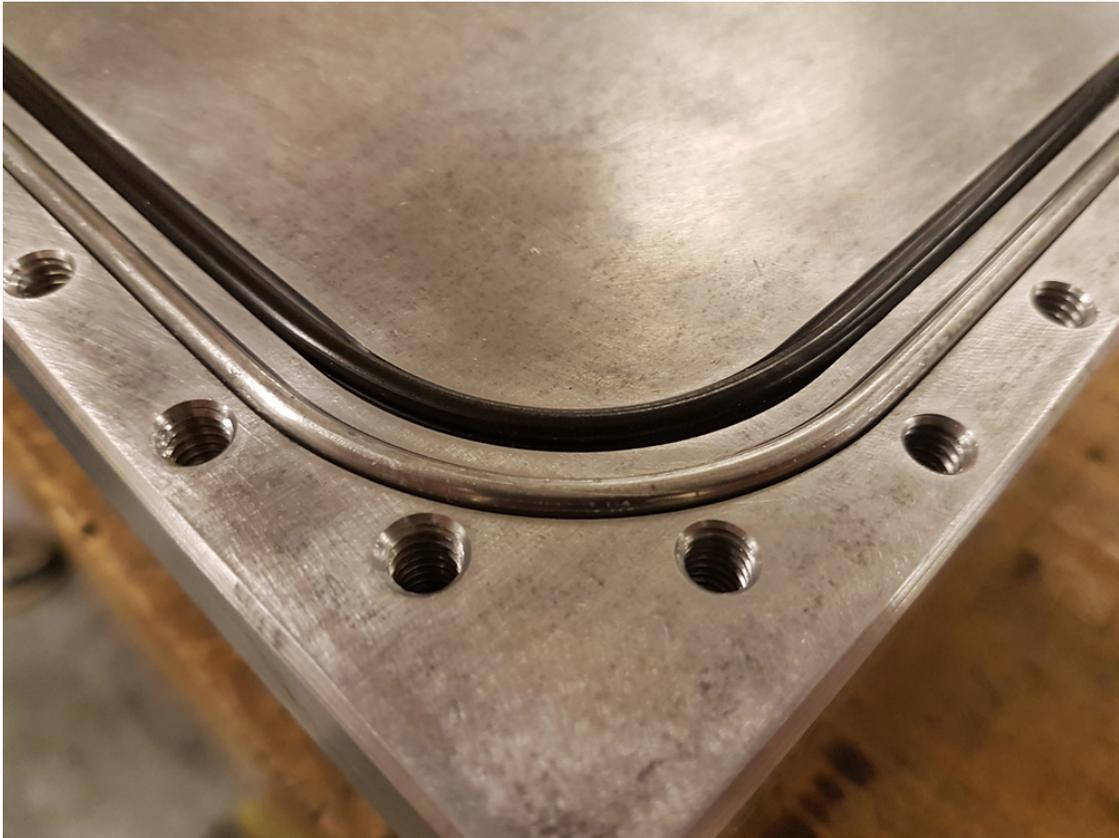
Based on results of prior tests, in which the clamping wire was placed outside of the bolts, the wire has been moved to be inside the bolts, consistent with the BNL thin window report [2]. The hypothesis is that the previous windows failed due to too much force being placed on the bolts, where the material is weak. Placing the wire inside should allow the wire to take this force instead. Fig. 3.

Figure 3: Close up of base plate edge, showing (from top to bottom), the O-ring, the clamping wire, and the bolt holes.

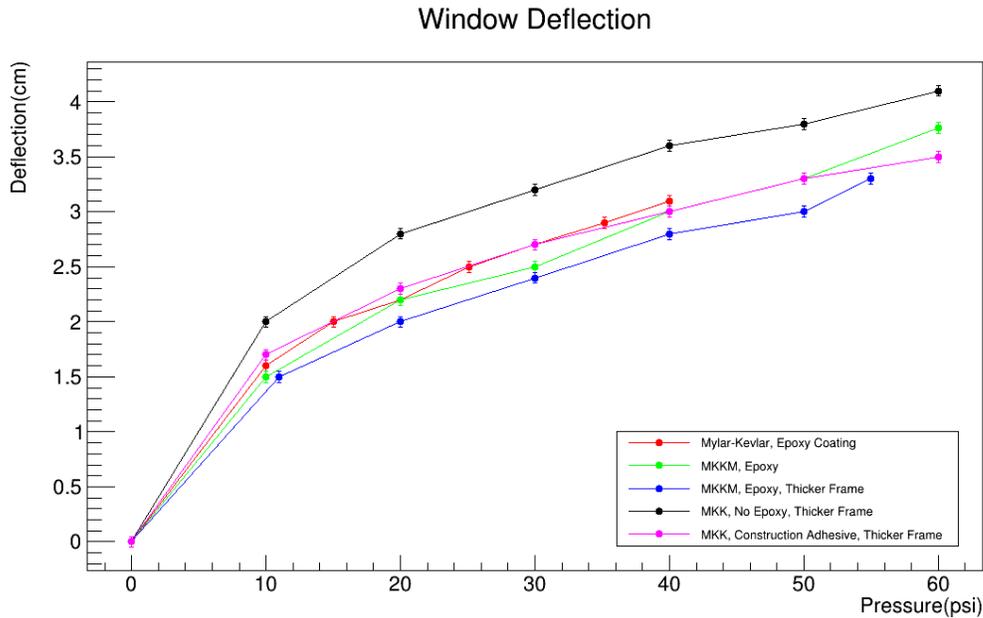
Figure 4: Raw deflection data of the five window tests.

These data indicate that the desired result of the pre-stretching was achieved; The shallower slope in the Deflection-Pressure plot sets in at a lower pressure, and the window bulges less overall. However, this has the undesirable side effect of increased tension in the window.

All windows in this series failed above 50 psi, versus the 35 psi failure point of the previous test using the acrylic flange. This indicates that the new clamp made a substantial improvement in gripping the window.

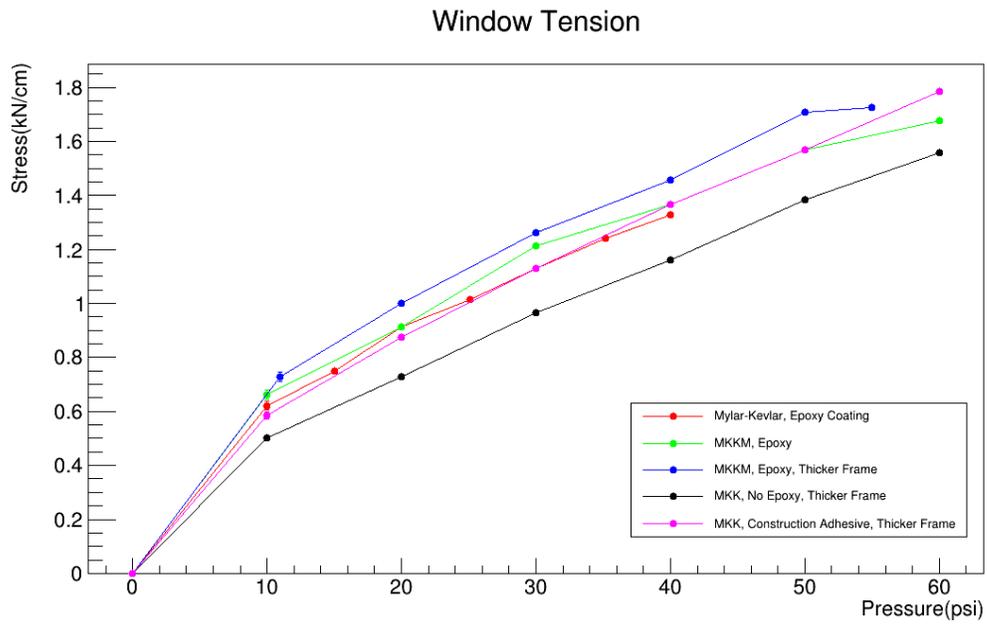
The raw deflection data are summarized in Fig. 4. Fig. 5 shows the tension in the window material based on the approximation of the shape of the window as spherical, and that the tension is equal to the pressure times the radius of curvature.

Figure 5: Tension in the material for each window.
