# HGC Window Prototyping - Full Scale Carbon Fiber Testing Series

#### University of Regina

August 20, 2019

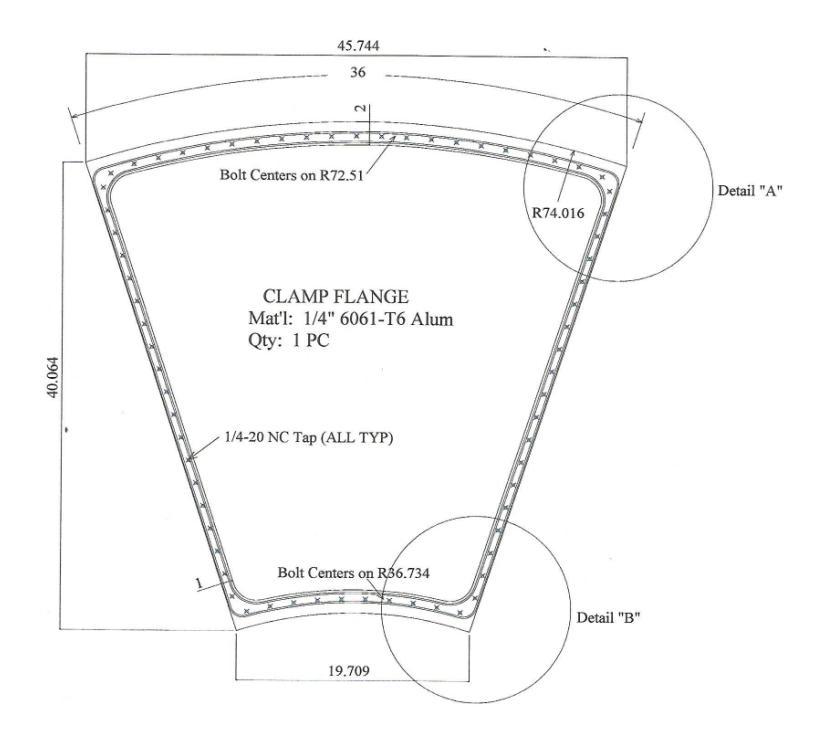
The window frame that was used during these tests was the original mock up of the design from 2015. Since its creation, several flaws have been found with the design, in the most recent design these have been addressed. The first draft of the window frame (Figures 1 and 2) was made using a poor estimate of the required clamping force. When the calculation was redone, it was found that the required clamping force was higher than expected and larger bolts were needed to hold the window in place. As such, the existing holes on the frame were drilled out to be wider than they were previously. In some areas the holes were close to the O-ring slot, causing the overlap seen in Figure 3. The quantity of bolts required to reach the

Figure 1: Original drawing of the frame, used to fabricate the design which was used in these tests. The current version that is in use now has been modified as calculations for the required clamping force were redone.

new clamping force value was also higher than in the initial design. The additional bolts that were required were placed further from the O-ring slot, this is the cause of the staggered bolt pattern that can be observed in Figure 3. The current design of the HGC window frame (Figure 4) now takes into account the required clamping force, as well as proper positioning of the bolts in relation to the O-ring. This has the net result of wider holes that are placed further from the O-ring and that are spaced further apart from each other. This design conforms to the requirements for clamping force and rigidity, as such, this updated design should resolve any leaking issues that are due to the frame.

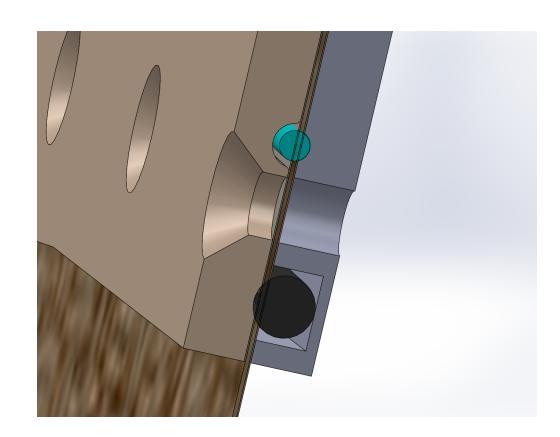
Figure 2: 3D rendering of the cross section of the original design for the HGC window frame. The black cylinder is the O-ring while the teal cylinder is where a clamping wire would have gone. This clamping wire is no longer is use and is not part of any current design.

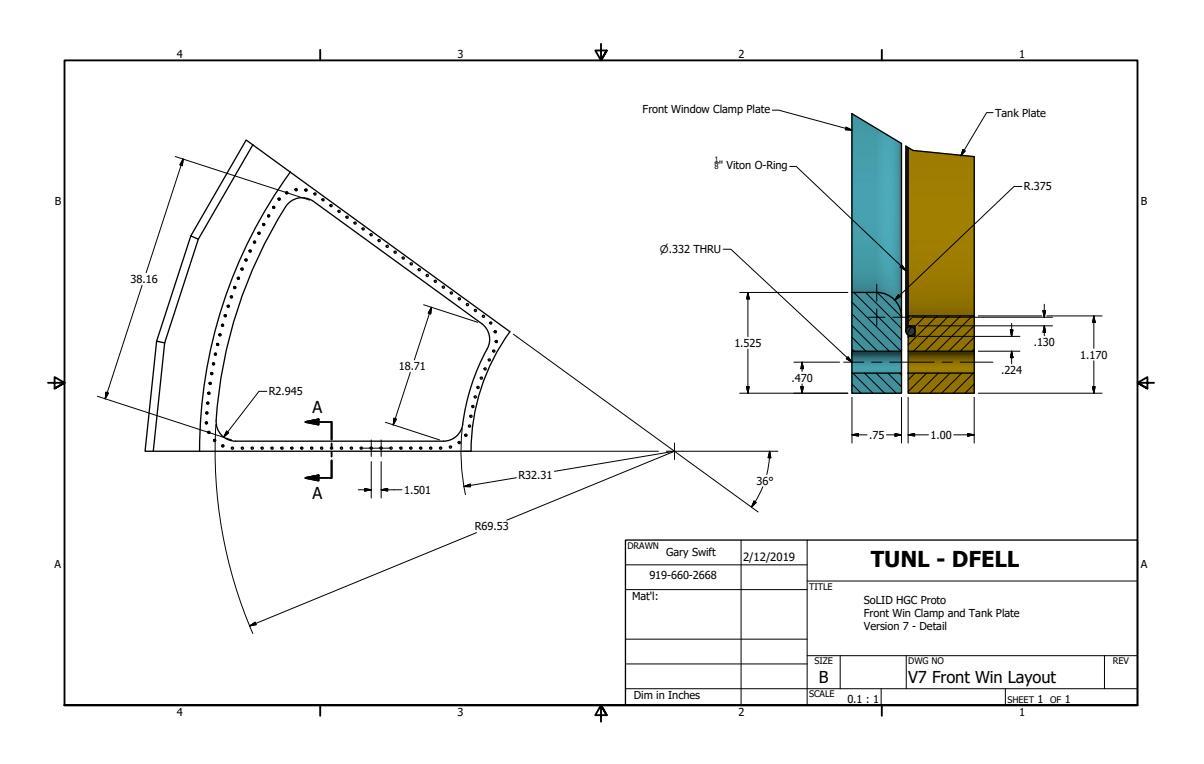
Figure 4: Current design for the HGC window frame. The spacing between the bolt holes and O-ring, and the spacing between bolt-hole and edge of frame is much more than it was in the old design (Figure 1).

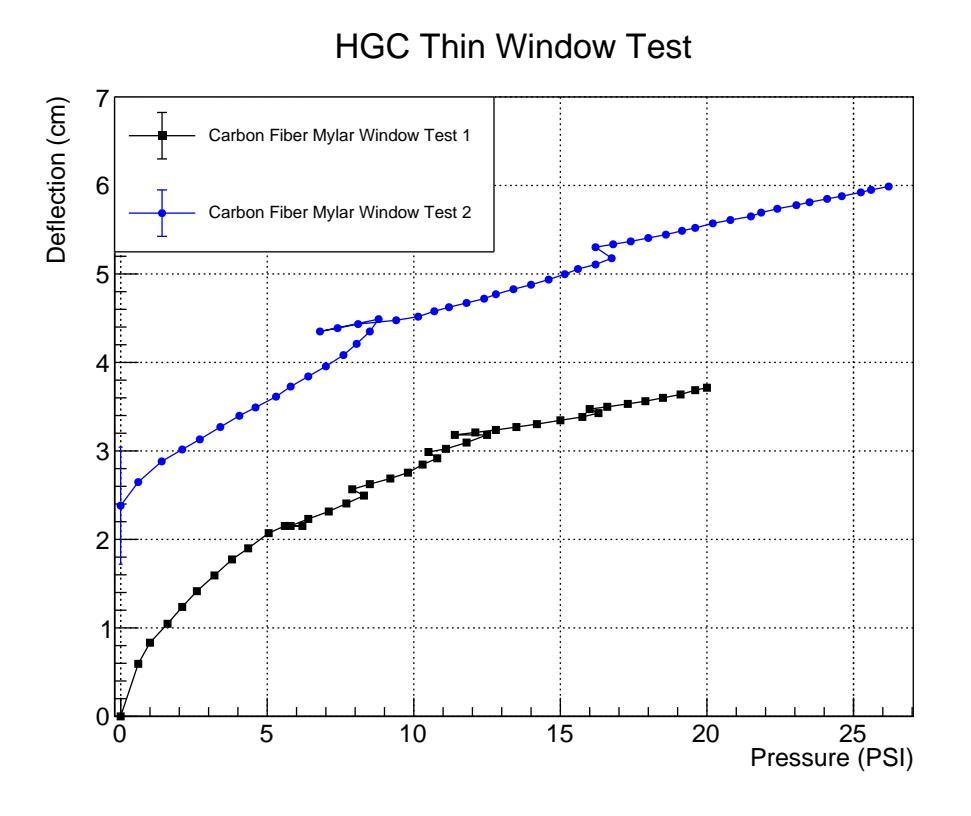
Figure 8: Pressure versus deflection of the window for the first two tests. The blue line starts above 0 because that is how much the window was deformed from the previous tests, the uncertainty from this base deflection is plotted only on the first point. The points on this plot where the pressure decreases are due to a pause in the inflation to work on the window or on the testing apparatus. This is further detailed for each test in Sections 5 and 6.

During the first test (Figure 8), the pressure was pumped up gradually until about 6.2 psi, at this point

the deflection gauge had to be re-zeroed. At 8.3 psi, a leak test was conducted and no leaks were detected. Another leak test was carried out at 10.8 psi, and at 12.5 psi leaks were observed coming from the Mylar layer, shown in Figure 10. Following this observation, the torque on the bolts was increased to 40 ft - lbsand inflation was continued. The inflation process was again paused at 16.2 psi for a further leak test, more leaks were discovered. It is notable that starting at 5 psi the occasional creaking noise could be heard from the window, this is similar to the noises that were heard during small scale testing [2]. These creaking noises continued intermittently and got somewhat louder as the pressure increased. At 20 psi, it was decided to stop inflating the window and see how quickly it deflated back to 0 relative pressure. The pressure and deflection was measured at somewhat regular intervals until the end of the day and then again in the morning, Figure 11 shows these data. Note that the first portion of the plot has an increasing deflection that then peaks and begins shrinking as the the air continues to escape. This is believed to be due to the relaxation of the carbon fiber. Also of interest, the deflection gauge rolls over every  $1/10^{\circ}$  meaning that  $456/1000^{\circ}$  looks identical to 556/1000", as such the last point was estimated to be the option that looked the most reasonable on the plot. After the test had been concluded, the window was taken apart and inspected. This post-mortem showed little to no obvious damage that would have caused the leaking. The carbon fiber was still intact, although it had been deformed into a different shape (Figure 12). The Mylar showed little in the way of stretching, although there was a cut to the Mylar at one of the bolt holes. However, the observed leaking was not around that location so it is thought that this was not the cause of the leaking (Figure 13).

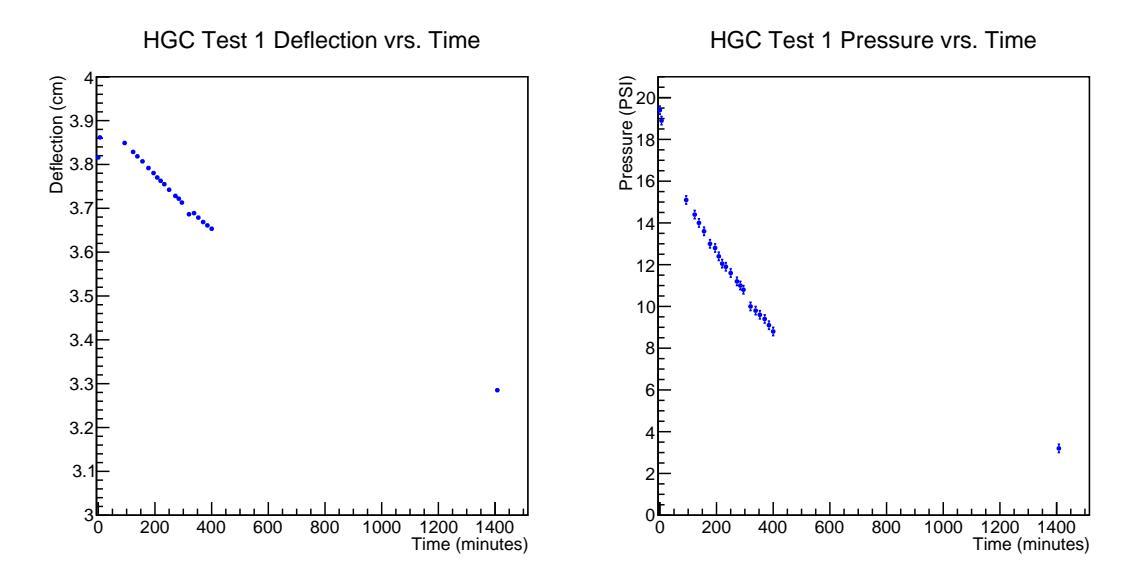
Figure 11: (left) Plot of the deflection versus time after the inflation of the first test. (Right) Pressure versus time after the inflation of the first test. Notice that the first portion of pressure dropping is accompanied by an increase in deflection as the window relaxes.

Later on, the valve and pressure gauge apparatus was used on a different piece of equipment and during that testing, the valve connecting the window test apparatus to the bike pump was found to be leaking.

Since this valve was used during the first two tests, this leak is thought to have had a significant effect. However, leaking was observed out of the sides of the window so the leak in the valve was not the only source of leakage.

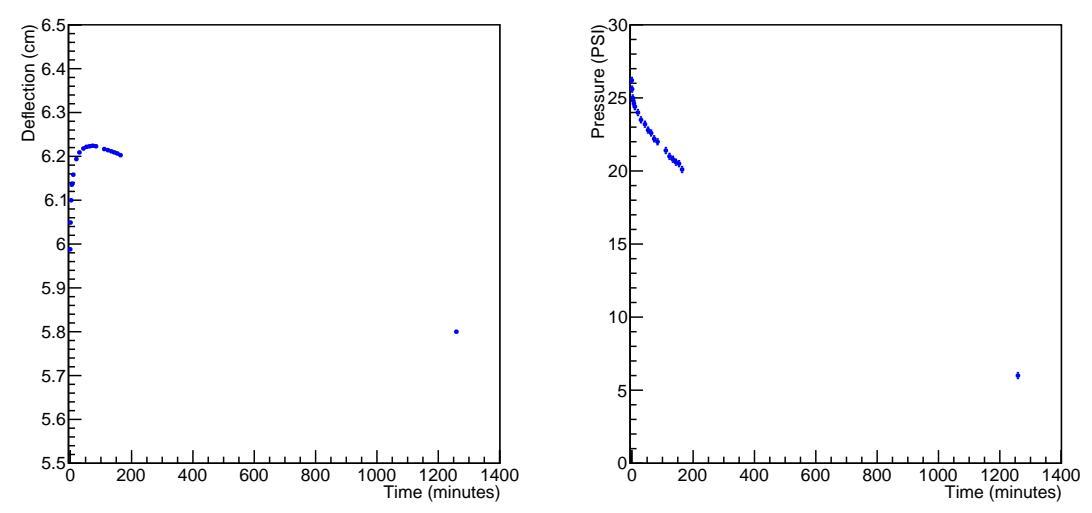
Figure 17: (left) Deflection versus time for the deflation of the second test. (right) Pressure versus time for the deflation of the second test. The last point is on its own because it was taken the morning after the test.

The deflation of this window proceeded very similarly to the first, the window relaxed and then began to deflate slowly. This process can be seen in the data when plotted in Figure 17. Due to the previously discussed issue with the deflection gauge, it is not possible to know what the last data point was exactly, so it was determined in the same way as with the last one.

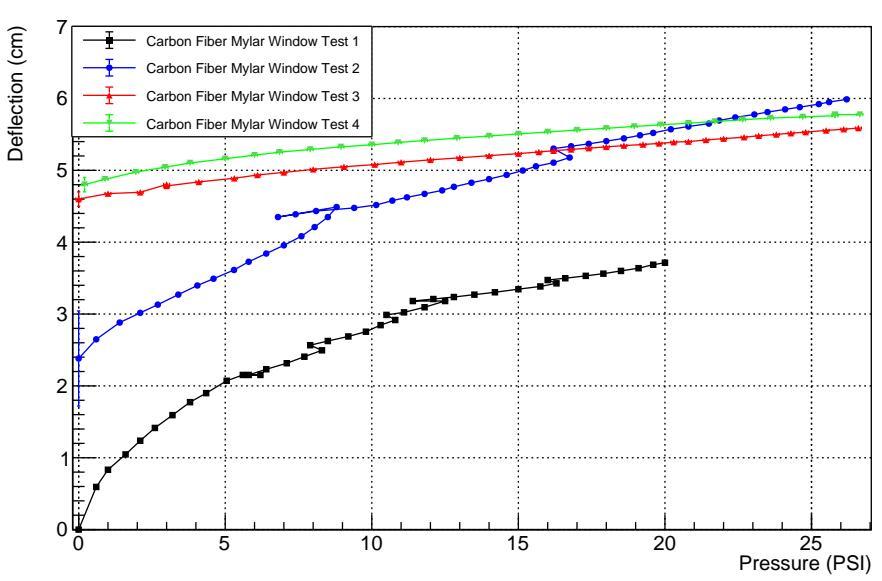
Figure 19: Pressure versus deflection of all four tests. The irregularity in test 3 at 3 psi is due to the air leaking from between the Mylar and carbon fiber layers.

plotted in Figure 19. This time, there was less interest in the leaking so during test 3 there was one stop to test for leakage. This was to check that the hole was not accidentally drilled into the Mylar as at around 3 psi the window started rapidly decreasing in pressure and deflection. There were a great deal of bubbles coming out of the hole in the carbon fiber. This behavior soon stopped though, it is thought that this was simply air escaping out of the gap between the carbon fiber and the Mylar. This is not seen much in the data as none were taken until it was clear that there was no hole in the Mylar. Curiously, this behavior was not seen during test 4 to any great degree, this may have been because in that test even though the air was drained there was still about  $0.2 \, psi$  still left in the window. Thus the Mylar may have already been pushed against the carbon fiber at the start of the test. Also of note is that as the pressure increased, the bicycle pump required much more force to pump than in the first two tests. This may have been due to the valve no longer leaking, or it may have been due to the hole in the carbon fiber.

Figure 19 also shows the data from these tests, it is clear that the window is bulging slightly with each inflation. In test 2, the deflection was within systematic uncertainties of both these tests, and test 3 deflected

less than test 4. This implies that after test 2, the carbon fiber came back and was similar to when it was inflated before, just bulged slightly further. It appears that repeated working of the window does weaken the carbon fiber slightly. Also, this configuration still leaked and the data from the leaking itself is also plotted, these can be seen in Figures 20 and 21. What is interesting is that in test 4, unlike the previous tests, there seems to be little to no relaxation. The curve flattens out at about 5.76 cm. There must be some relaxation as the window is still deflating during that time, but the two effects are canceling each other out. This suggests that the window is reaching a completely worked state.

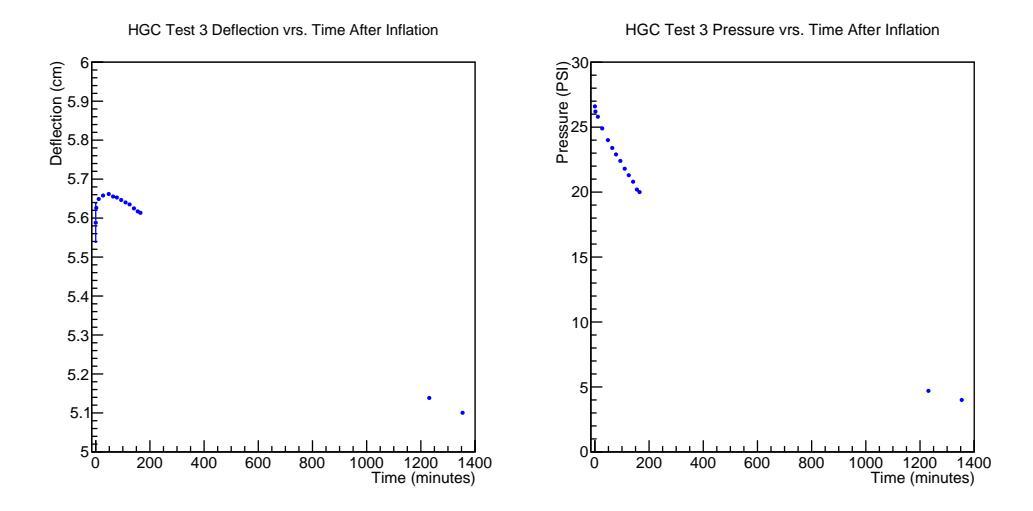
Figure 20: Data taken as the HGC deflated in test 3. (left) Deflection versus time after inflation. (right) Pressure versus time after inflation

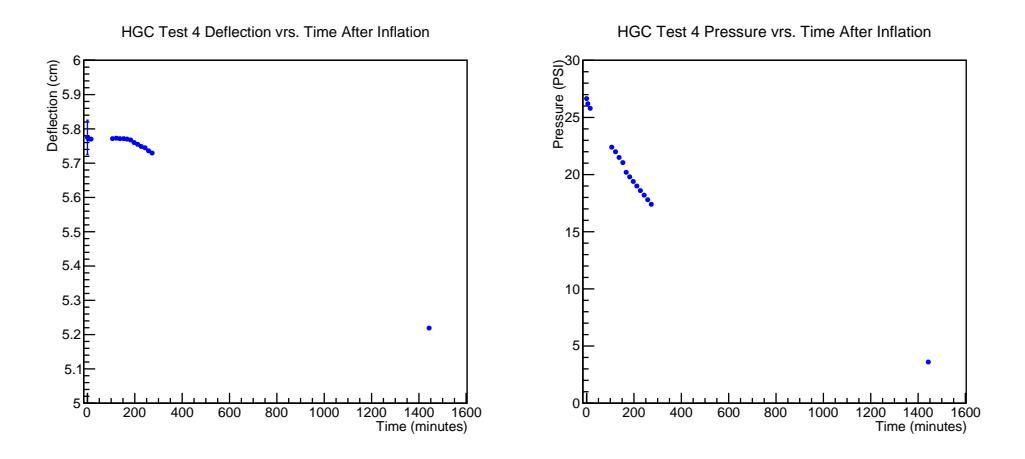
Figure 21: Data taken as the HGC deflated in test 4. (left) Deflection versus time after inflation. (right) Pressure versus time after inflation

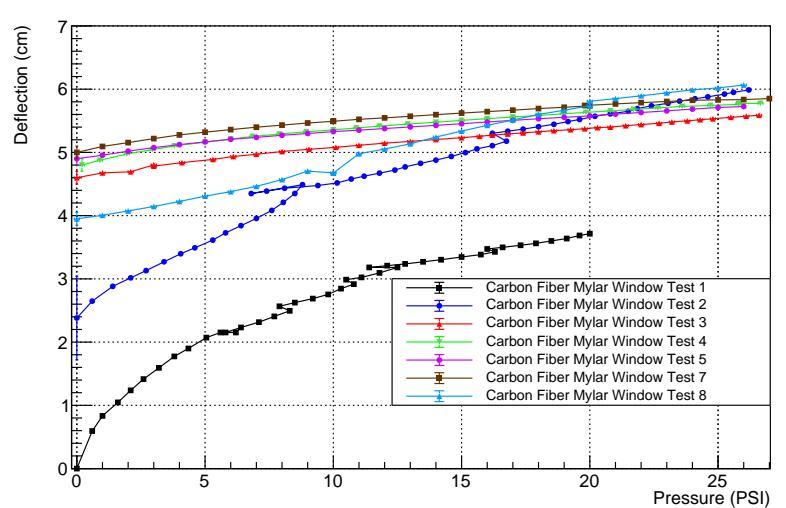
After reassembly, the eighth and final test was done and the data can be seen in Figure 25. The inflation went smoothly until 10 *psi* where a leak test was conducted, this test showed that the valve that was being used was once again leaking, but other than that no leaks were detected. Then another leak test was done at 20 *psi*, this one showed some small leakage around edge of the window like in other tests. The test concluded at 26 *psi*, deflection data started to be taken but it was decided that the valve was leaking too fast for deflation data to be meaningful, so this was not taken.

Figure 25: Plot of pressure versus deflection for tests up to date. Test 6 was omitted because its data fell directly on top of Test 7

The data from this test (Figure 25) shows that the window had relaxed while it was out of the window frame. This may have been simply because it was no longer in the frame or, it may be due to storing the window upside down. This inflation reached the same deflection, within systematic error, as the second test and it also is in the same region as the other tests. This shows that there is no significant drop in the performance of the window if it is taken apart and reused.
