SoLID HGC Prototype Front Window Testing

University of Regina

June 21, 2021

Abstract

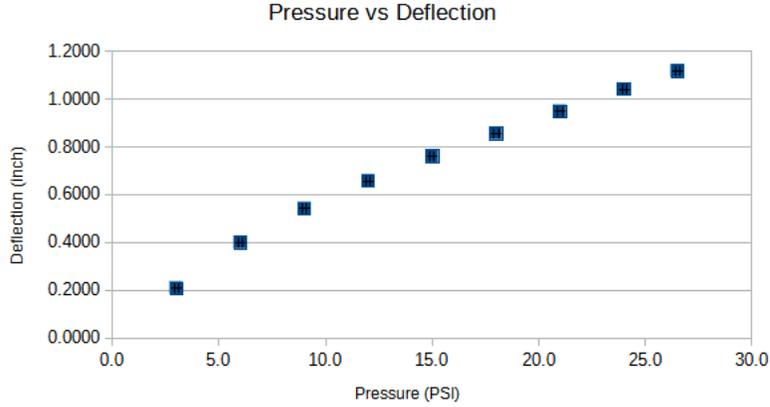
The first pressure test of the aluminum window happened on February 8th. The window was set up in the manner described in the experimental procedure. The dial gauge was placed on the window's estimated high point. An issue occurred with this test where the valve was leaking. The results are listed in Table 2. A graph of the deflection over pressure is in Fig. 8.

Pressure (psi)	Deflection (inches)	Pressure (Torr)	Deflection (cm)
3.0	0.209	155	0.531
6.0	0.400	311	1.015
9.0	0.542	466	1.377
12.0	0.658	620	1.671
15.0	0.760	776	1.930
18.0	0.856	931	2.174
Dial was re-zeroed			
21.0	0.948	1086	2.408
24.0	1.041	1241	2.644
26.5	1.116	1370	2.835
Residual deformation afterward at 1 psi: 1.001 inches

Figure 8: A graph showing the relationship between pressure and deflection for the first test in imperial units.

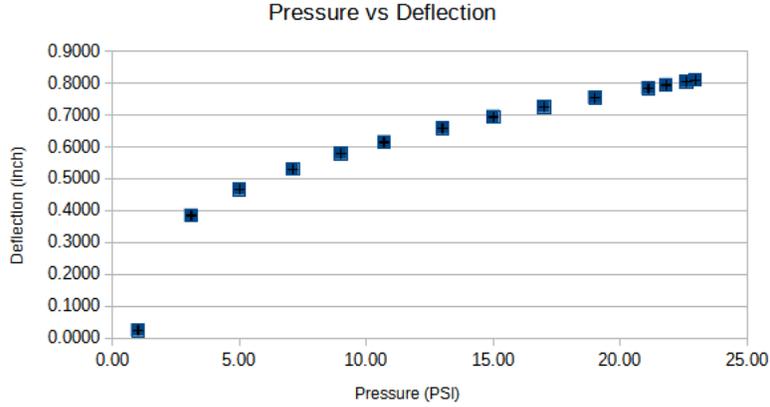
The deflection was tested for a second time on February 10th. The window had 1 psi before it was inflated. Some problems that occurred with this test were that both the bike pump and the valve were leaking. The results are in Table 3. A graph of the deflection over pressure is in Fig. 9.

Figure 9: Test 2.1 A graph showing the relationship between pressure and deflection for the second test in imperial units.

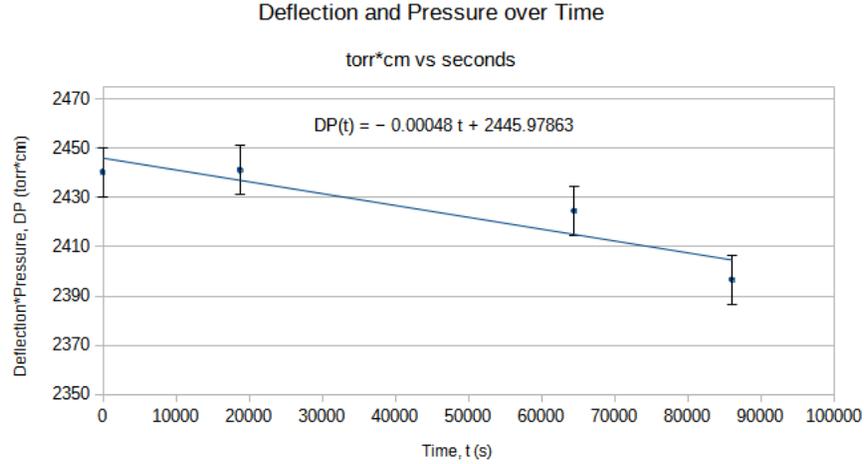
After this test, the window was left inflated for almost one day. The window's deflection and pressure were checked periodically. The results are in Table 4. A graph of the deflection and pressure over time is in Fig. 10. The leak rate of the window was $0.0035 \pm 0.0003 \frac{\text{Torr}\cdot\text{L}}{\text{s}}$. This leak rate was affected by the leaking valve.

Figure 10: Test 2.2 The deflation of the aluminum window over time.

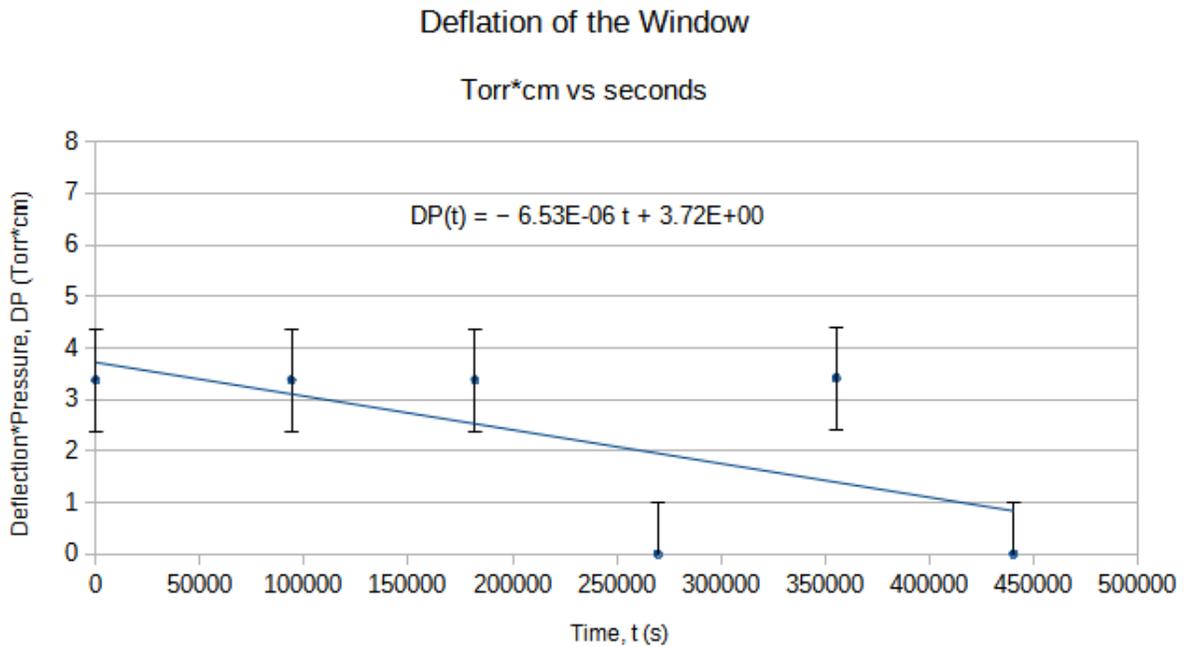
The window was left inflated over six days. The results are in Tables 6, 7. The pressure and deflection over time are graphed in Fig. 11. The leak rate is $(5 \pm 3) \times 10^{-5} \frac{\text{Torr}\cdot\text{L}}{\text{s}}$. There is much error in calculating this leak rate, due to the leak rate being so small. Afterwards, the window was deflated and used to test the vessel.

Figure 11: Test 2.4 The rate is $(-7 \pm 4) \times 10^{-6} \frac{\text{Torr}\cdot\text{cm}}{\text{s}}$.

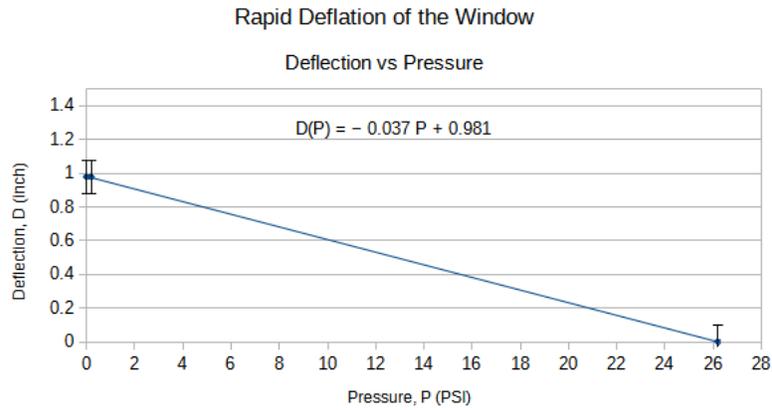
Figure 12: Test 3. The window's rapid deflation.

The deflection decreased rapidly when the window's pressure was almost gone (during the last 10 psi). The measurements can be found in Table 8. A graph of this deflation is in Fig. 12. After the window was deflated, the window was removed and its deformation was measured using a dial gauge. Some elongation around the bolt holes was noticed (see Fig. 13). Unfortunately, the dial gauge was bumped in the process of removing the window. Since the gauge was bumped, the deformation may be either 1.102 inches or 1.202 inches. The window was placed back on the steel plate and was bolted in a zigzag pattern with 100 in-lbs torque, then 110 in-lbs and finally 120 in-lbs torque.

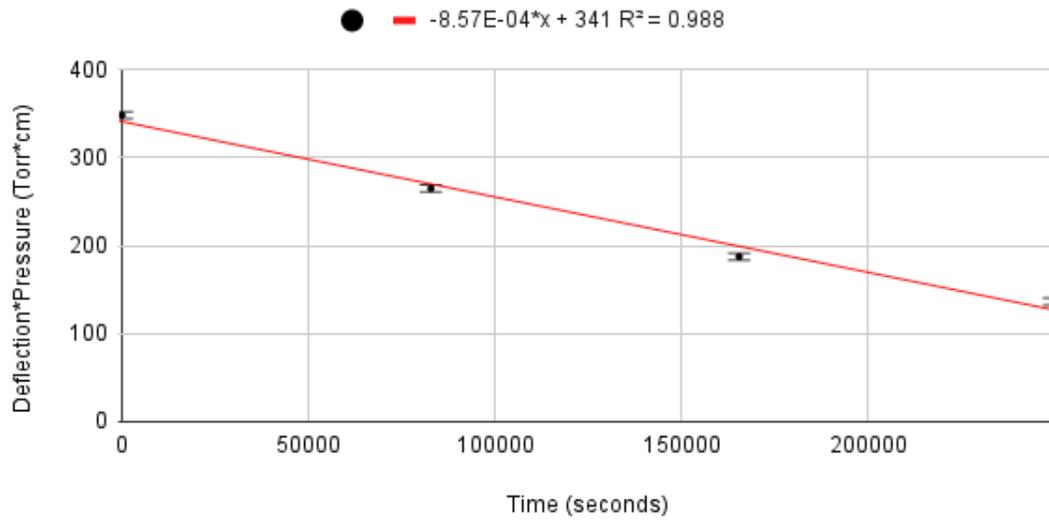
The leak rate for the carbon fiber window is about $0.0062 \pm 0.0002 \frac{\text{Torr}\cdot\text{L}}{\text{s}}$. This leak rate was calculated using the change in deflection and pressure from the last time it was pumped during the test. However, since the window was pumped up multiple times, this number doesn't describe the window's full behaviour. It was clear that there was a leak from some part of the setup. There were attempts to fix leaks in the plumbing underneath the steel plate. The window was pumped up to 26.0 psi and left overnight. On April 18th, at 11:50 the pressure dropped down to 23.9 psi, which showed the leaks were still there.

Figure 29: The deflection and pressure from the last time the window was pumped to 26 psi. This rate was used to calculate the leak rate of the carbon fiber window.

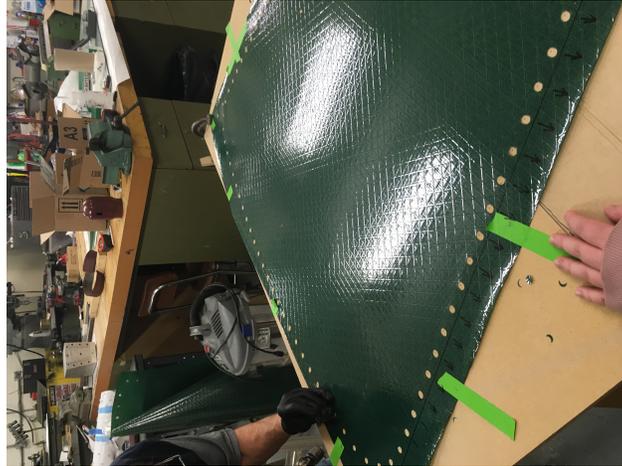
On April 20th, a sheet of Mylar was cut out using a similar method as the Tedlar sheet. However, the bolt holes were cut to an oblong shape this time, to allow the material to move during inflation (see Fig. 33). The bolts were tightened down while the window was slightly inflated. All the bolts were tightened to 120 in-lbs and the window was inflated to 26.0 psi. The window began to creak and the right side became larger than the left (see Fig. 34). A loud crack was heard and the pressure quickly dropped. The window was leaking on the right side. Torn carbon fiber could be seen poking outside the window frame (see Fig. 35). The window was deflated and removed from the frame. The window had a lot of tearing and stretching by the bolt holes (see Figs. 36, 37 and 38). The window may have slipped in the frame due to the glossy texture of the Mylar. Note that this problem was not experienced in previous tests with Mylar inner liner [3].

Figure 33: The Mylar was cut with oblong holes.
