# SoLID HGC Prototype Vessel Leak Testing

University of Regina

August 20, 2021

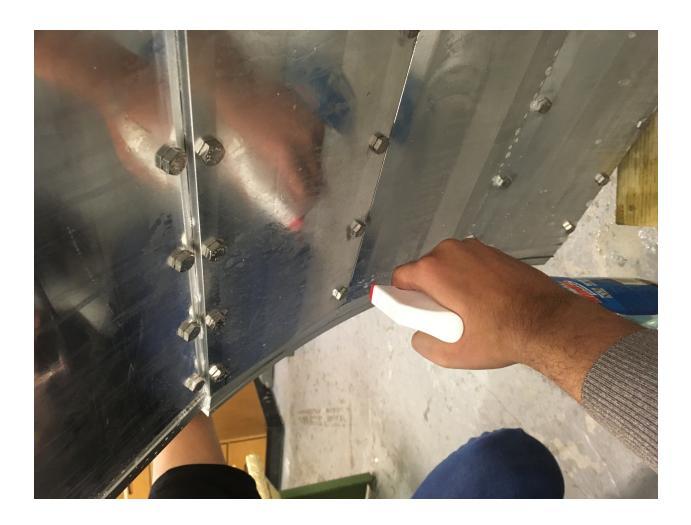
Figure 6: The soapy water test is done by spraying soapy water over the seams.

On February 8th, the front window with an O-ring was bolted to the vessel. The window's frame was accidentally placed on backwards, so it had to be taken and placed back on again. The vessel had no sealant or epoxy on it at this time. The vessel was pressurized with an air hose, but there were many leaks, enough that no differential pressure could be built up. Soapy water was sprayed onto the vessel to check for leaks (see Fig. 6). If a leak was found, it would bubble like in Fig. 7. Some of the leaks were large enough to feel by hand and to hear. They were located:

- edge of front plate towards the outer radius
- edges of side plate-left, especially where it connects to the back plate extension and the top plate
- between back Window and side plate
- between back window and rib
- a bad leak on the entire seam between the back plate and top plate
- between the top plates
- between front top and top plate

- some leaking on the bottom plates
- in the corner where the top plate, back plate and rib meets

Between February 9th–11th, the vessel was cleaned four times to prepare it for the sealant. Ethanol was used to clean most of the vessel and acetone was used to clean difficult areas. Rags were used to clean large areas, kimwipes where used to clean smaller areas and Q-tips where used to clean the seams. The first time, it was cleaned with ethanol using kimwipes. The second time, it was cleaned with ethanol using rags, kimwipes and Q-tips. The third and fourth times, it was cleaned with both ethanol and acetone separately, using rags, kimwipes and Q-tips. The cleaning was done with the vessel back panels removed, to allow for more ventilation, and a fan was used to help with air flow. Due to concerns with fumes while cleaning the vessel, breaks were given at least every hour. Foam was used for padding to protect knees. The setup can be seen in Fig. 8. The sealant was then applied on the 11th and the 12th. The setup was similar to the cleaning setup. A lamp was used to help illuminate the vessel and its heat helped the sealant to cure. Headlamps and flashlights were also used to illuminate the inside of the vessel.

About 7 tubes of RTV sealant were used. There were some challenges when applying the sealant. The sealant formed a skin rather quickly, roughly within five minutes, which made making a continuous seal difficult. If the sealant was applied too thickly, there was a tendency for air bubbles to form in the sealant. The glossy black finish made of the RTV it difficult to see imperfections in the application. On February 16th, the back panels were placed back on the vessel. RTV sealant was sandwiched between the back panels and the vessel (see Figs. 9 and 10). The panels were bolted on with 120 in-lbs of torque, as measured by a torque wrench, and the excess sealant on the inside of the vessel was smoothed down with a wet glove.

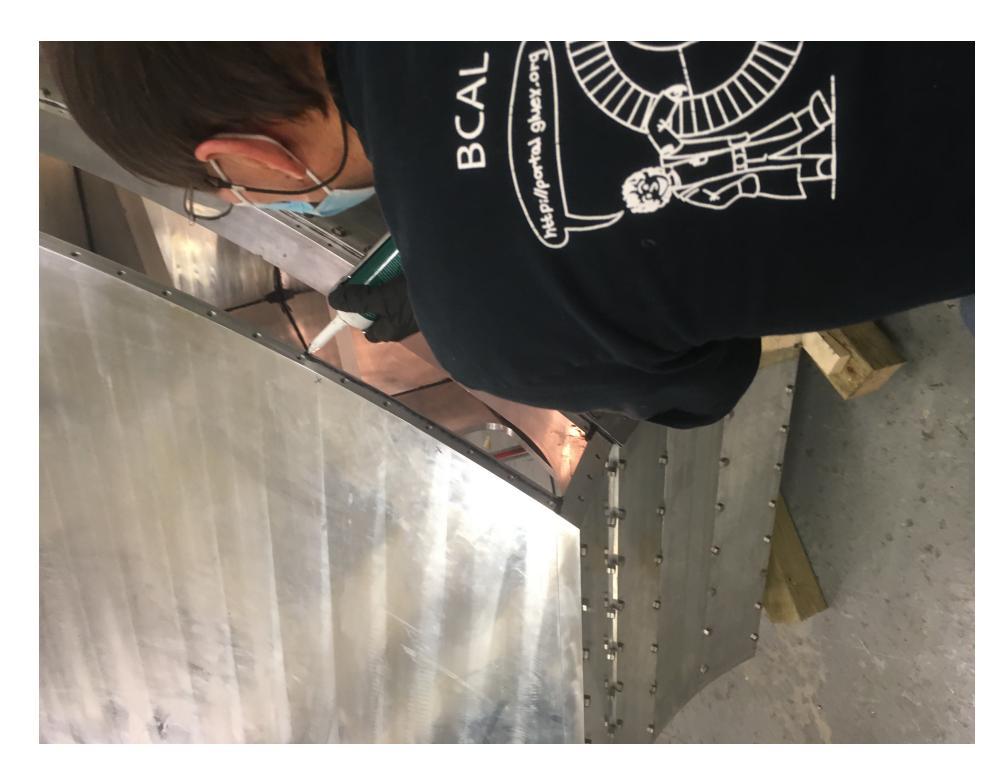
Figure 9: Some sealant was used when bolting on the back panel.

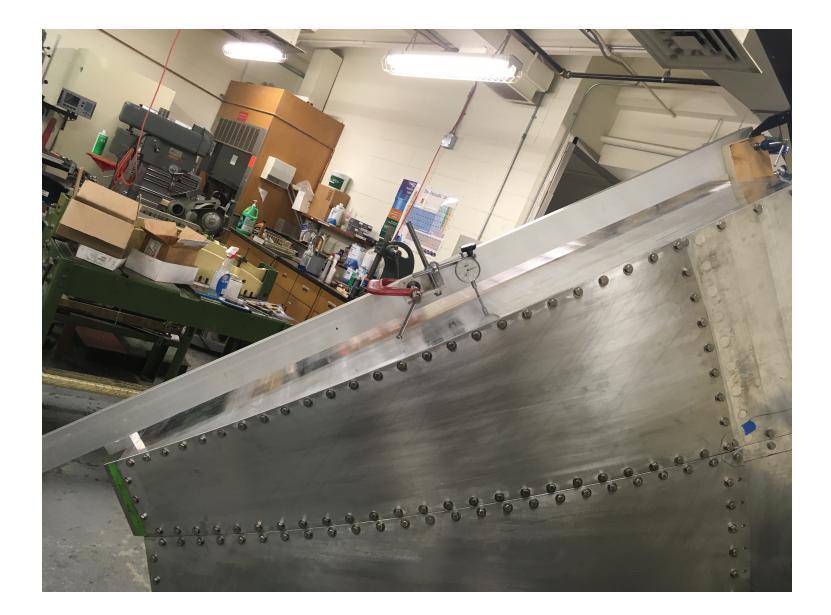
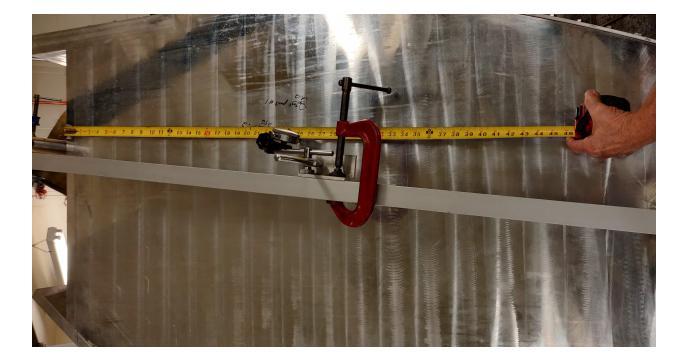
The deflection of the vessel side panel was measured. Measurements were taken by placing a dial gauge suspended by a steel beam on the panel's estimated high point (see Figs. 15 and 16). The vessel was slowly deflated and the decrease from the gauge measured the panel's deflection. The results are in Table 4 and graphed in Fig. 17.

Figure 15: How the deflection of the side panel was measured.

Figure 16: A closer look at the setup for measuring the side panel.

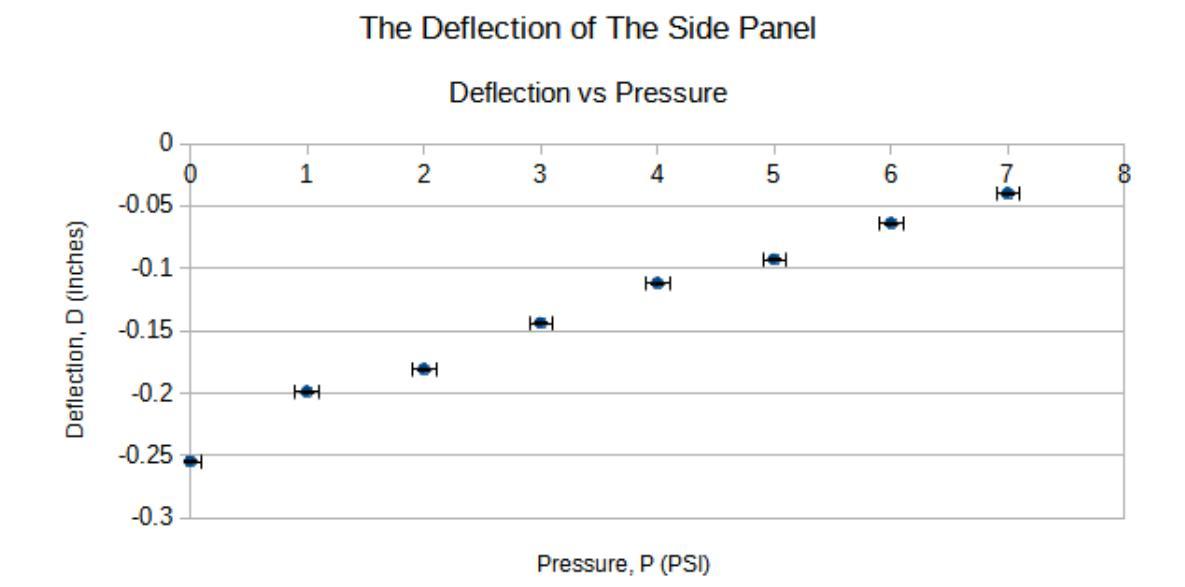
Pressure (psi)	Deflection (inches)	Pressure (Torr)	Deflection (cm)
7.0	-0.040	362	-0.102
6.0	-0.064	311	-0.163
5.0	-0.093	259	-0.236
4.0	-0.112	207	-0.285
3.0	-0.144	155	-0.366
2.0	-0.181	104	-0.460
1.0	-0.199	52	-0.506
0.0	-0.255	0.0	-0.648

Figure 17: The movement of the side panel while the vessel deflates.

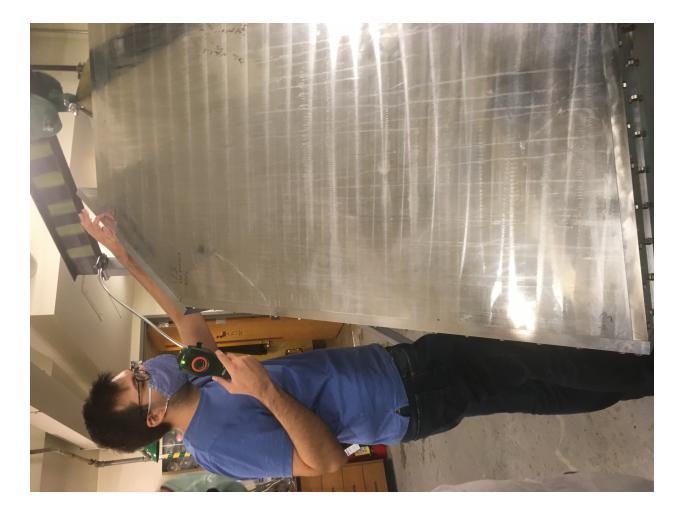
On March 8th, the vessel was first inflated with air to 14.0 psi. Soapy water was spritzed on the vessel, but no leaks were found. The vessel was then left for 2 hours and 45 minutes and the pressure dropped to 13.75 psi. The air was released from the vessel and then it was inflated with a mixture of 98.013% dry air and 1.987% hydrogen[6] to 12 psi (relative pressure). The vessel was tested for leaks using with the EZ40: EzFlex<sup>TM</sup> Combustible Gas Detector [3] natural gas sniffer (see Fig. 20). The sniffer was zeroed outside the room, so that it would tick at a slow rate. The sniffer was then brought into the room and run along the seams of the vessel. If the sniffer is ran by a leak, the tick rate will increase and we'll know that the leak is in that area. The leaks were located:

- By the long sides of the front window frame
- In the corner between the front plate, the front plane extension and the the top front plate PMT
- In-between the bottom plates
- Near the top of the side panel
- Along the seam between back plate and the back plate extension
- Near the valve and the ribs

Figure 20: The hydrogen test is done with a natural gas sniffer
