Magnet, Support and Infrastructure

Whit Seay March 5, 2016

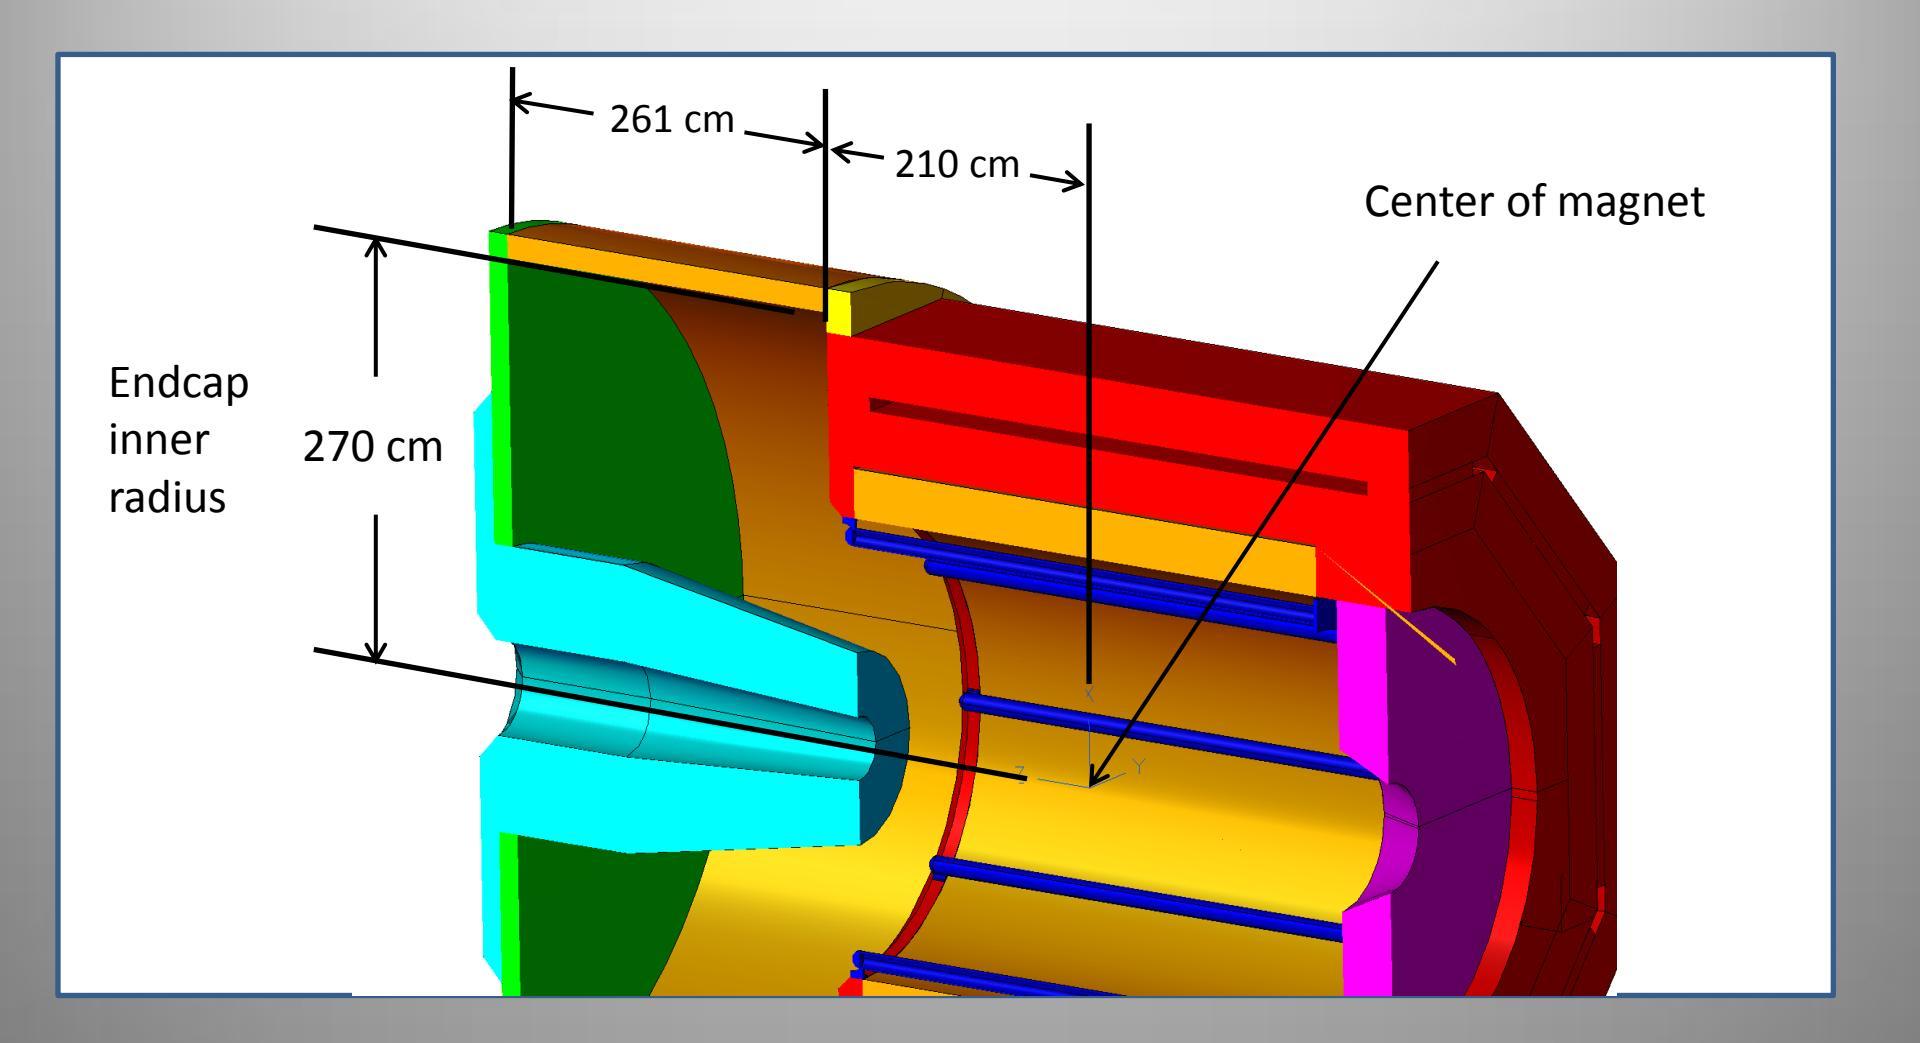
A Few Notable Dimensions of the Endcap

original endcap – not Jay's extended version

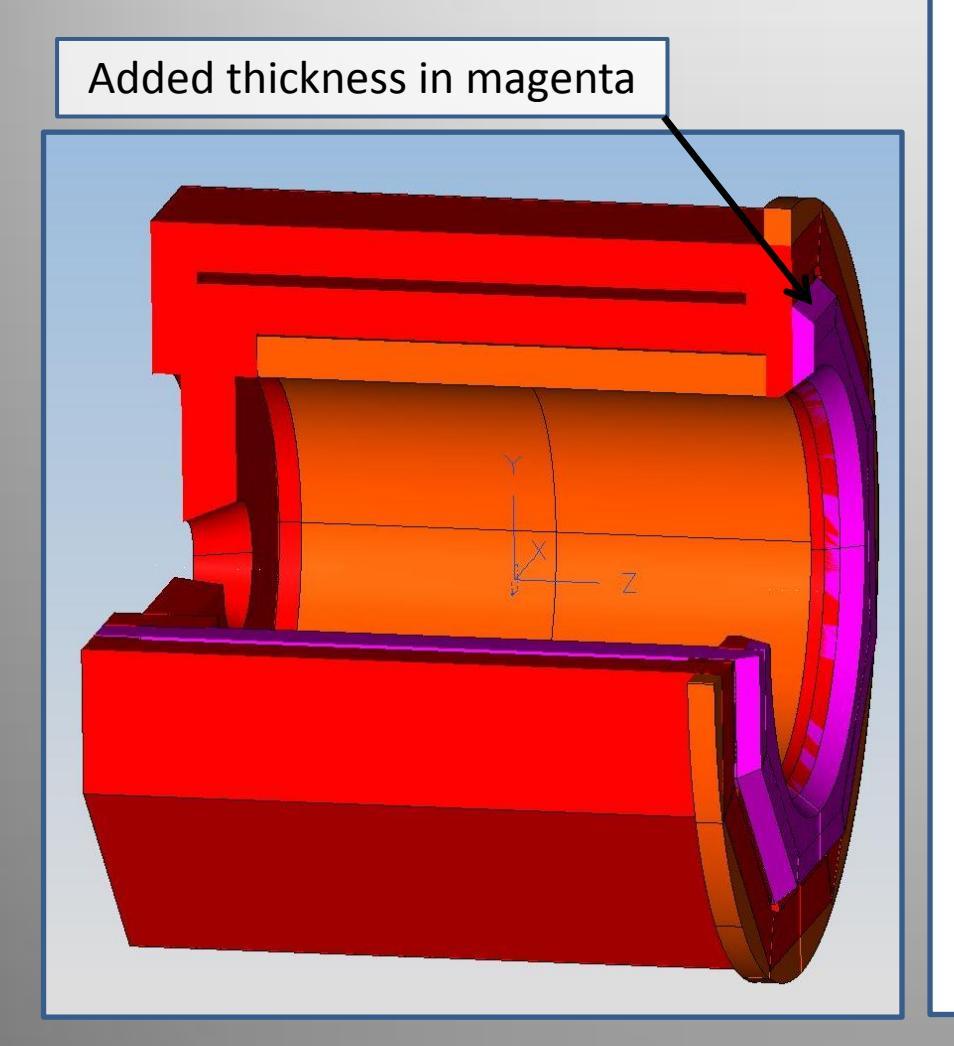
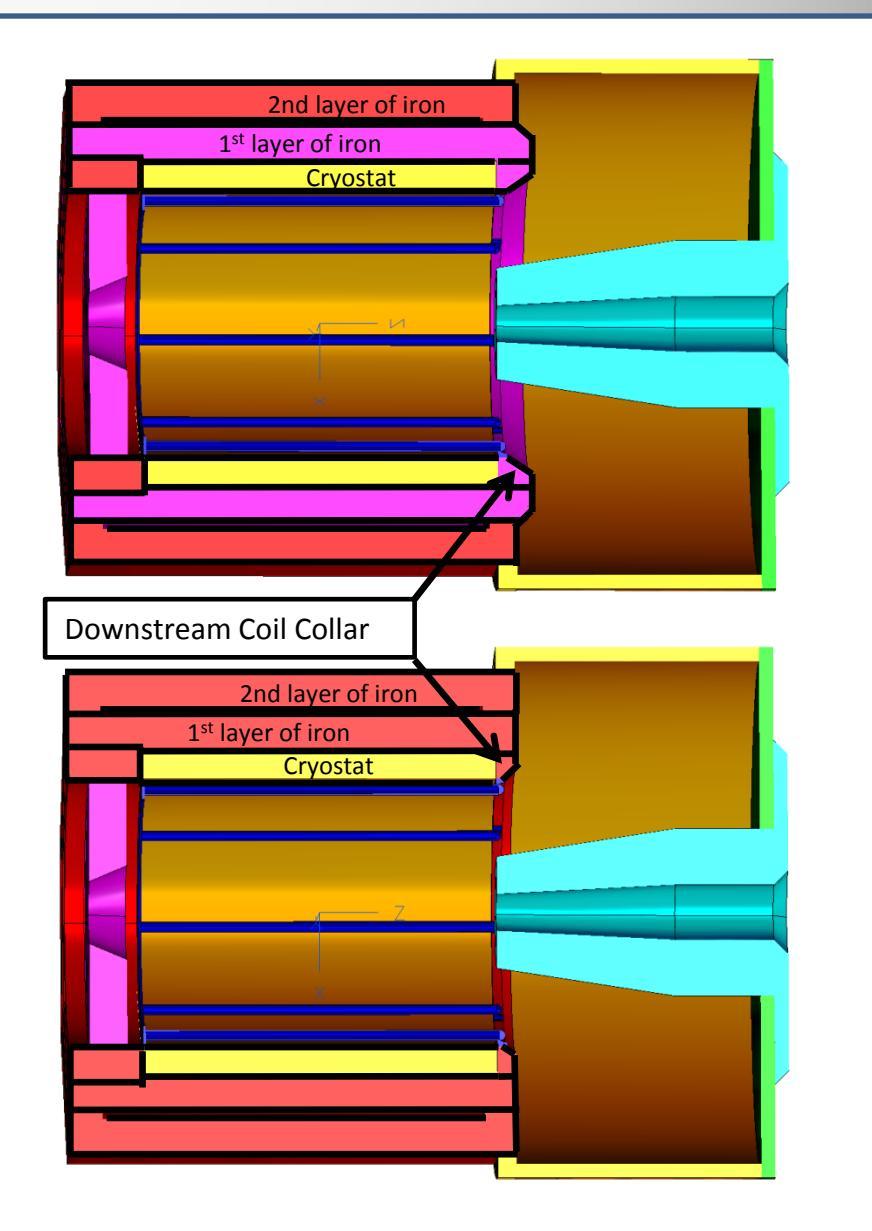
Thicker Coil Collar and Extended 1st layer of Iron

Thickness of DS coil collar increased from 20 cm up to 35.6 cm. 1st layer of iron's length increased by same amount with a 38.6 deg chamfer added at the top.

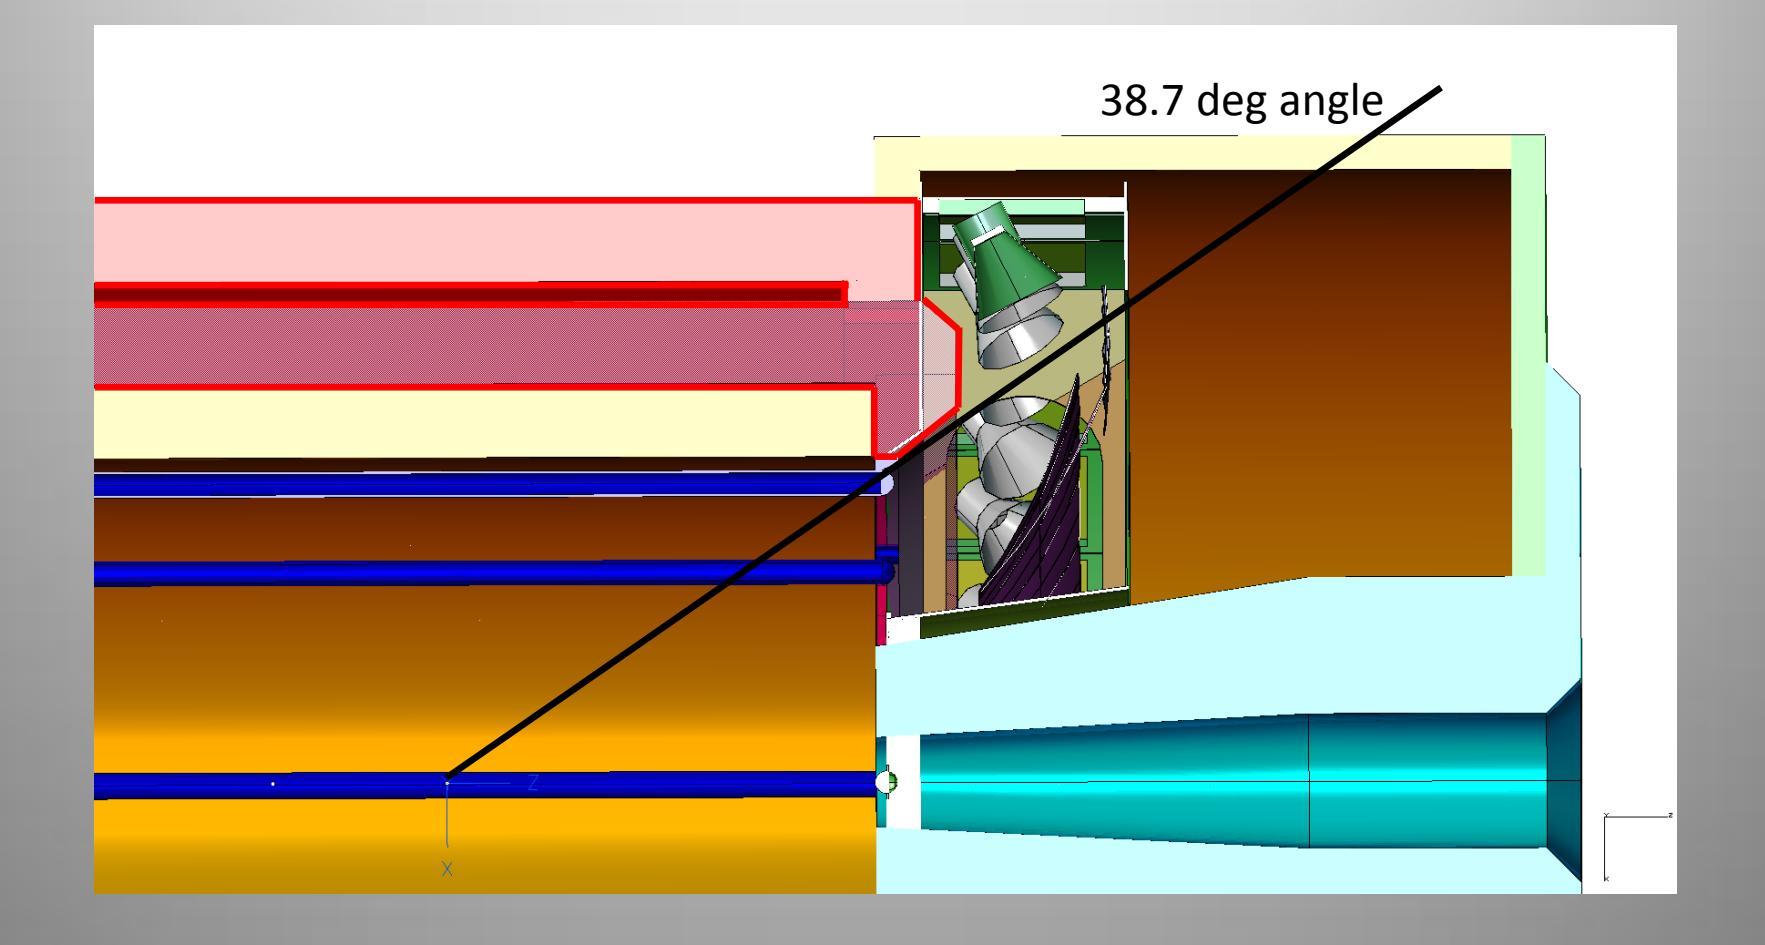
Extended Iron into LGC Space

The LGC's cones and PMT's appear to have clearance with the extended iron. The tip of the cone is 3.96" from face of the iron at its closest approach.

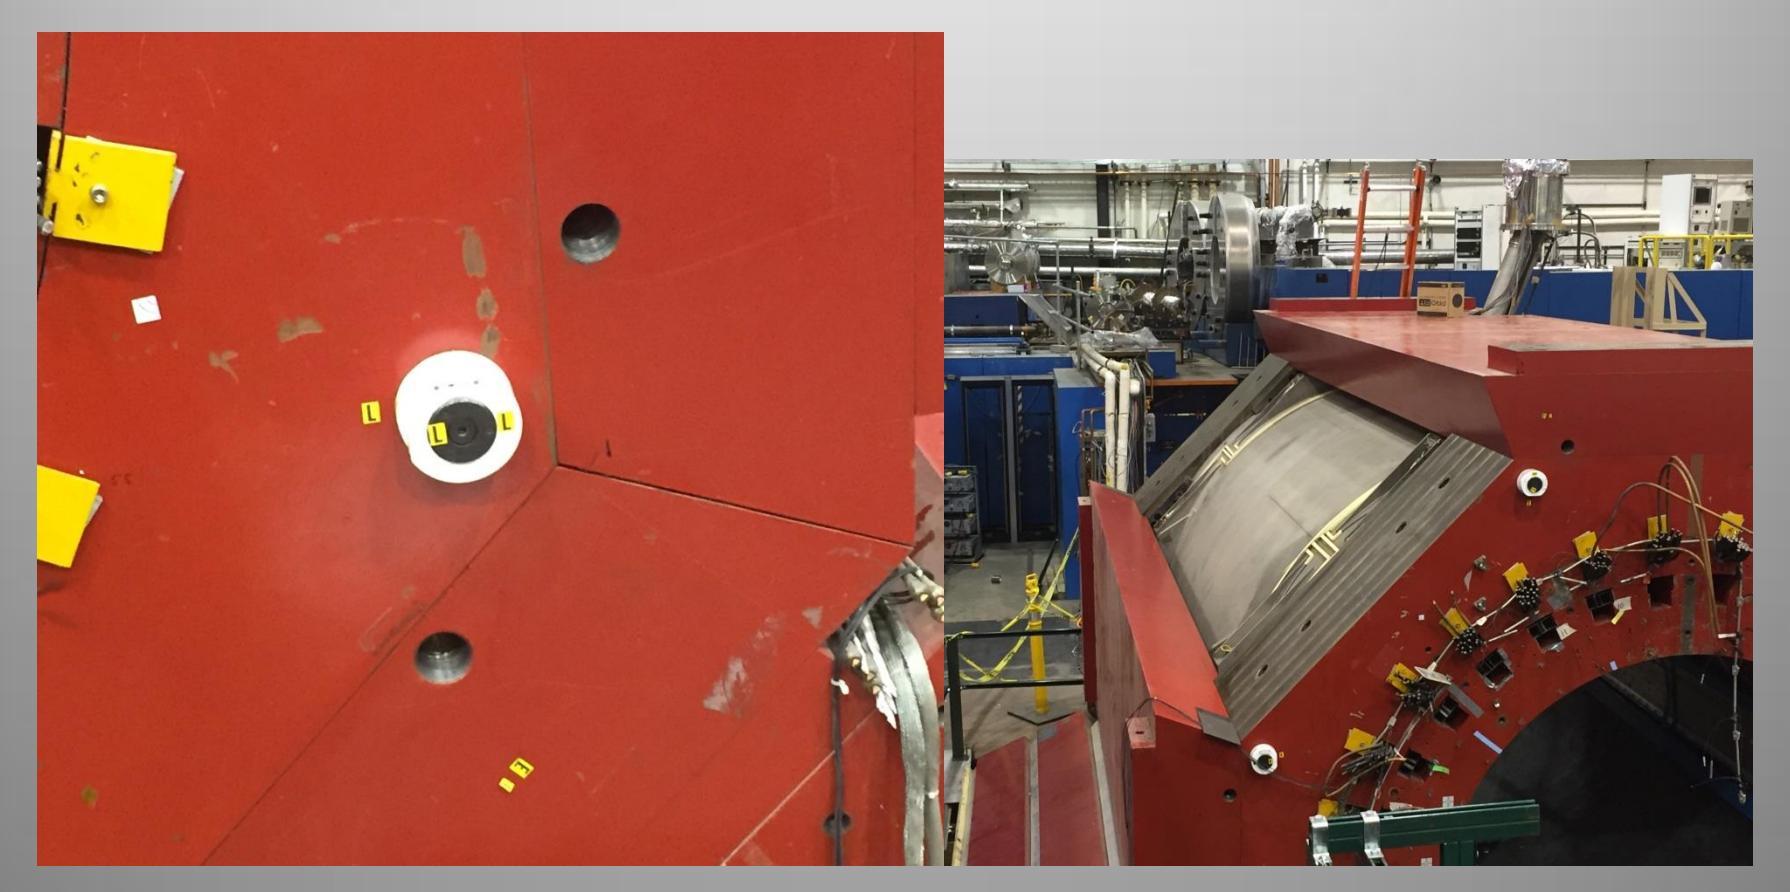
Radial Coil Support Adjusters

There are eight, white puck sized cylinders adjusters, that sit on the downstream face of the coil collar that adjust the radial forces on the coil supports. There are mechanical counters built into the pucks that provide feedback of coil position. The pucks will also need clearance that will intrude into the LGC space. Our model does not have that level of detail yet.

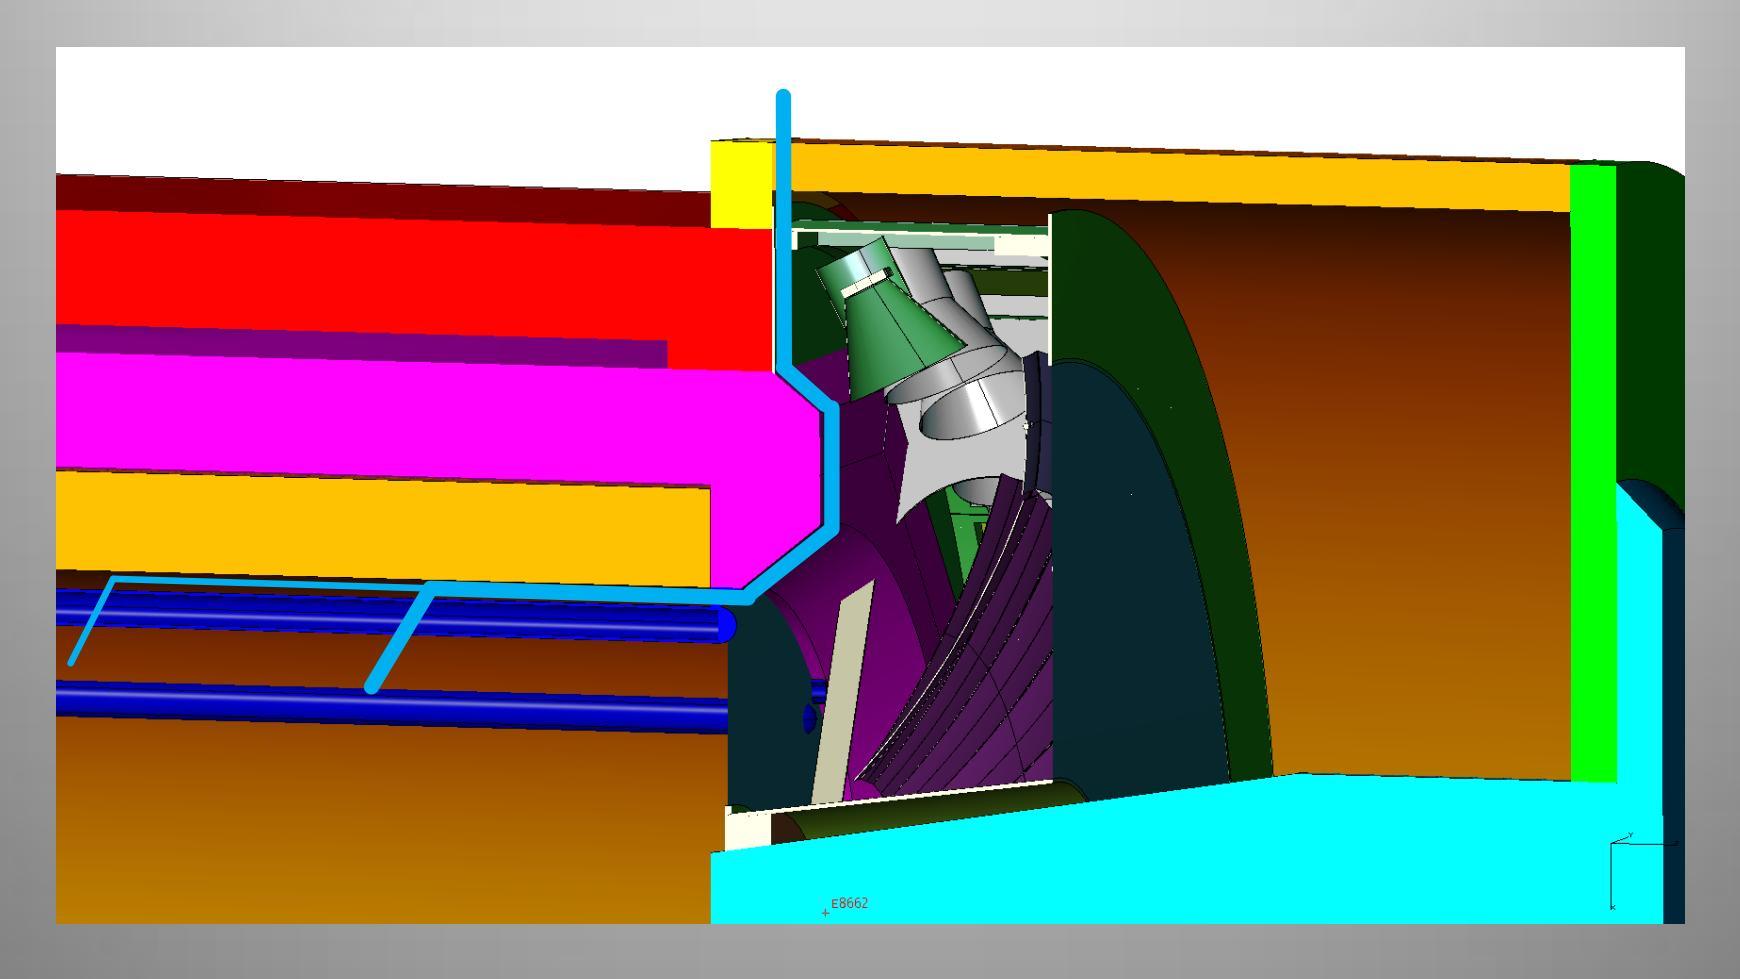
Cable Routing?

Below demonstrates the possibility of running cables from inside the bore downstream and out radially along the perimeter of the coil collar, layers of return iron and out through opening in the front of the endcap. This could create channels for bundles to weaves their way out. This also impacts the LGC space.

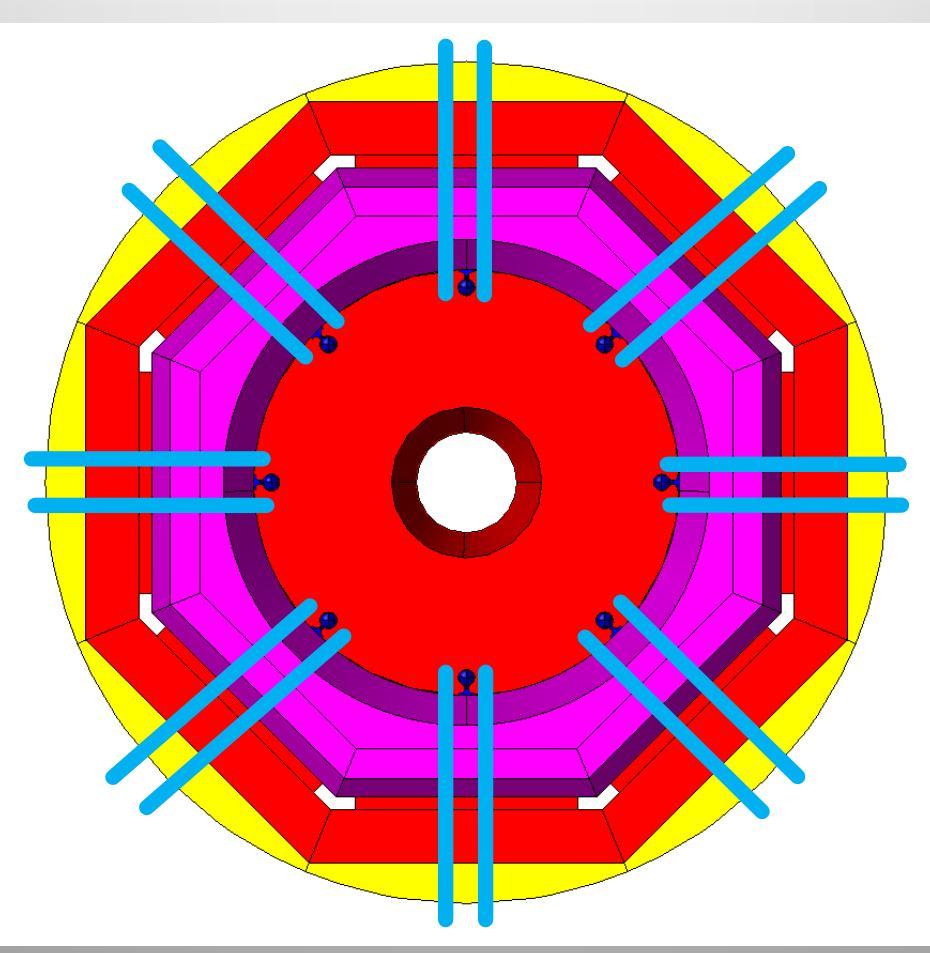
Cable Routing Continued

Looking upstream towards the target at the rear of the magnet steel. The endcap and detectors are hiding for clarity.

Eight sectors for cable exit were chosen because of ease to replicate in powerpoint. It seems logical the number of routes and the paths taken would be dictated by the total volume of bundles and the location of DAQ interfaces.
